PACIFIC PILOTAGE AUTHORITY

NOTICE TO INDUSTRY

Notice Number: 02/2020

Subject: Standards for Pilot Transfer Arrangements

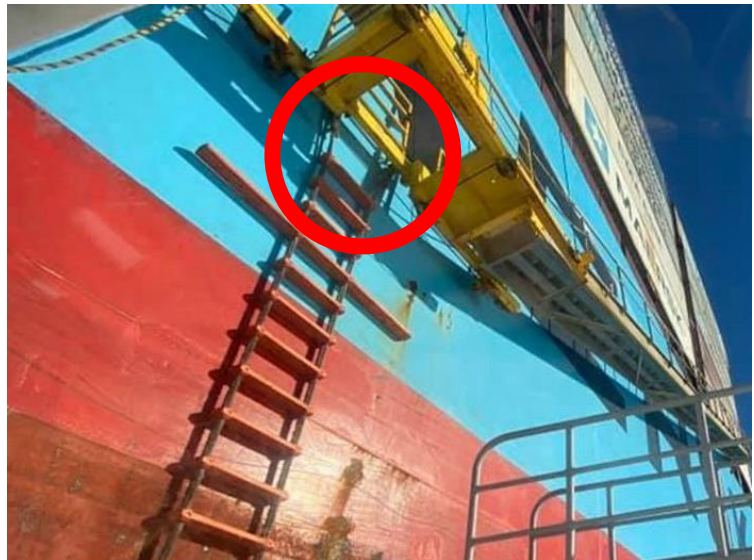
On 30 December 2019, a New York marine pilot fell and sustained severe injuries when he endeavored to transfer from the pilot ladder to the accommodation ladder through a trapdoor in the platform of the accommodation ladder. The pilot subsequently died of his injuries.

The pilot ladder was rigged in a manner whereby it was hanging from a bar near the bottom of the platform. The top step of the pilot ladder was significantly below the level of the platform. In such cases, pilots must pull themselves through the trapdoor while twisting to get a secure footing on the accommodation ladder platform.

Figure 1 - Improperly rigged pilot transfer arrangement

The combined arrangement of the pilot ladder and accommodation ladder were contributing factors in the recent death of the US pilot. The Pacific Pilotage Authority requires that pilot transfer arrangements be in full compliance with both SOLAS Chapter V, Regulation 23, and IMO Circular 1045(27). If trapdoors are used, the pilot ladder steps **must** extend above the platform up to the height of the handrail and securely fastened to a strongpoint on deck. Vessels with pilot transfer arrangements that do not meet these standards are at risk that the pilot may not board until the transfer arrangement has been corrected and complies with the above requirements.
