# National Transportation Safety Board

## Marine Accident Brief

### Contact of *Cooperative Spirit* Tow with Hale Boggs Memorial Bridge Pier

<b>Accident type</b>	Contact	<b>No.</b> DCA20FM015
<b>Vessel names</b>	<i>Cooperative Spirit</i> , ART1008, ART44080B, and other barges	
<b>Location</b>	Lower Mississippi River, mile 121.6, near Luling, Louisiana 29°56.52' N, 90°22.45 W	
<b>Date</b>	March 15, 2020	
<b>Time</b>	0113 central daylight time (coordinated universal time – 5 hours)	
<b>Injuries</b>	None	
<b>Property damage</b>	\$1.65 million est. (barges and lost cargo)	
<b>Environmental damage</b>	None reported	
<b>Weather</b>	Visibility 10 miles, clear, winds east-southeast at 5 knots, air temperature 68°F, water temperature 50°F	
<b>Waterway information</b>	The Lower Mississippi River near Luling, Louisiana, is about 0.5 miles wide. Barge anchorages line both sides of the navigable channel. On the accident date, the river stage at the Carrollton Gage, 19 miles downriver in New Orleans, was 15.3 feet, and the current was reported to be 6 miles per hour at the accident location.

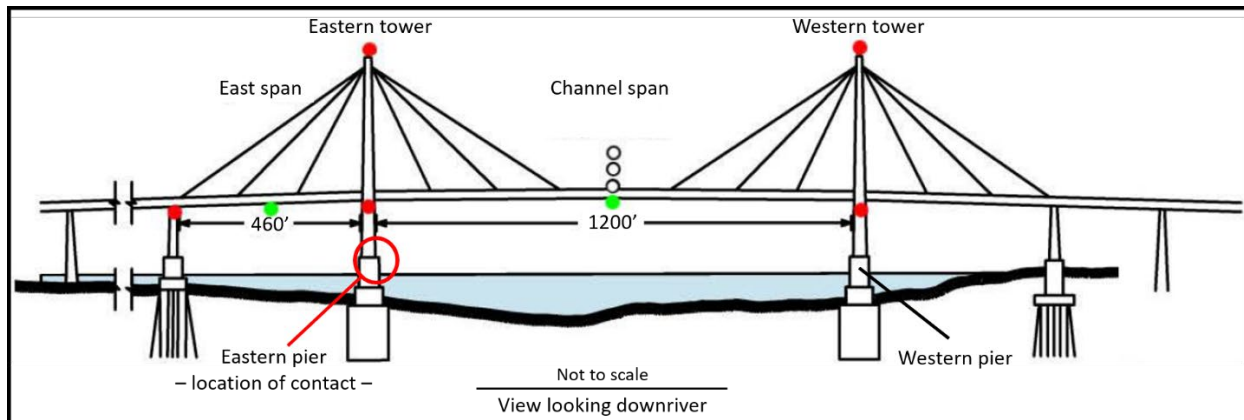
The Hale Boggs Memorial Bridge, with location of bridge strike on eastern tower pier indicated by a red circle. (Background source: US Army Corps of Engineers)

At 0113:03, barges *ART1008* and *ART44080B* on the forward port side of the *Cooperative Spirit* tow struck the eastern pier of the Hale Boggs Memorial Bridge at a speed of 11.9 mph. The tow immediately broke apart, and the *ART1008* eventually sank, stern first, about 1 mile downriver from the bridge, with its bow remaining above the water. The remaining barges floated freely

Barge *ART1008* was salvaged and later determined to be a constructive total loss. Barge *ART44080B* was also deemed a total loss following a damage assessment. Several other barges in the tow and along the river bank were damaged and required repairs. The eastern tower pier was scraped by the tow but did not require any repairs.

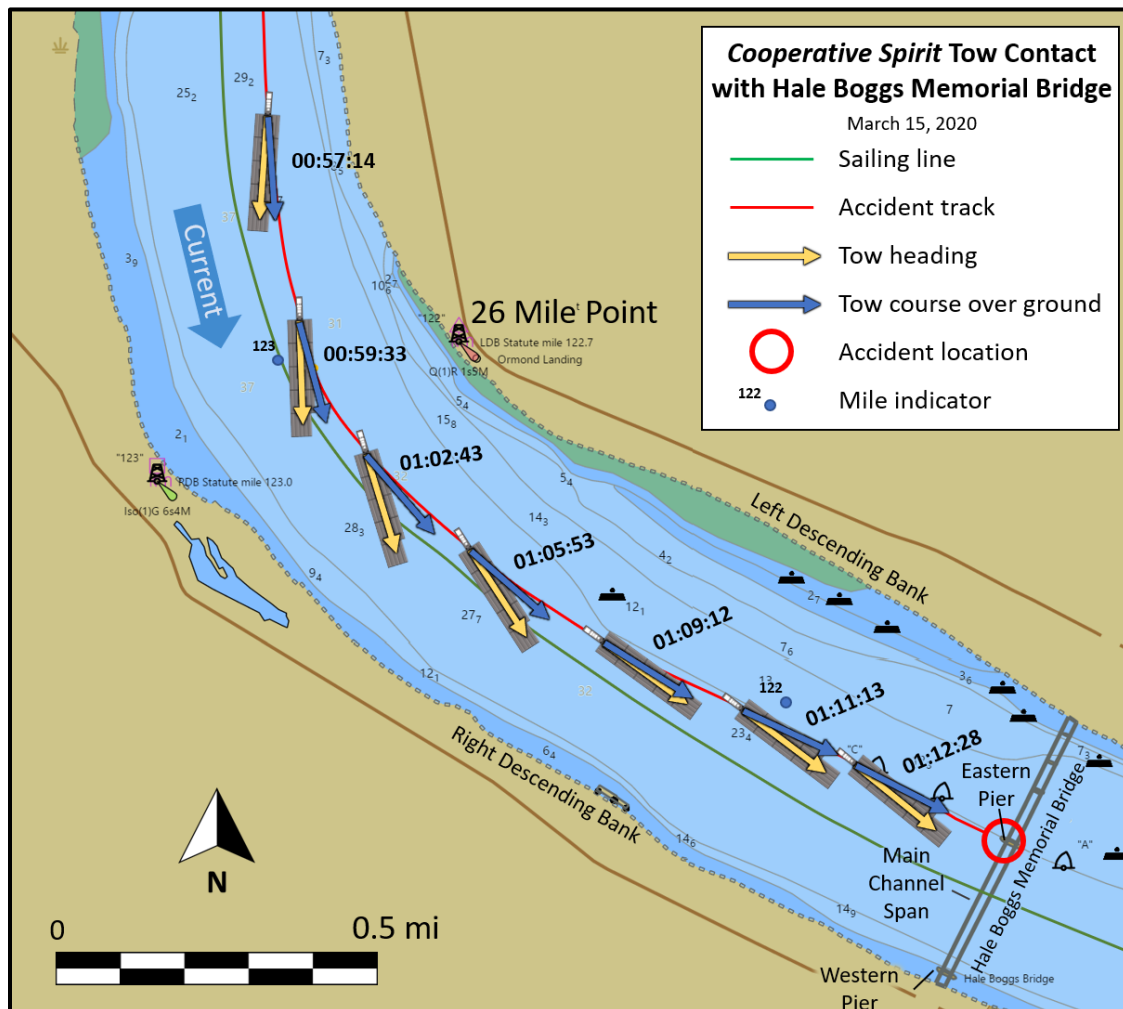
**Track of *Cooperative Spirit* tow as it flanked the bend at 26 Mile Point and maneuvered prior to the accident. (Background source: National Oceanic and Atmospheric Administration electronic navigation chart US5LA52M)**

At 0110:12, the tow was about 0.30 miles from the bridge, and its heading was 124 degrees. The course over ground was 114 degrees, with the tow continuing to move toward the left descending bank and the eastern bridge pier at a speed of 7.25 mph. The pilot increased speed on the center and starboard shafts and then, 30 seconds later, increased speed on all propeller shafts to their maximum of 212 rpm. Although the tow's heading had shifted 3 degrees to starboard by 0111:13, its course over ground had shifted only 1 degree to starboard. The pilot applied starboard rudder for short periods, and the tow's course over ground began to turn more quickly to starboard, but the change was not sufficient to avoid hitting the bridge.

The pilot stated that, as the tow came out of the turn at 26 Mile Point, the stern of his vessel was too close to the left descending bank, and the current was setting the tow into the bridge pier. About 3 minutes before the accident, the tow’s heading was 124 degrees, while its course over ground was 114 degrees, which is consistent with the pilot’s statement. Due to high-water conditions, the current was stronger than normal, and an eddy may have formed upriver of the bridge along the left descending bank, making maneuvering more difficult.

Although the pilot stated that he used starboard rudder and increased engine speed in an attempt to counteract the current, the video evidence showed that he used limited rudder as the tow approached the bridge. The pilot chose to primarily use increased engine speed in an effort to move the tow to starboard away from the bridge pier, stating that he “tried to outrun [the current].” However, the tow’s course over ground did not appreciably change as engine speed increased, while the increasing speed over ground reduced the time the pilot had to maneuver. Ultimately, the pilot’s actions in compensating for the strong current were ineffective, resulting in the tow hitting the bridge’s eastern tower pier.
