1000 stanchions around....

Which ones are correct and which ones are killers?

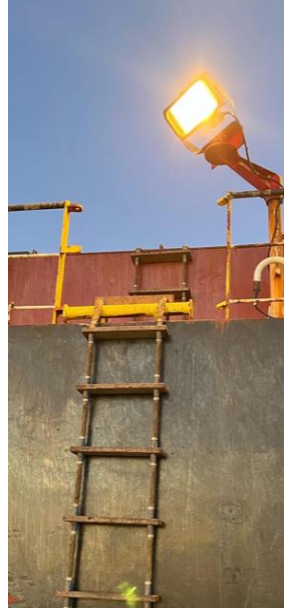
No stanchions provided...

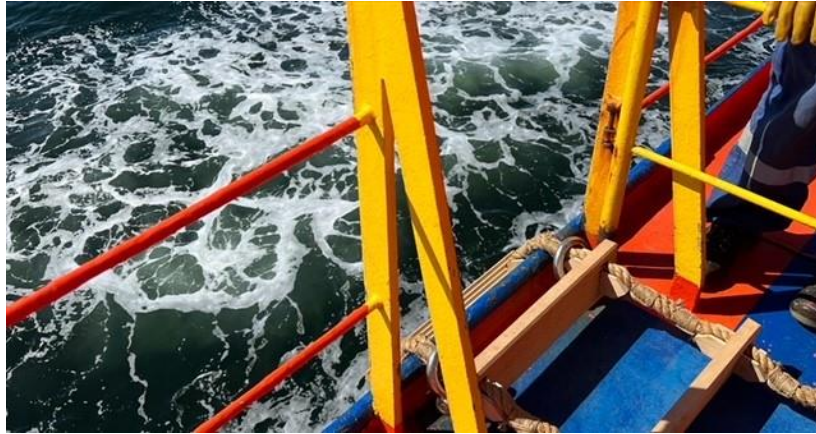
Again no stanchions present...

In rule one (general) this resolution states “ship designers are encouraged to consider all aspects of pilot transfer arrangements at an early stage in design..... “ In the few photos earlier in the article we can clearly see that the stanchions were designed nor placed. Basically, this means the pilot transfer arrangement has not been designed in accordance with regulations, but of course it is nevertheless class approved. I have told this before and I will keep repeating this: whenever a pilot is confronted with a pilot transfer arrangement that is to be considered ‘non-compliant by design’, it means the entire chain of design, construction, classification, surveys, vetting and flag state inspections have failed, resulting into a dangerous setup.

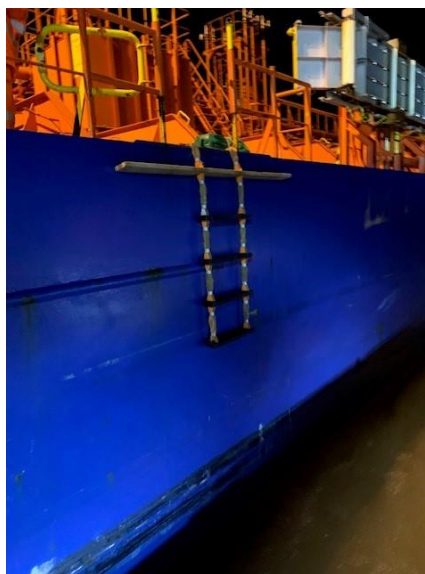
Again, no stanchions, seems like a trend...

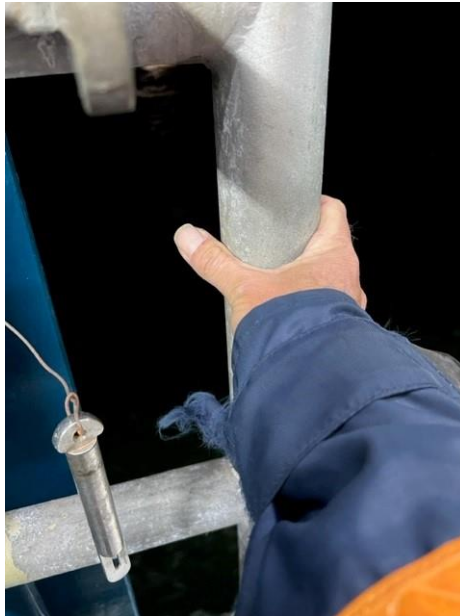
No firm grip, slipping hazard..

The vessel in the above photo is a newbuild. All signed off and approved by class. I wonder if the class inspector actually inspects the vessel thoroughly or is he/she due to the immense work pressure that is put on class inspectors during the final stage of a newbuild process, confined in the office with 3 laptops, 2 computers and various telephones... working hard to sign off the lot? Looking at the minimum diameter of a stanchion on which we just read something, it seems ok: the diameter is more than 32mm.. thanks for nothing on this one.

Is it safe? No, it is not safe and therefore non-compliant. Actions taken by the writer of this article were to contact class/psc and owner of the vessel. Together with the owner of the vessel we worked out a solution and now the setup is safe to use. Basically, a waste of time and money when you have to do the job twice. Root cause is obviously that in the design phase the rules on pilot transfer arrangements were overlooked or in best case scenario read diagonally and fast.

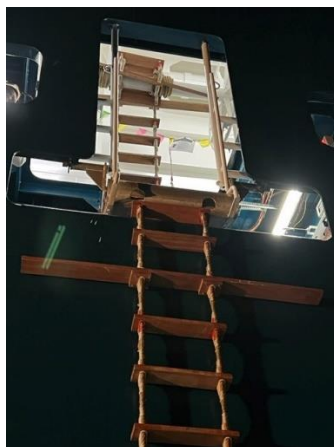
All's well that ends well

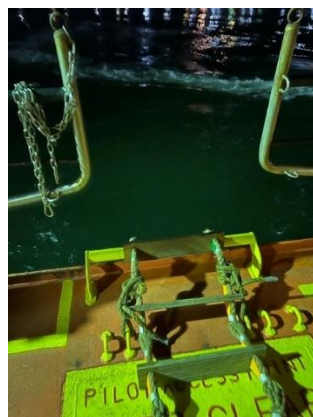
Why does it seem so difficult???

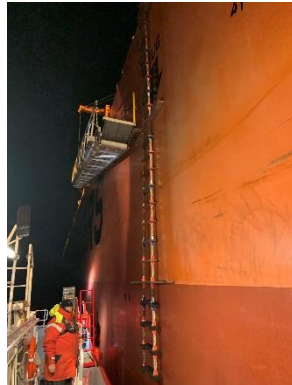
In the photo above we can clearly see the outboard stanchion plus protective ropes have been forgotten for some reason... quite scary when you're on a moving 60x60cm platform and there is nothing to hold on to or prevent you from tipping over the side. Normally the inside stanchion is not installed as per regulations. Upon asking the crew, they told me that some pilots demand the inboard stanchion to be removed... This again proves the fact that we are our own worst enemies, you just need it to transfer yourself from the ladder to the gangway and vice versa, it's there for a reason.

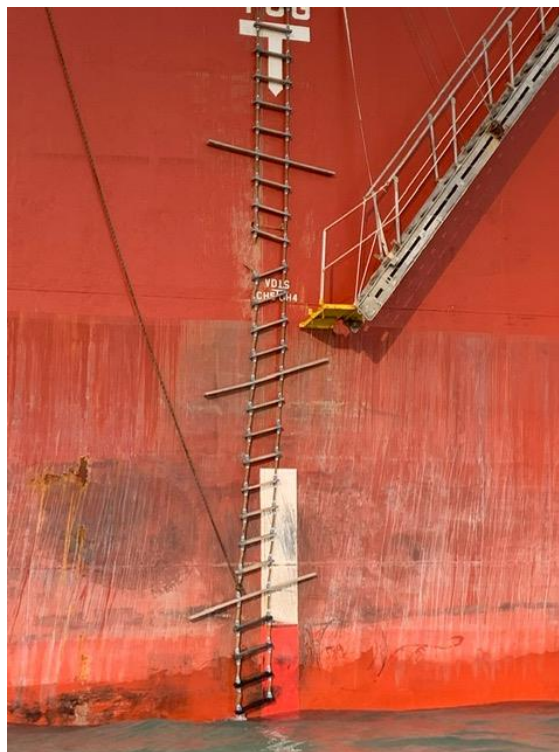
See? Inboard stanchion missing... Ow and this ladder snapped when the pilot tried to climb up... did I mention the badly rigged retrieval line as well as the ladder being uncertified and therefore illegal?

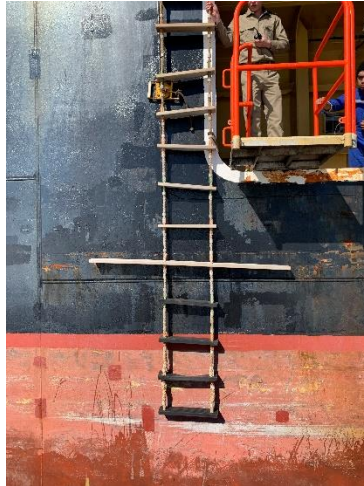
Correct stanchions

Ladder incorrectly secured at the hull

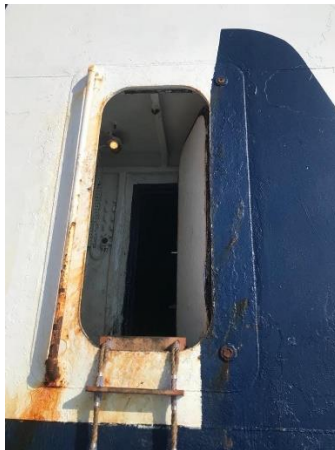
No stanchions again..

Looks a bit creepy even
