Title of Work: *Securing of pilot ladders at intermediate lengths – testing*

Reference No: *NCC453*

Work for: *International Maritime Pilots Association*

Report Issue No. *3*  
Date: *17 July 2023*

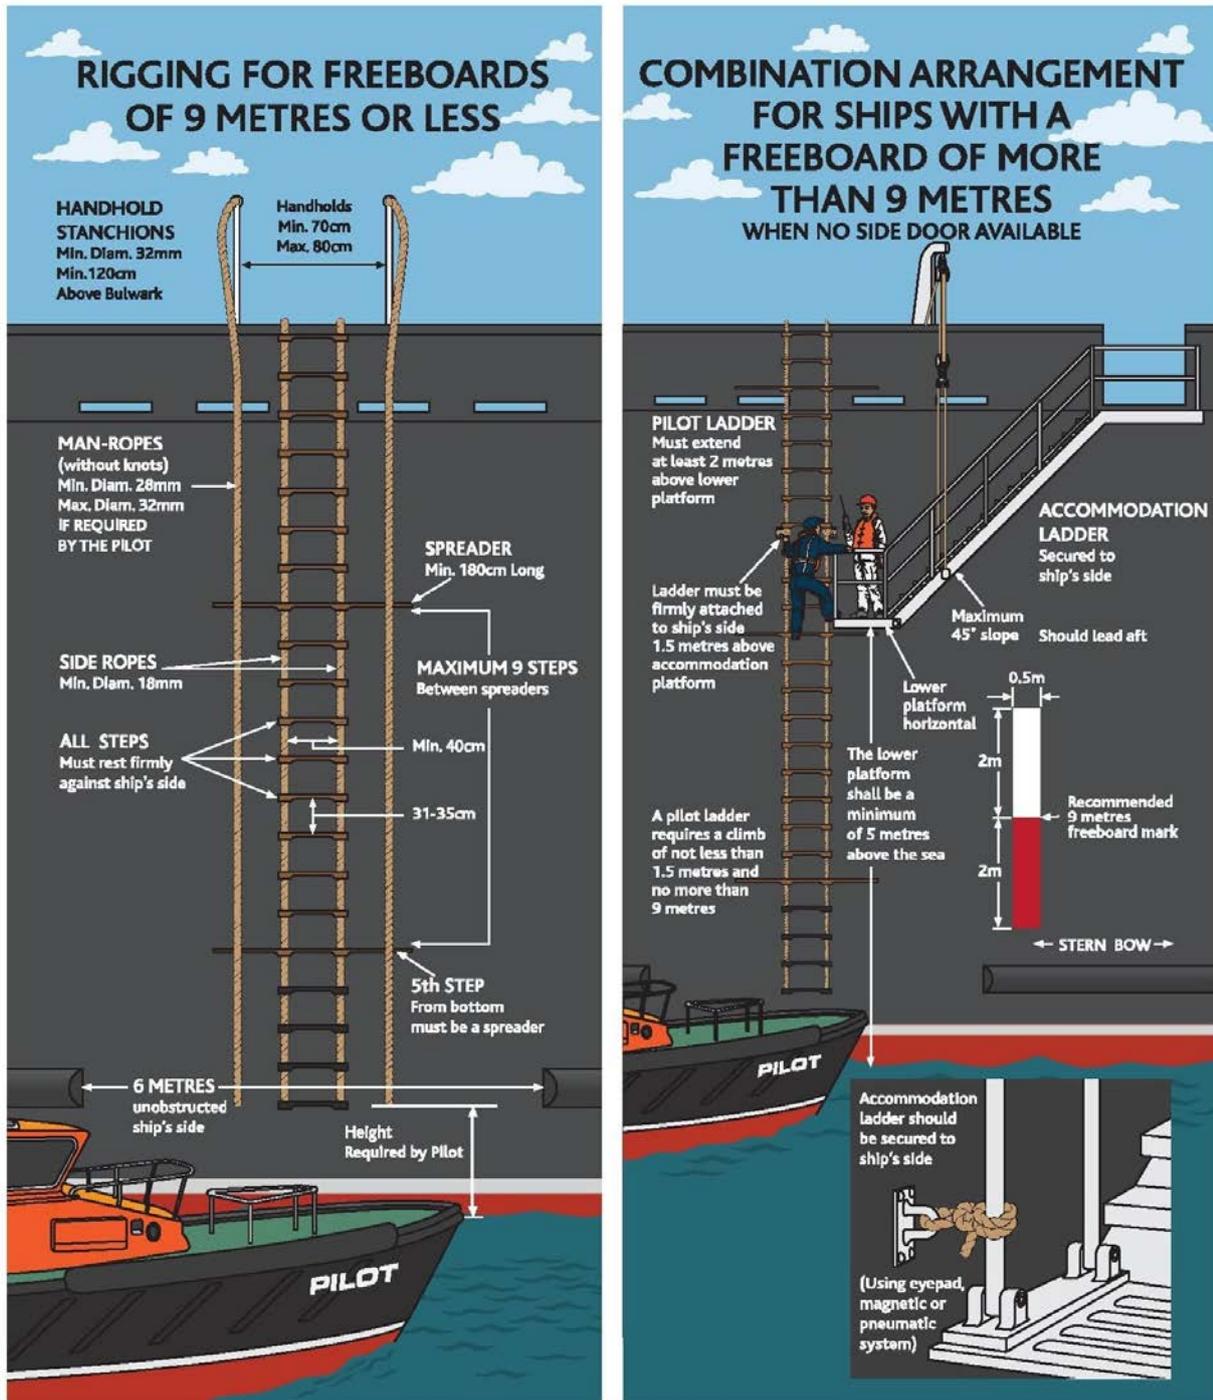
Figure 1: Schematic showing two examples of pilot ladders less than and more than 9 metres in length in-use.

Schematics of a typical pilot ladder arrangements are given in Figure 1. The ladder steps are held in place by step fixings (wood or plastic) and either rope seizing or a metal clip, as shown in Figure 3. The top of each ladder side rope end with a shackle (see Figure 2). These shackles are used to secure the ladder to hard points on the ship, when deploying the full ladder length.

- The weight of the ladder cannot be transferred to the steps, the spreaders (Figure 1) or the chocks (Figure 3), since they are not intended to be used for this purpose.
- The securing arrangement must be such that no damage is done to the structural integrity of the pilot ladder.

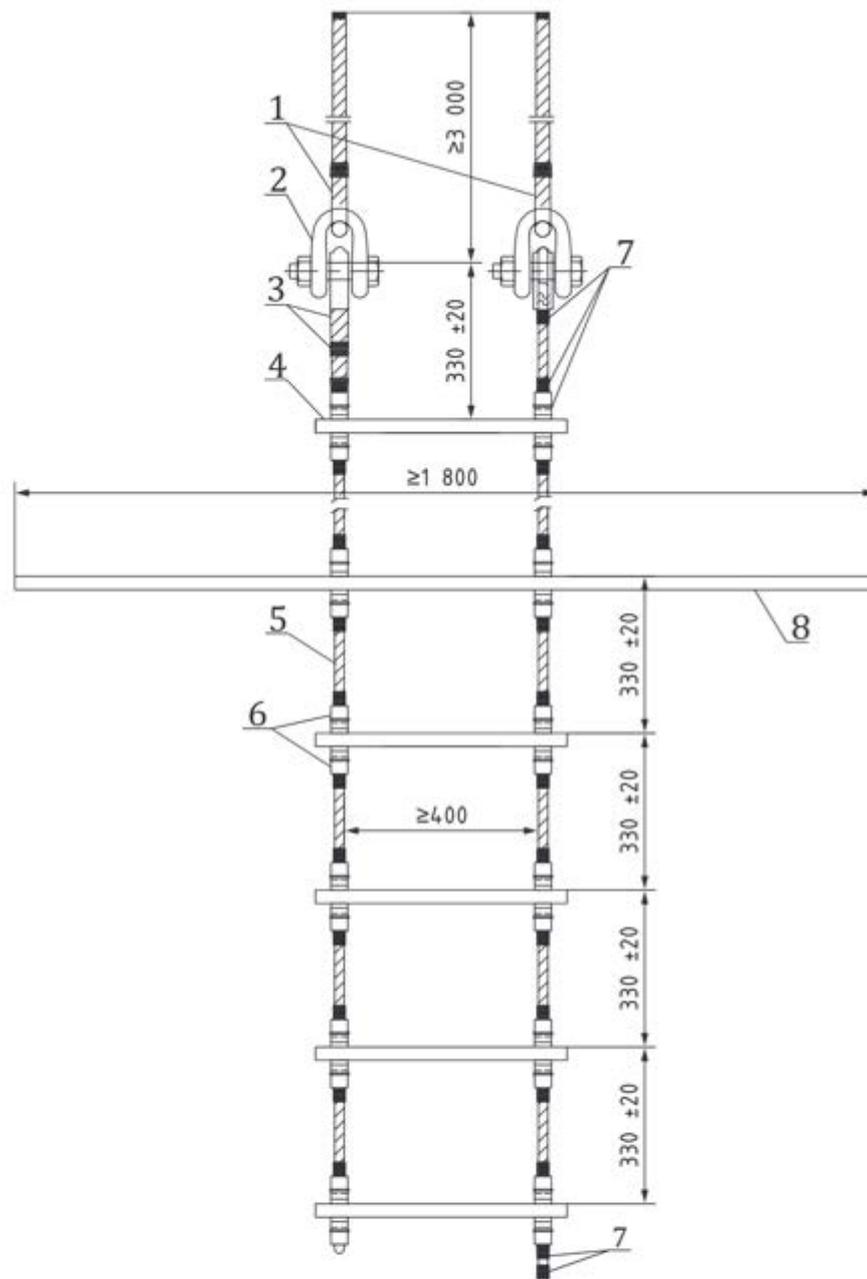
Figure 2: Construction details of a typical pilot ladder from BS ISO 799-1 2019.

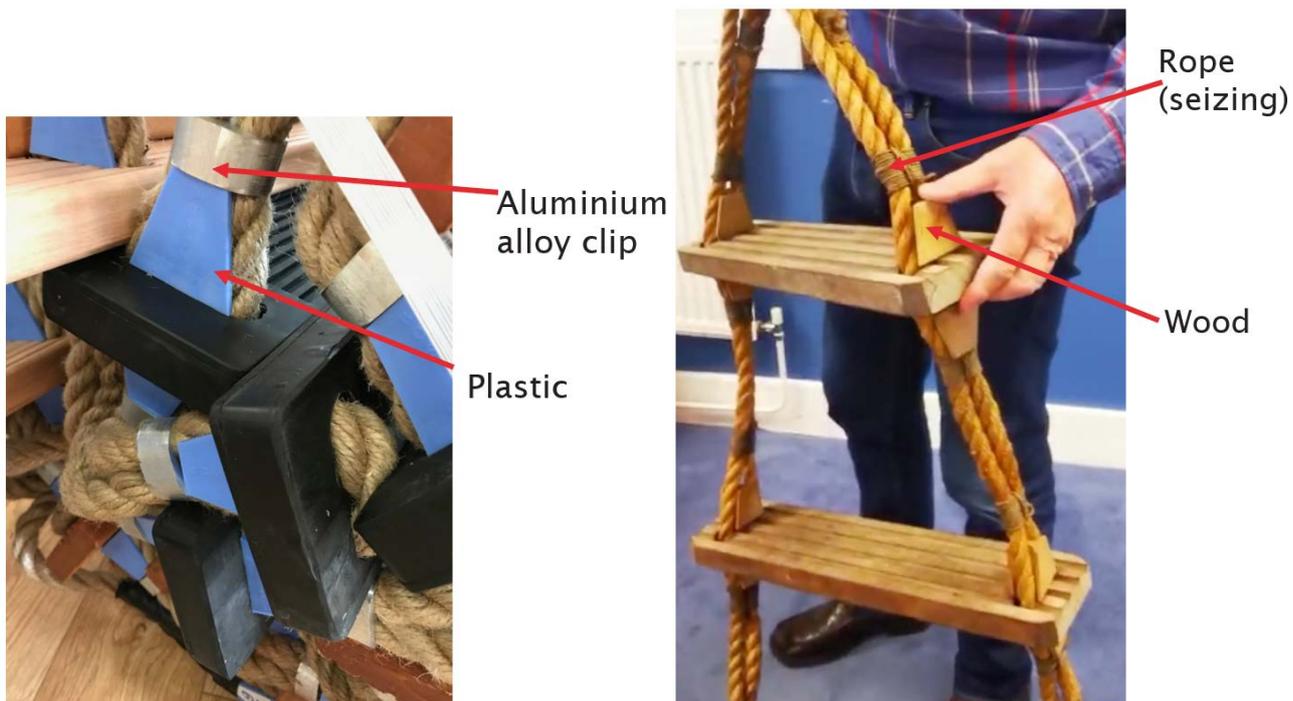
Figure 3: Step fixing (wedge/widget/chocks) with plastic and aluminium construction (left) and with wood (right) with rope seizing construction.

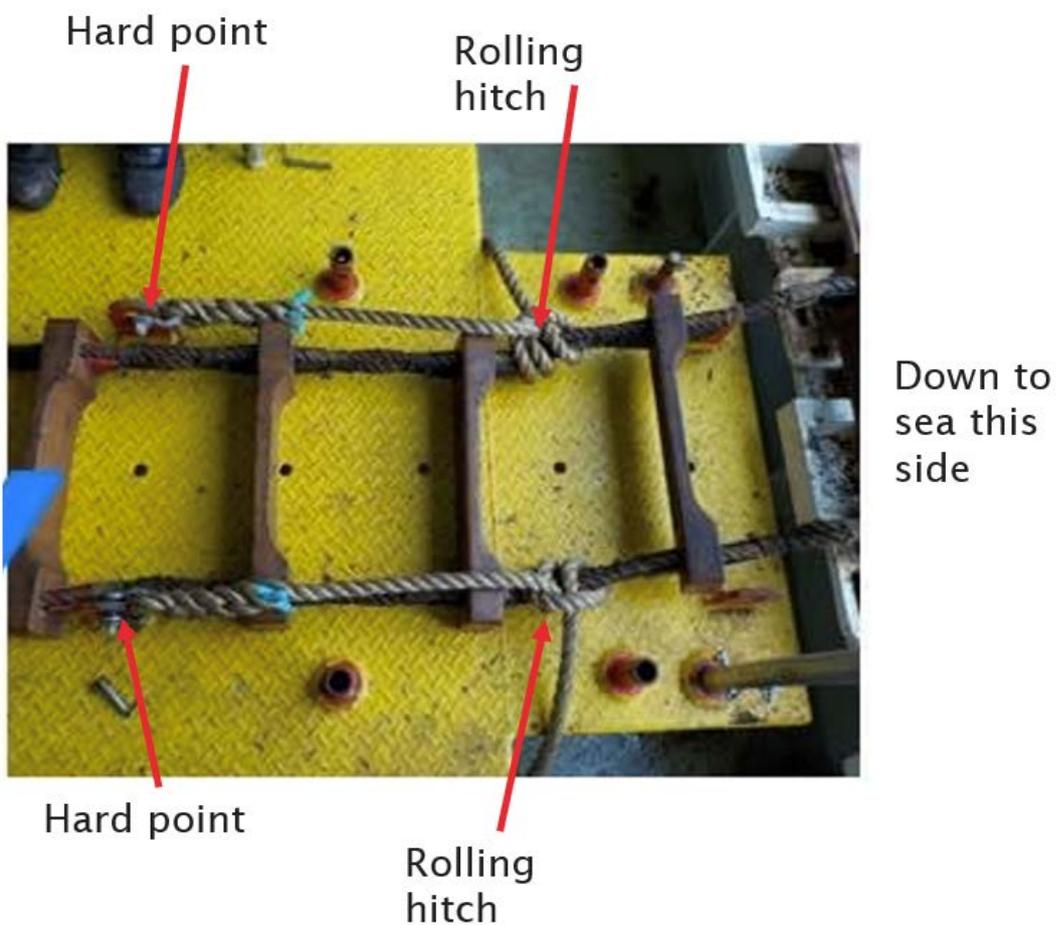
Figure 4: Example of tie-off of intermediate ladder length using rope.

- Hitches – whereby a short length of rope is secured to the ship via a hard point such as a lug, and secured at the other end to the ladder via either a cow hitch or rolling hitch (Figure 4). In this scenario, the slippage of the rope and possible wear on the ladder is of concern.
- 'D' shackles – The ladder ropes are secured to the hard point without the use of other ropes (Figure 5). In this scenario, the force applied to the step fixing pieces from the shackle may cause damage to the step fixing pieces.
- Loading Straps – Cargo lifting straps have been used to secure the ladder via cow hitches (Figure 6). In this scenario, potential slippage and wear of cargo straps or ladder rope is of concern.

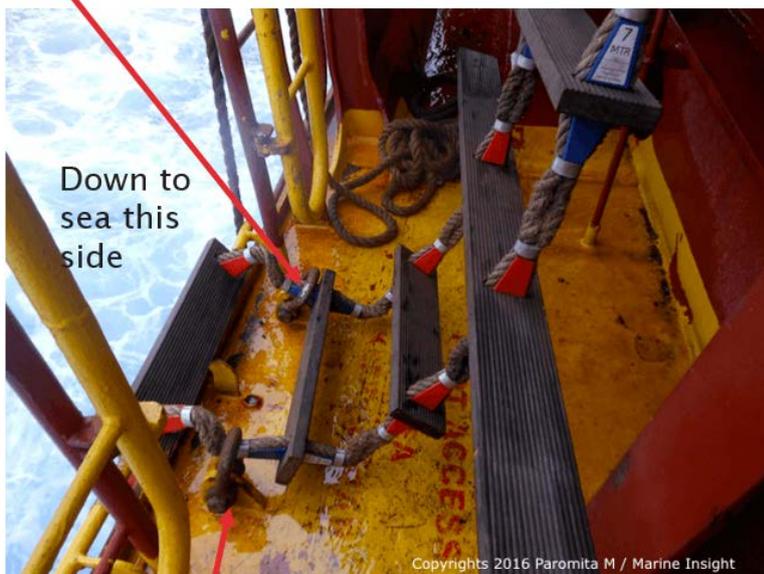
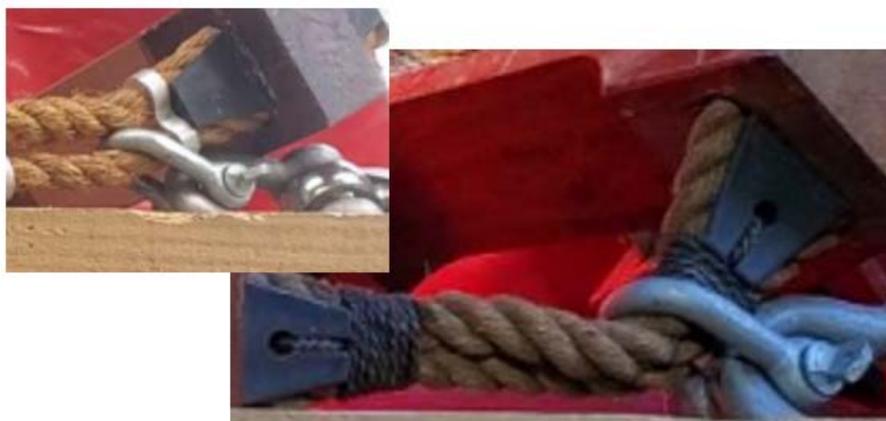
Figure 5: An example of 'D' shackles being used as a tie-off method.

Rope ladders used in-service are frequently being secured with the use of D shackles in a shackle within shackle arrangement, see Figure 5. The aim of Work Package 3 (WP3) was to design and perform a repetitive test in the laboratory that would simulate the loading from D-shackle attachments on a section of a pilot ladder. The aim of the work was to investigate this securing method and determine the wear of the pilot ladder over its intended life in-service. Focus was made on one side of the ladder. It was assumed that the D-shackle would be attached across the rope pair between two steps and that this shackle would in turn have another floating shackle connected to this – which in service may be a hard point or thimble connection for further securing the rope length.

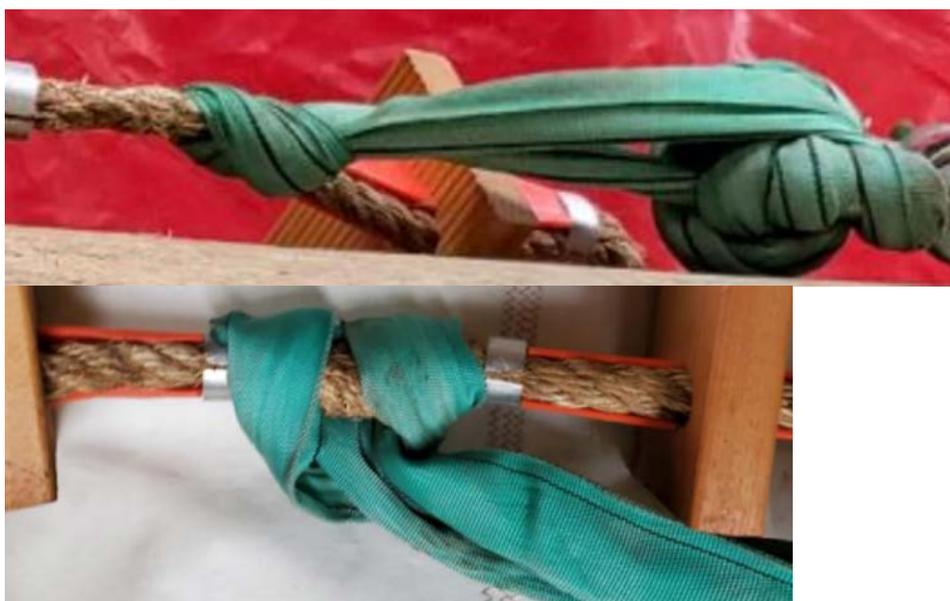
Figure 6: An example of loading straps (cargo lifting devices) being used as a tie-off method.

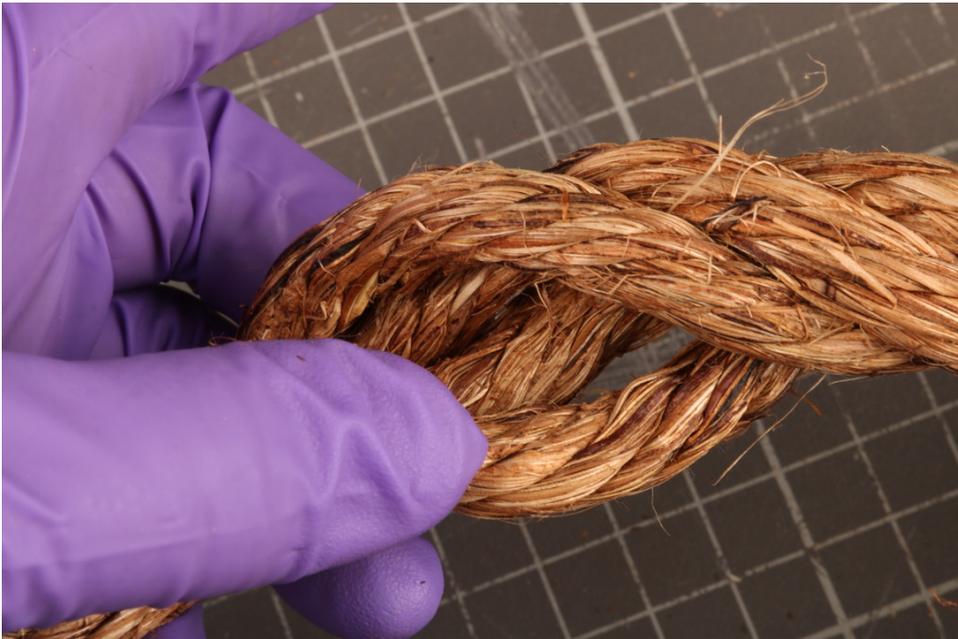
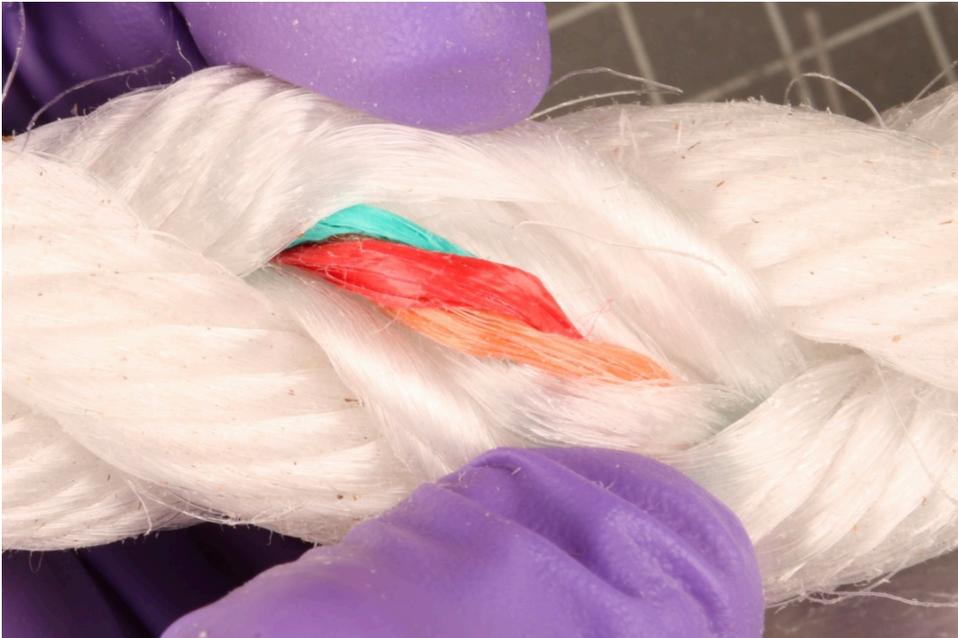
Figure 7: An example of ropes provided. A: 20 mm, four strand manila. B: 20 mm, three strand polypropylene with an inner core weaving.

IMPA provided all the test materials for the work packages. Two rope types were used throughout (see Figure 7), both meeting the BS ISO 799 requirements:

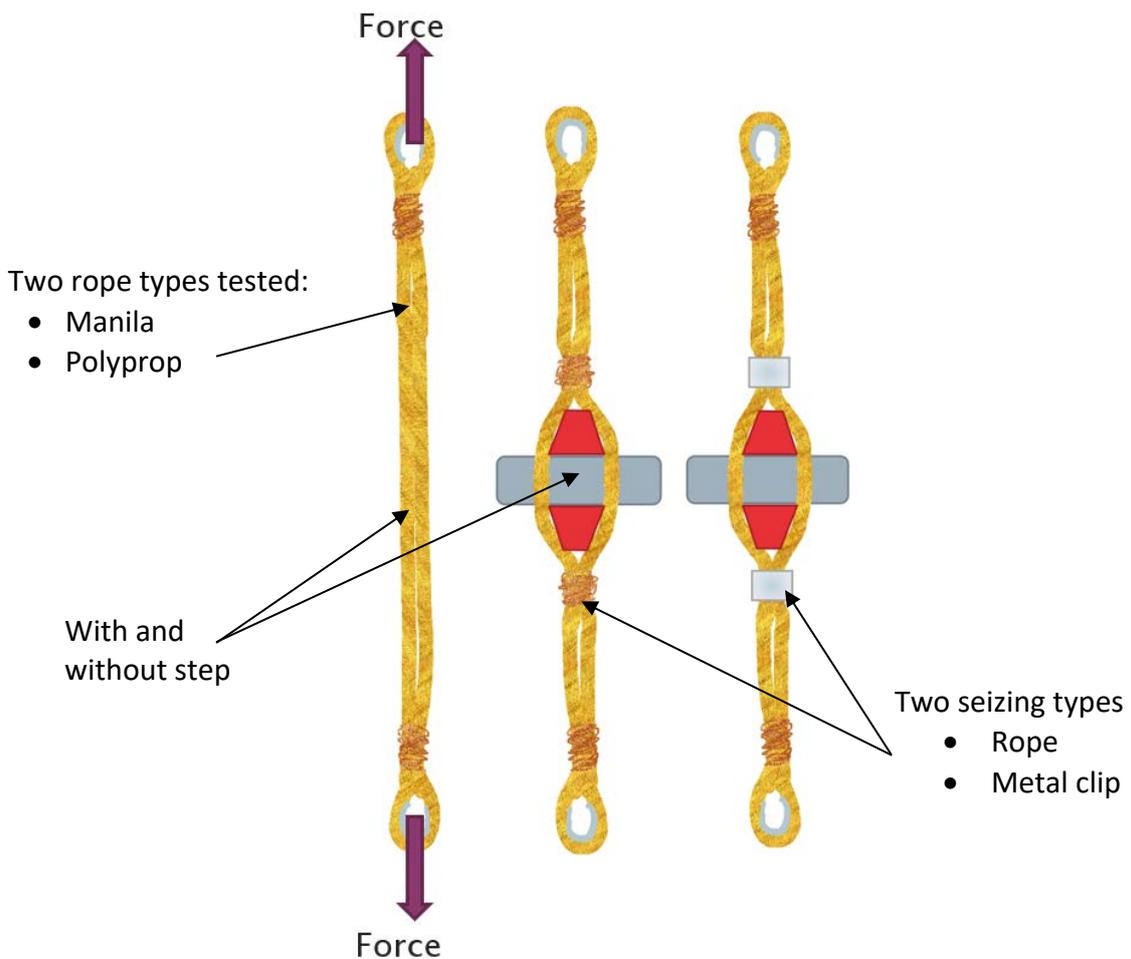
Figure 8: Schematic showing the baseline tensile testing of the rope, the rope with step and rope seizing, and the rope with step and aluminium clip.

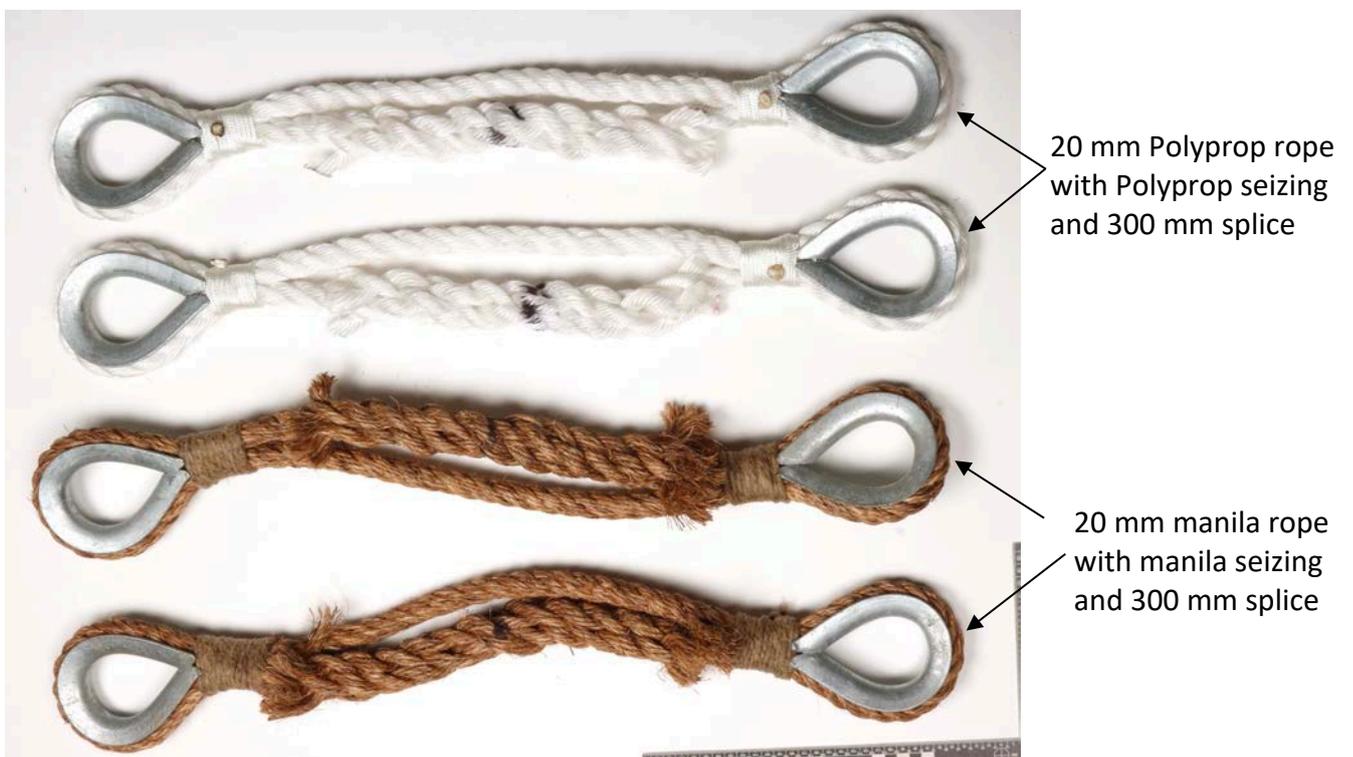
Figure 9: As received condition of samples (no step) for WP1.

The aim of Work Package 1 (WP1) was to determine the baseline properties of two ladder ropes, synthetic polypropylene and natural manilla, with and without steps. As a further variable the effect of the seizing applied above and below the step fixing was also investigated. The matrix of test samples is shown in Table 1, it was decided to have two of each unique scenario. Images of the prepared provided samples are shown in Figure 9 and Figure 10.

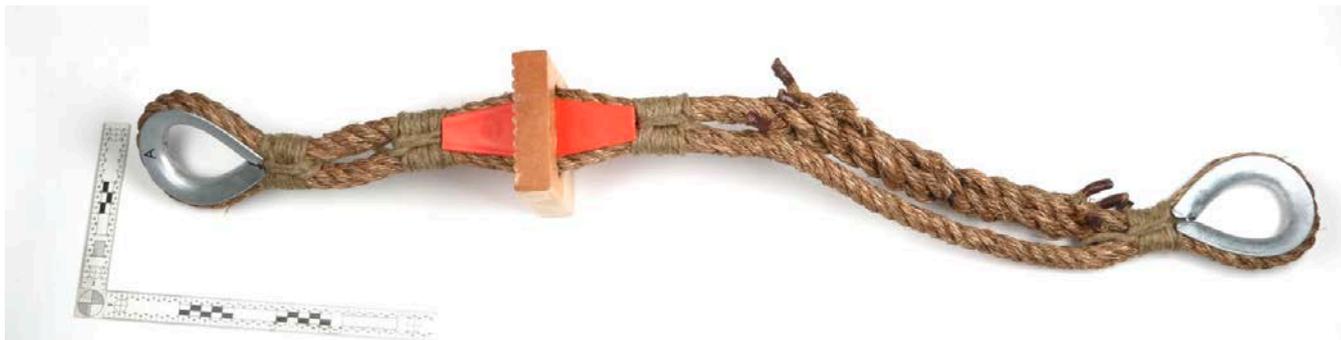
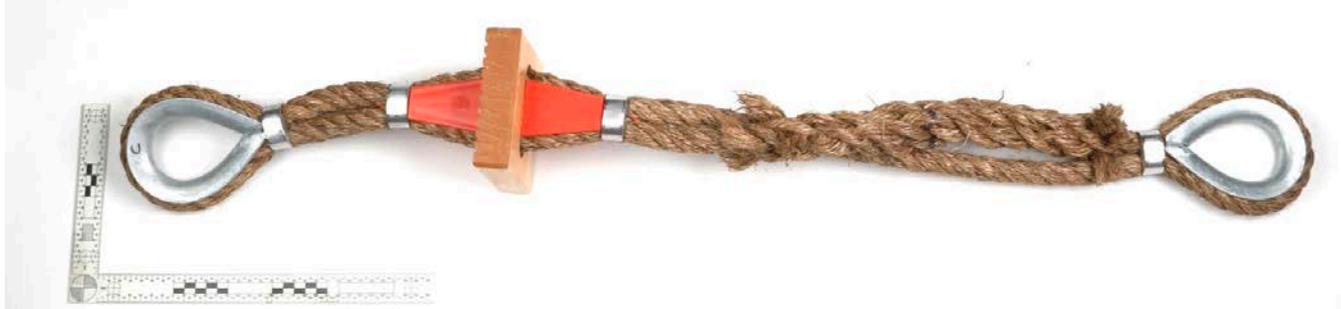
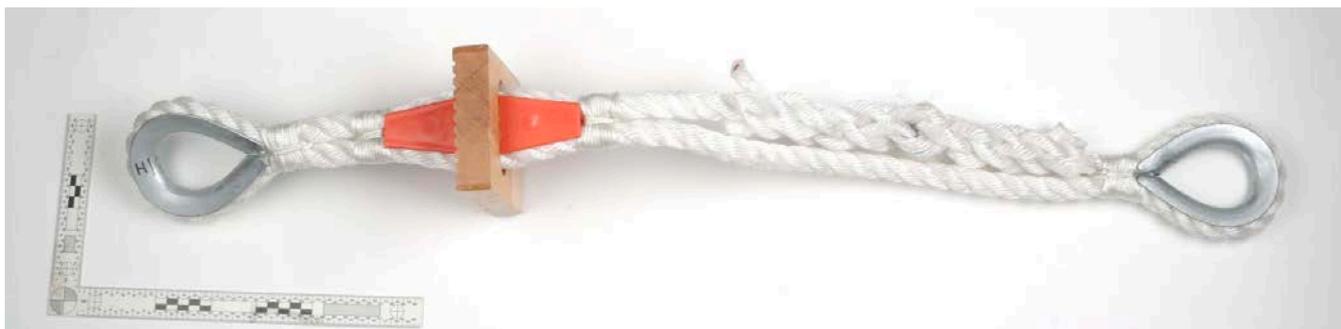
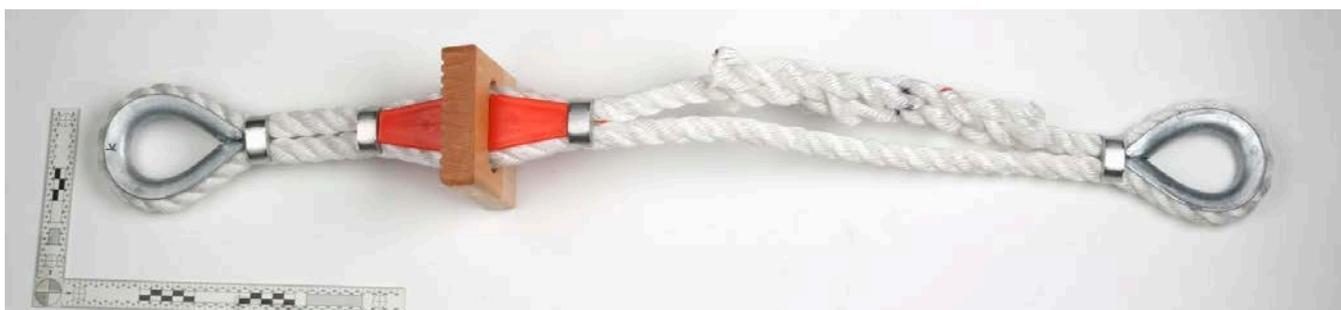
A: 20 mm manila rope, with step and manila rope seizing (sample B the same)

C: 20 mm manila rope, with step and metal clip seizing (sample D the same)

I: 20 mm polypropylene rope, with step and polypropylene seizing (sample J the same)

K: 20 mm polypropylene rope, with step and metal clip seizing (sample L the same)

Figure 10: As received condition of samples (with step) for WP1.

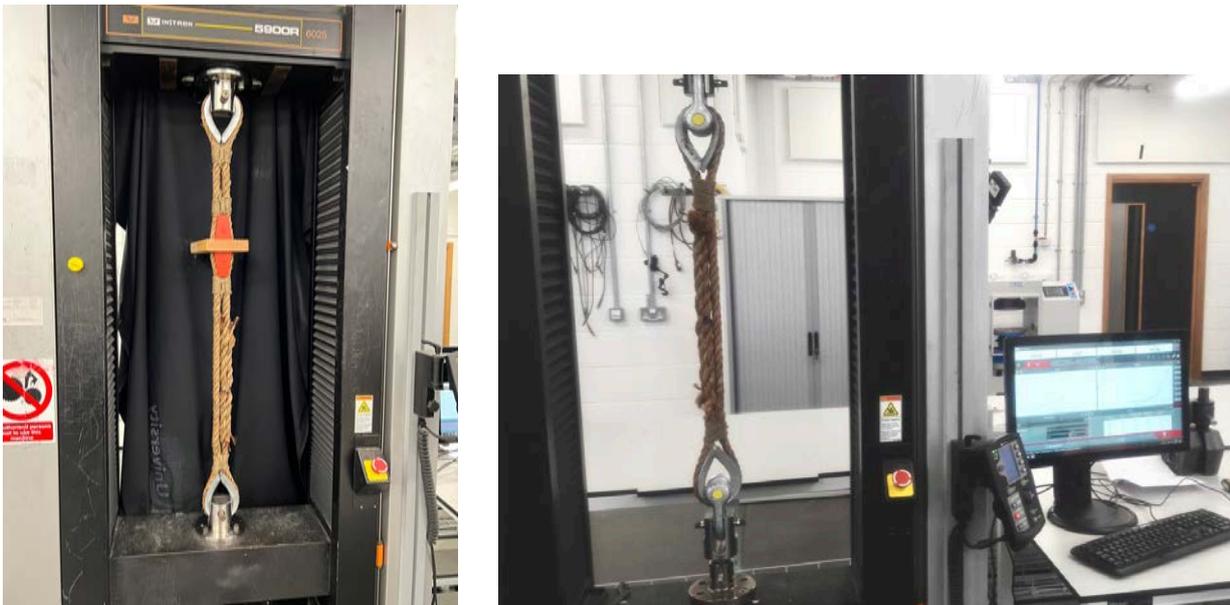
Figure 11: Tested in tension on an Instron 6023 Electromechanical test machine, operating with Instron Bluehill Universal software and fitted with a 100 kN load cell.

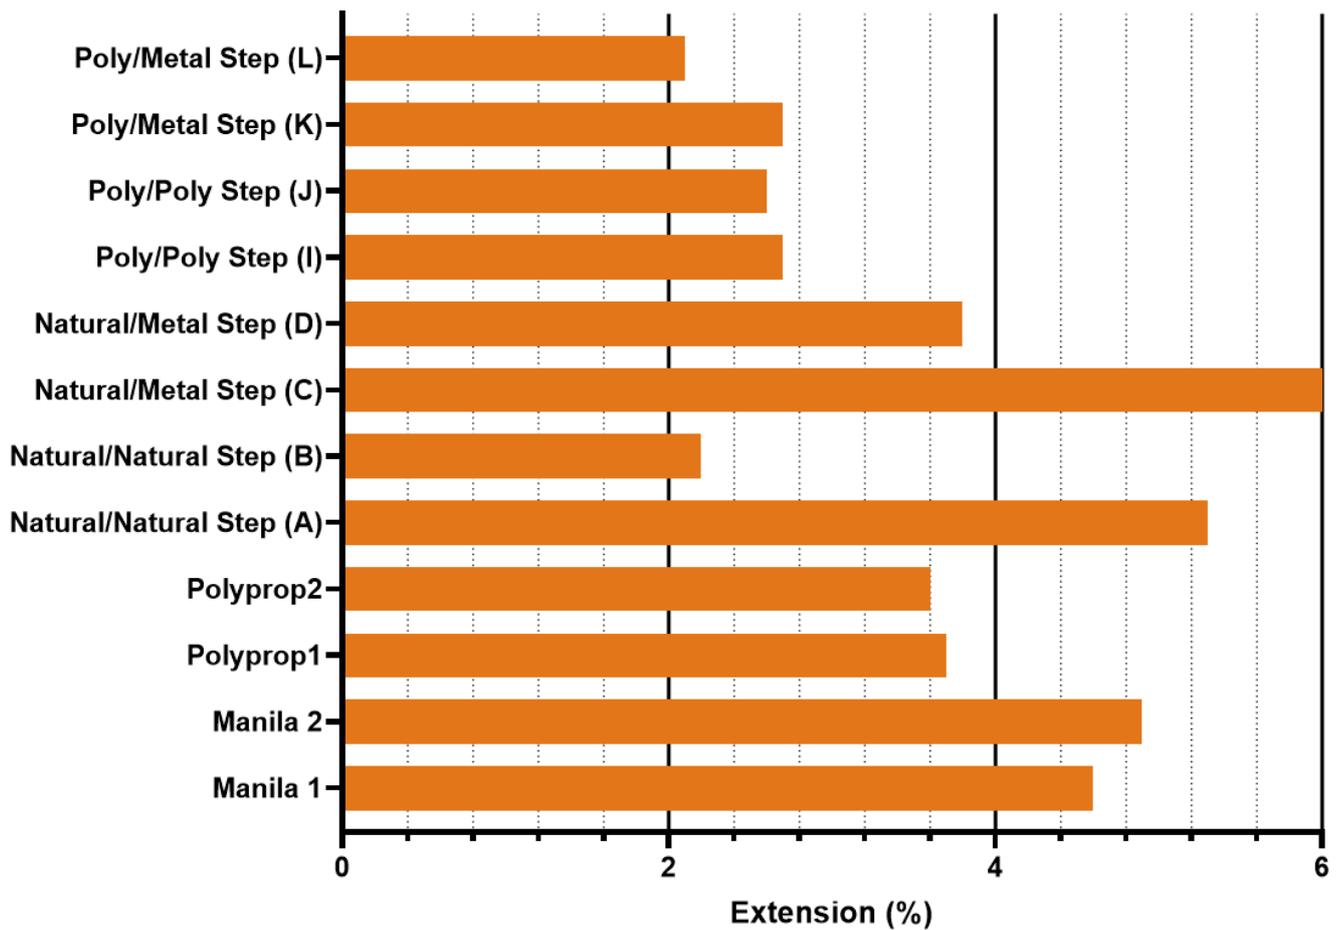
Figure 12: Residual extension in % after the first run for the ropes with and without the steps.

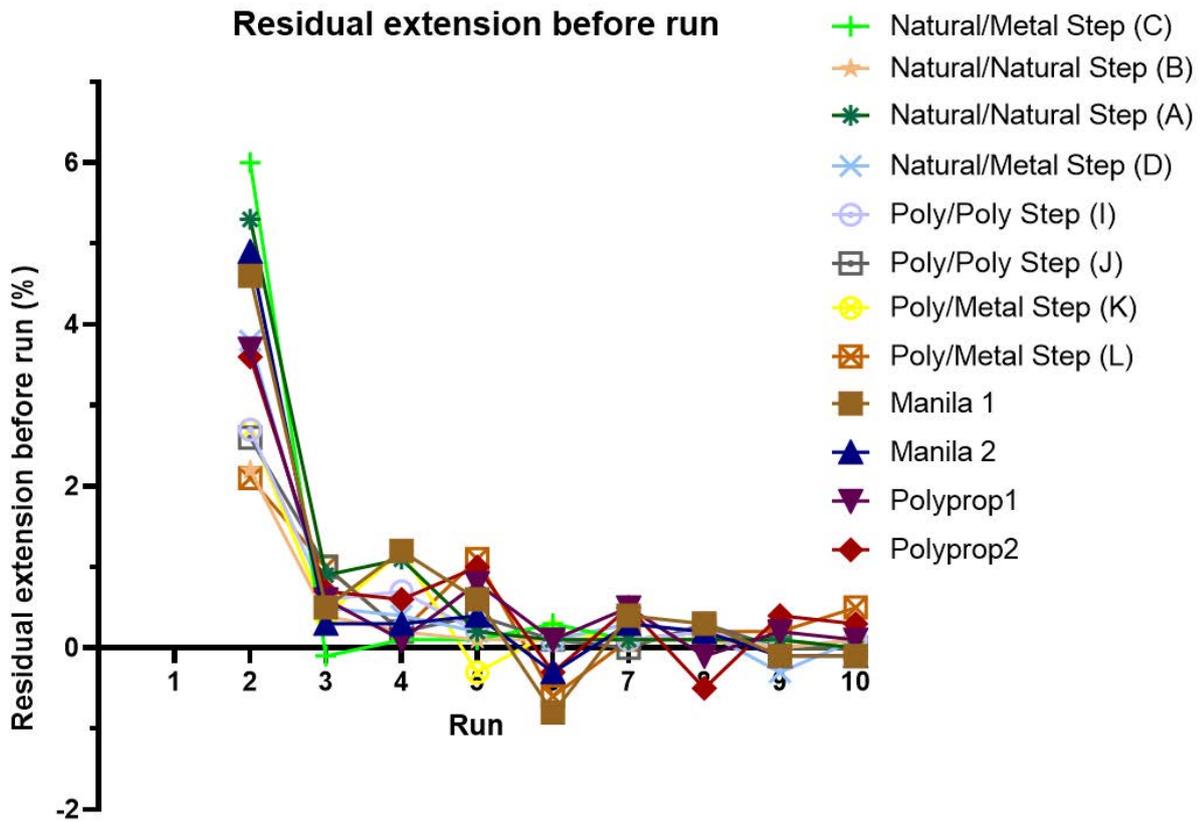
Figure 13: The residual extension in % before a run.

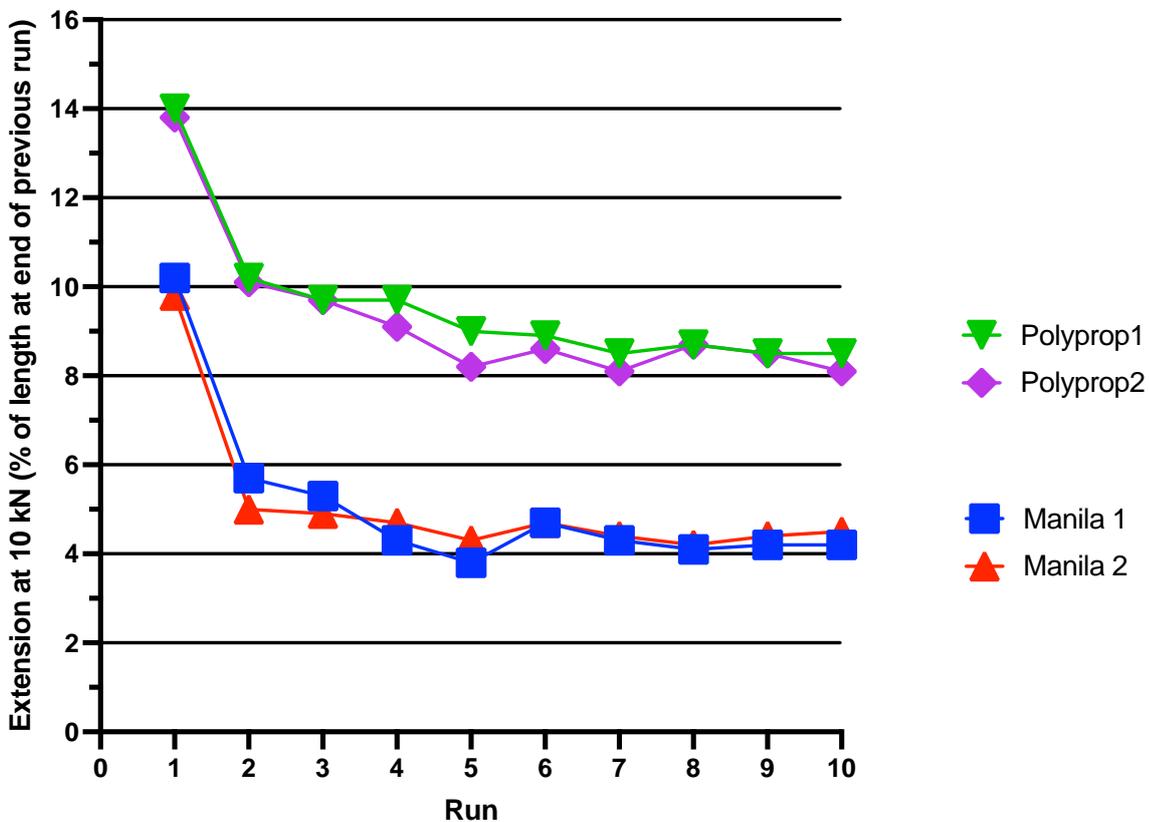
Figure 18: Extension in percentage of original length for each run to 10 kN of the polypropylene and manilla rope.

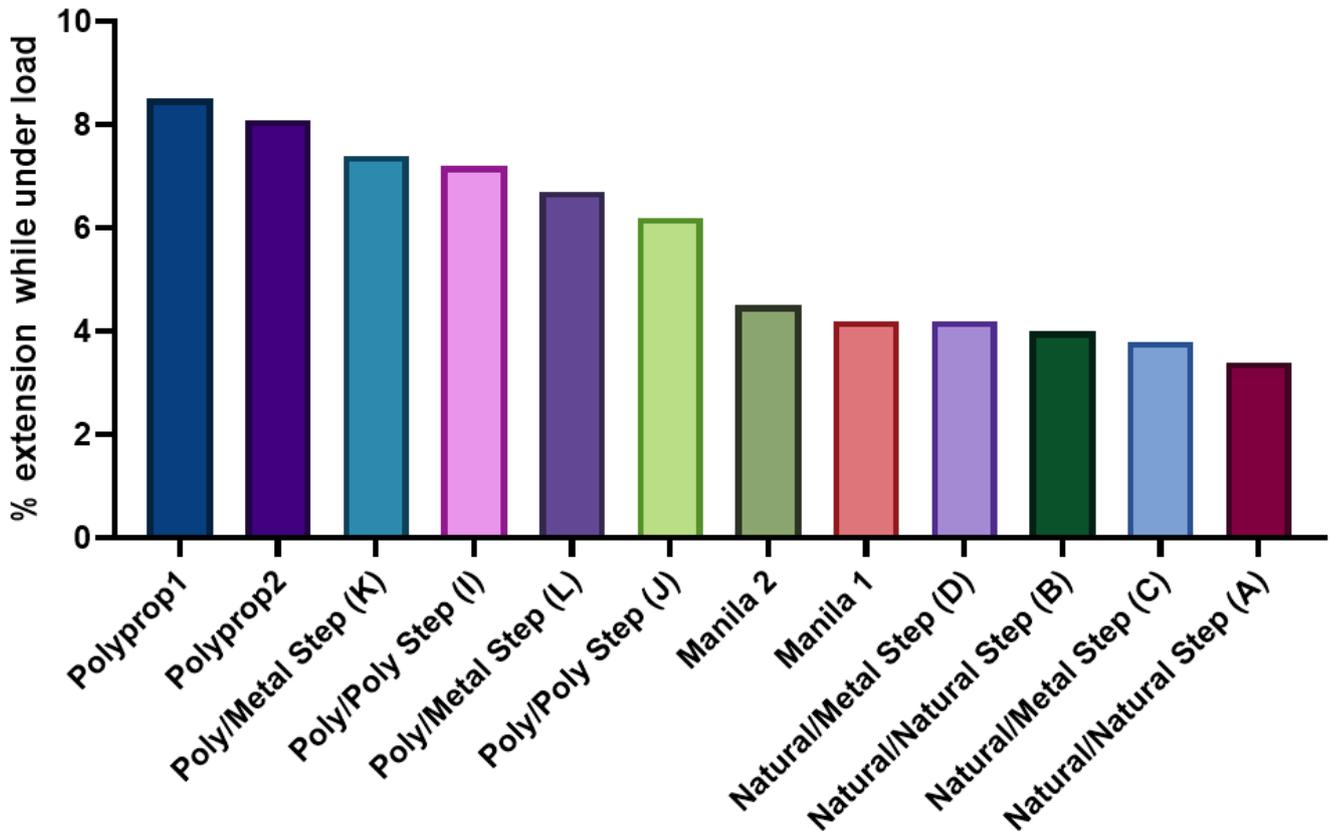
Figure 21: The stabilised extension in % under a force of 10 kN for the ropes and rope with steps combination in order from largest extension in % to lowest.

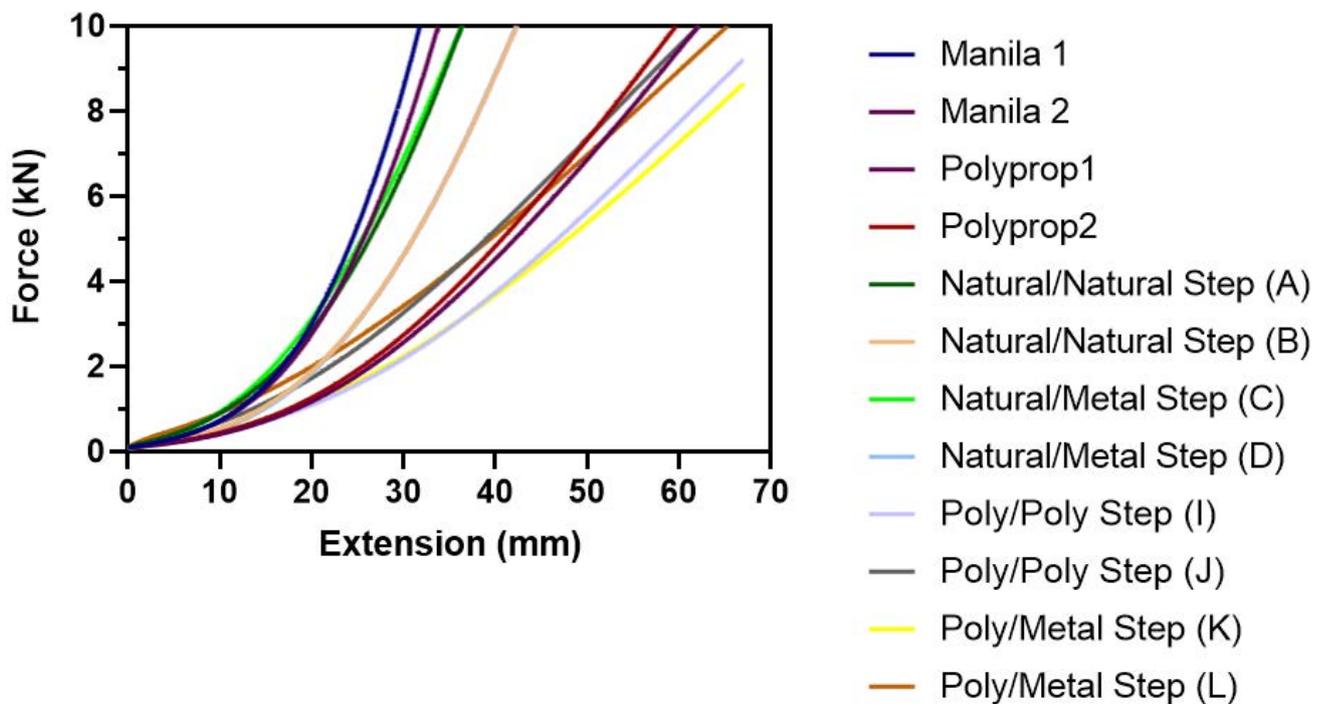
Figure 22: Performance after bedding in stress-strain graph (force-extension) of the behaviour of the ropes under test during run 10 with steps and without steps under test during test 10.

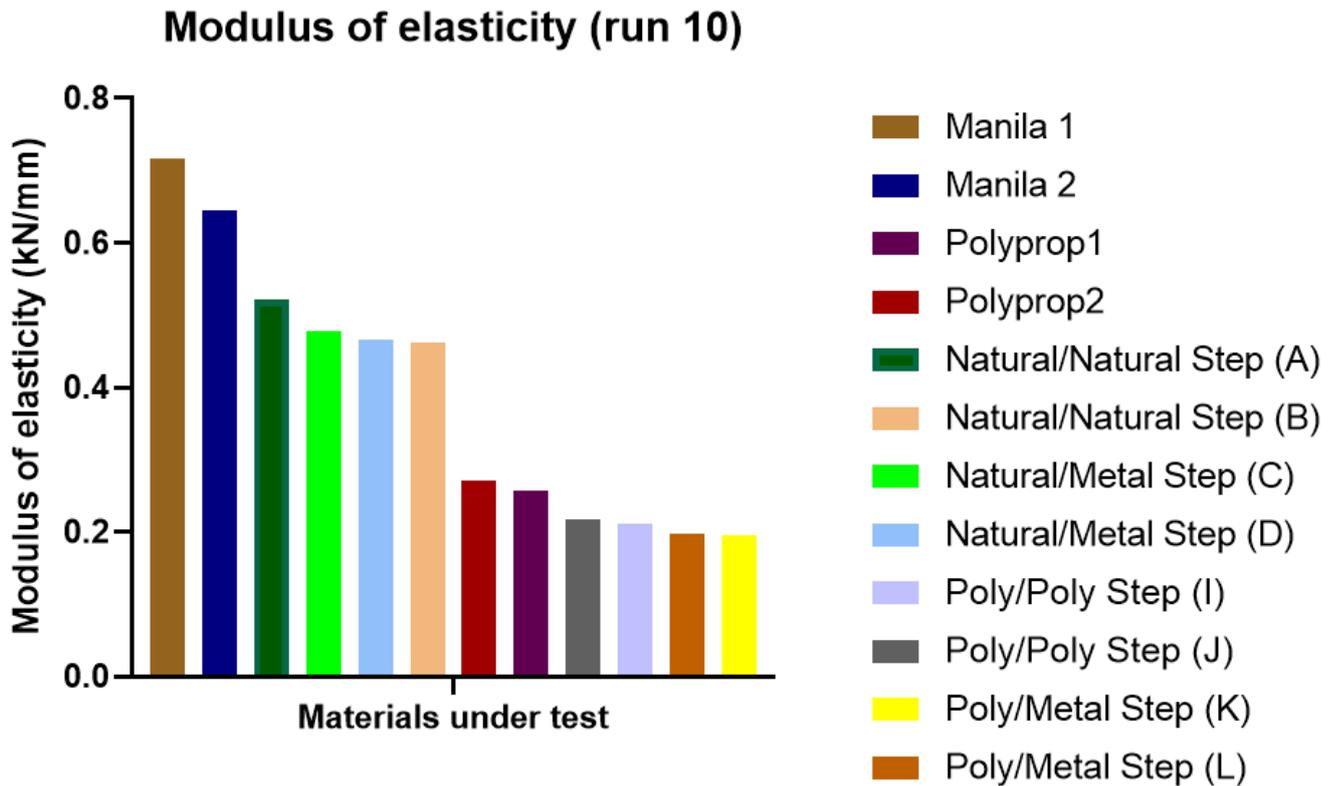
Figure 25: Stiffness data (modulus of elasticity) recorded during run 10 (linear section of data when force > 6 kN). The results are presented from highest modulus of elasticity to the lowest from left to right.

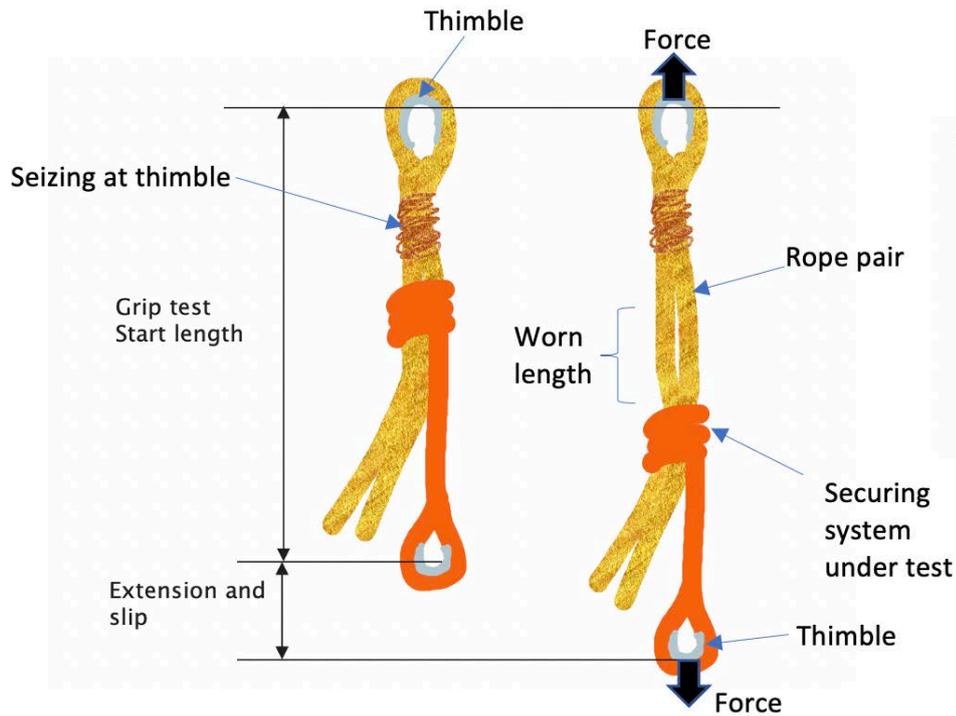
Figure 29: Schematic showing the pre-test arrangement (Left) and the expected post-test arrangement.

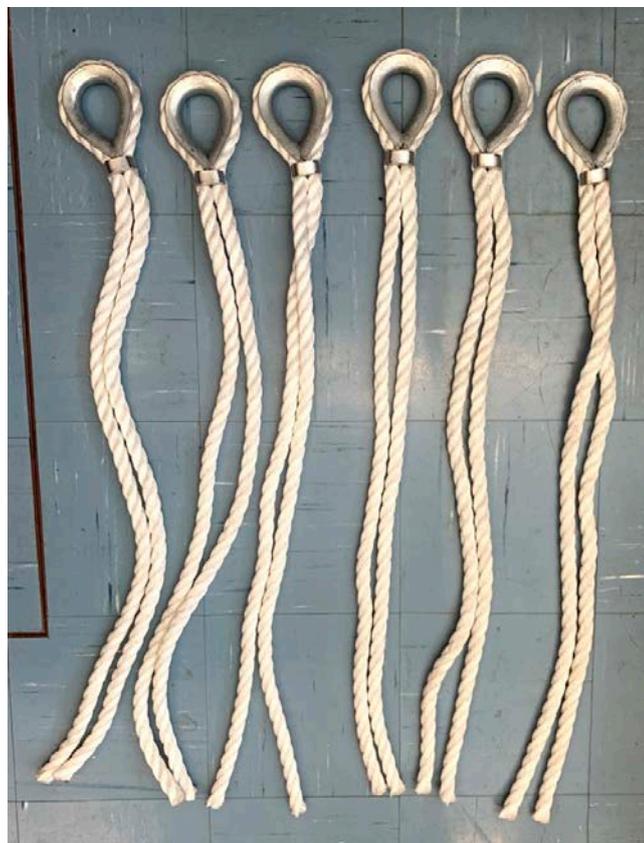
Figure 30: Examples of the polypropylene rope pairs provided for WP2 (manila pairs also provided).

A schematic of the testing arrangement is presented in Figure 29 and a matrix of the test scenarios is given in Table 2. Images of the provided materials are given in Figure 30 and Figure 31. Recorded details of the two cargo straps are given in Table 3.

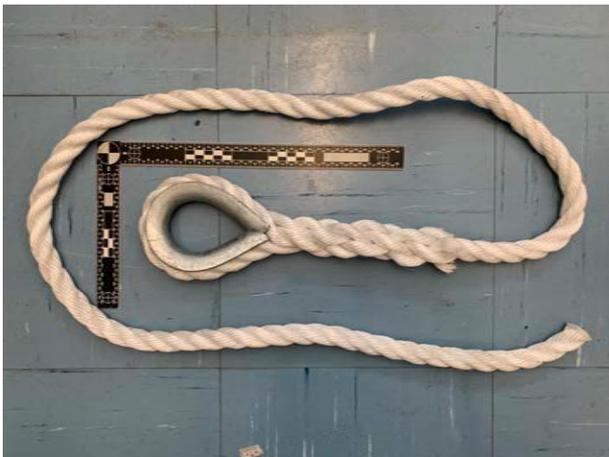
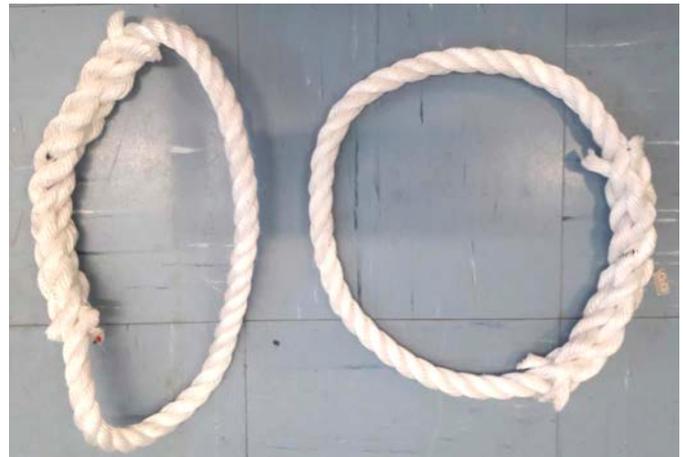
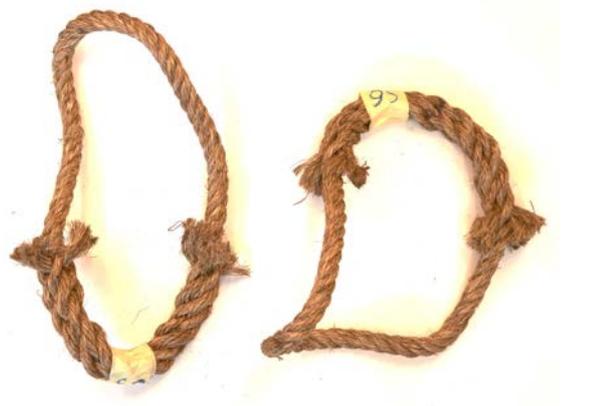
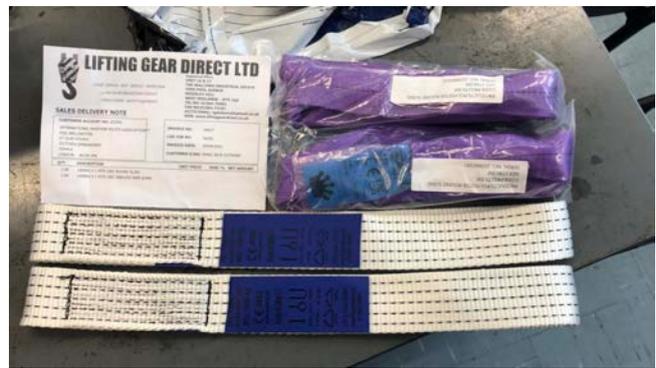
Figure 31: Examples of the securing systems under test. A: Polypropylene single rope to be tied as a rolling hitch (manila also provided). B: Polypropylene hoops to be tied as a cow hitch to the ladder pair. C: Manila hoops to be tied as a cow hitch to the ladder pair. D: Cargo straps, two types identified as purple and white.

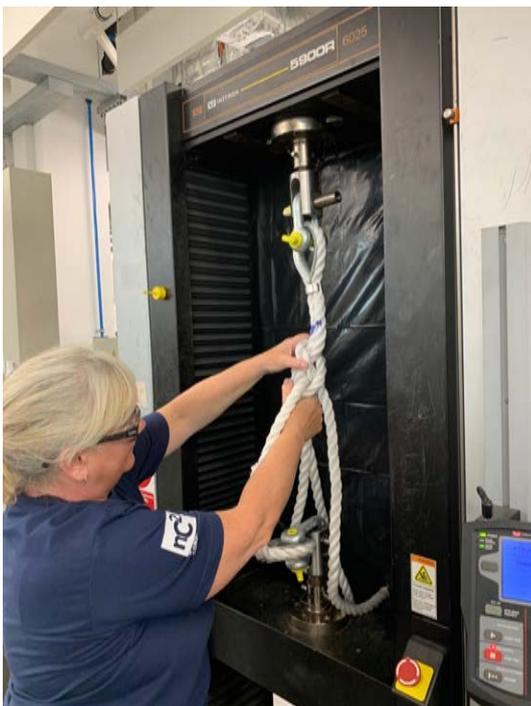
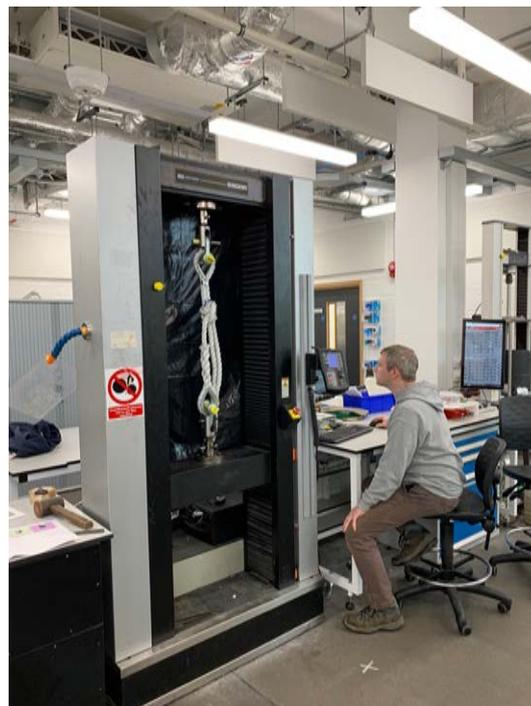
Figure 32: Slip and Grip Scenario 1 being tested on the Instron 6025 electromechanical testing machine.

The secured (rolling hitch or cow hitch) system scenarios of ropes and cargo straps (Figure 29 and Table 2) were attached in turn to an Instron 6025 electromechanical tensile testing machine and loaded via the metal eye (thimble) in the rope pair and through the knot/hitch and to the lower hard point on the rig (Figure 32).
