Title of Work: *Securing of pilot ladders at intermediate lengths – testing*

Reference No: *NCC453*

Work for: *International Maritime Pilots Association*

Report Issue No. *3*  
Date: *17 July 2023*

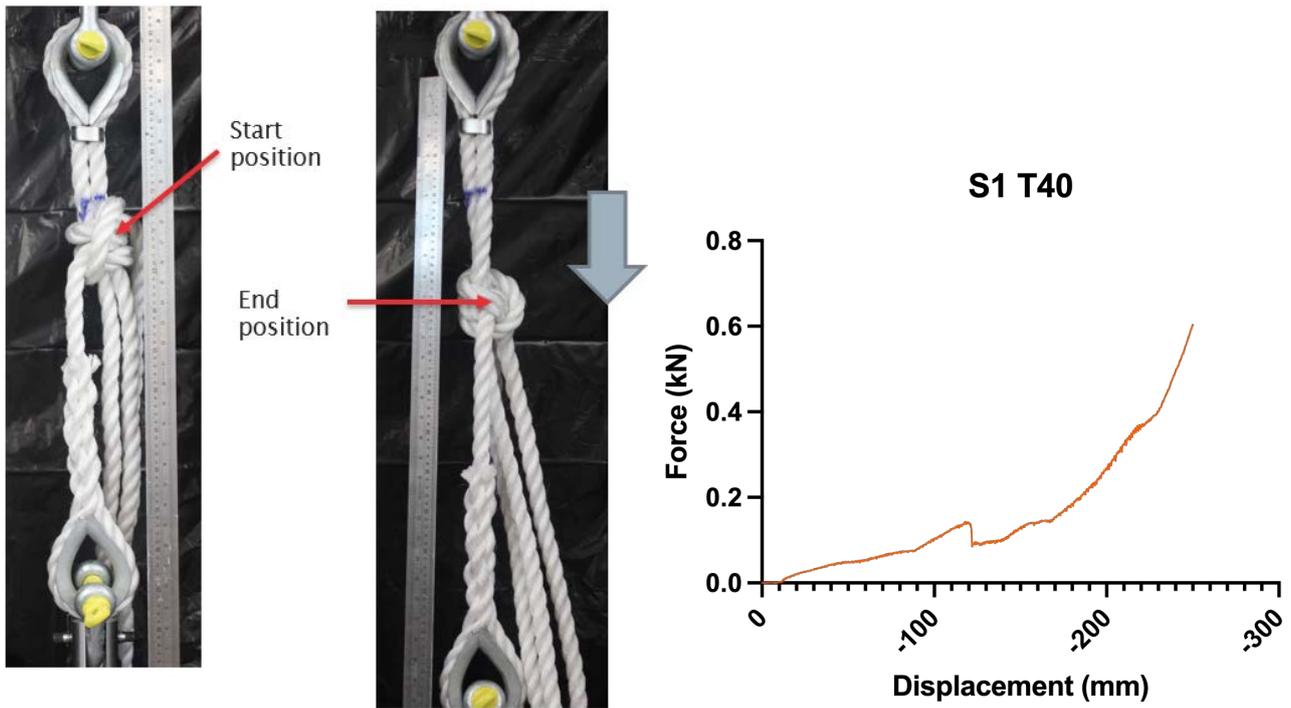
Figure 33: Scenario 1 tested without an initial tightening force and the corresponding force versus displacement graph (Right).

Scenario 1 (polypropylene with polypropylene rolling hitch) was the first to complete the 50 test runs, the results of a typical run are shown in Figure 33. It was noted that the hitch slipped down the rope pair with very little resistance. However, it was known that rolling hitch knots are designed to tighten, but the 200 mm/min was not creating this desired effect. It was therefore decided that the rolling hitch (S1 to S4 see Table 2) should have a tightening force applied by hand before testing, to simulate a shock loading event, such as the ladder being unravelled down the side of the ship, to reduce the slack in the knot. In this case the rope continued to tighten causing a much larger tensile force and a small amount of slippage was observed (Figure 34 and Figure 35). S1 completed a further 50 runs all with a pre-test tightening force. All scenarios featuring a rolling hitch (S1 to S4 see Table 2) were subjected to a pre-test tightening force to reduce slack in the rolling hitch knot before testing.

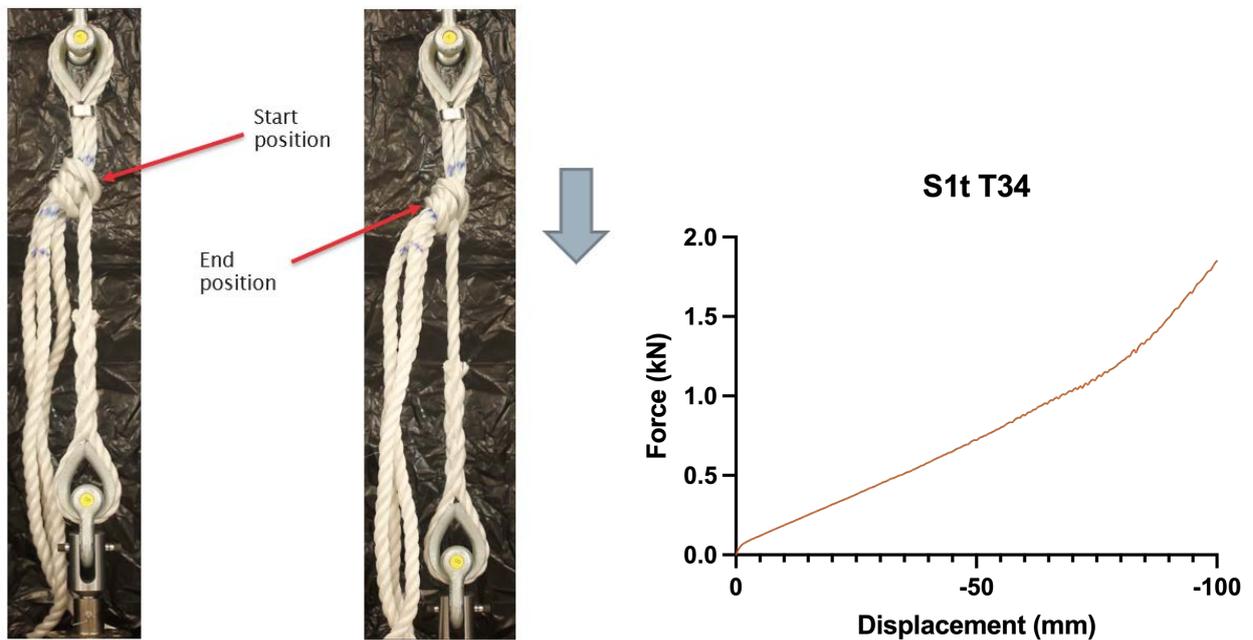
Figure 34: Scenario 1 tested with an initial tightening force and the corresponding force versus displacement graph (Right).

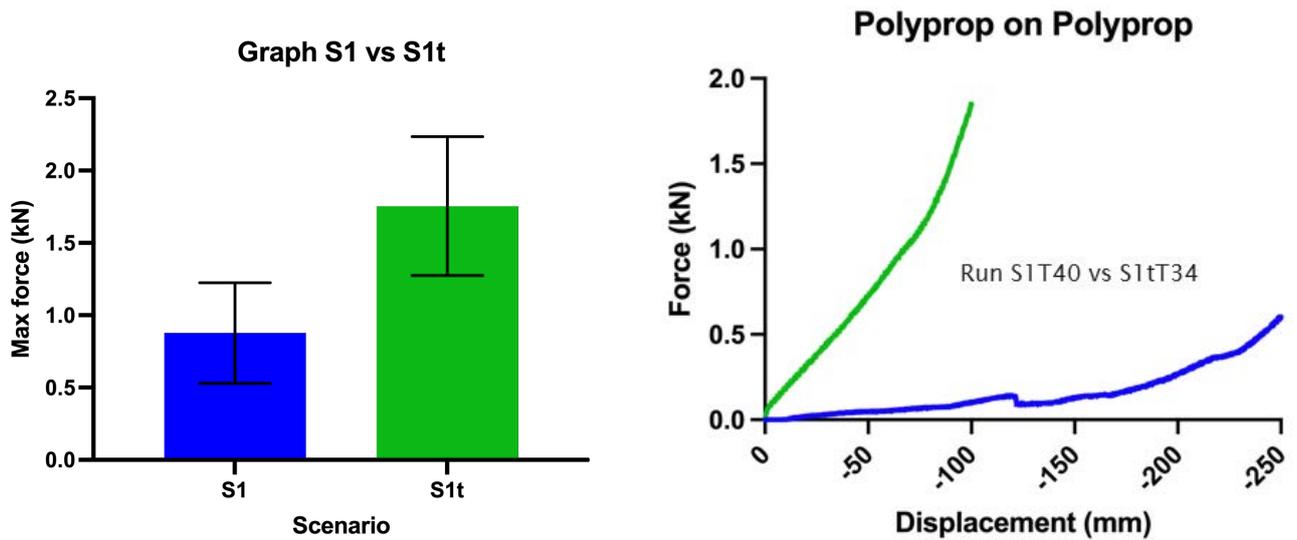
Figure 35: Scenario 1 maximum force recorded during the test for no pre-test tightening force (S1) and with tightening force (S1t). Force versus displacement graphs of one typical test run of each type.

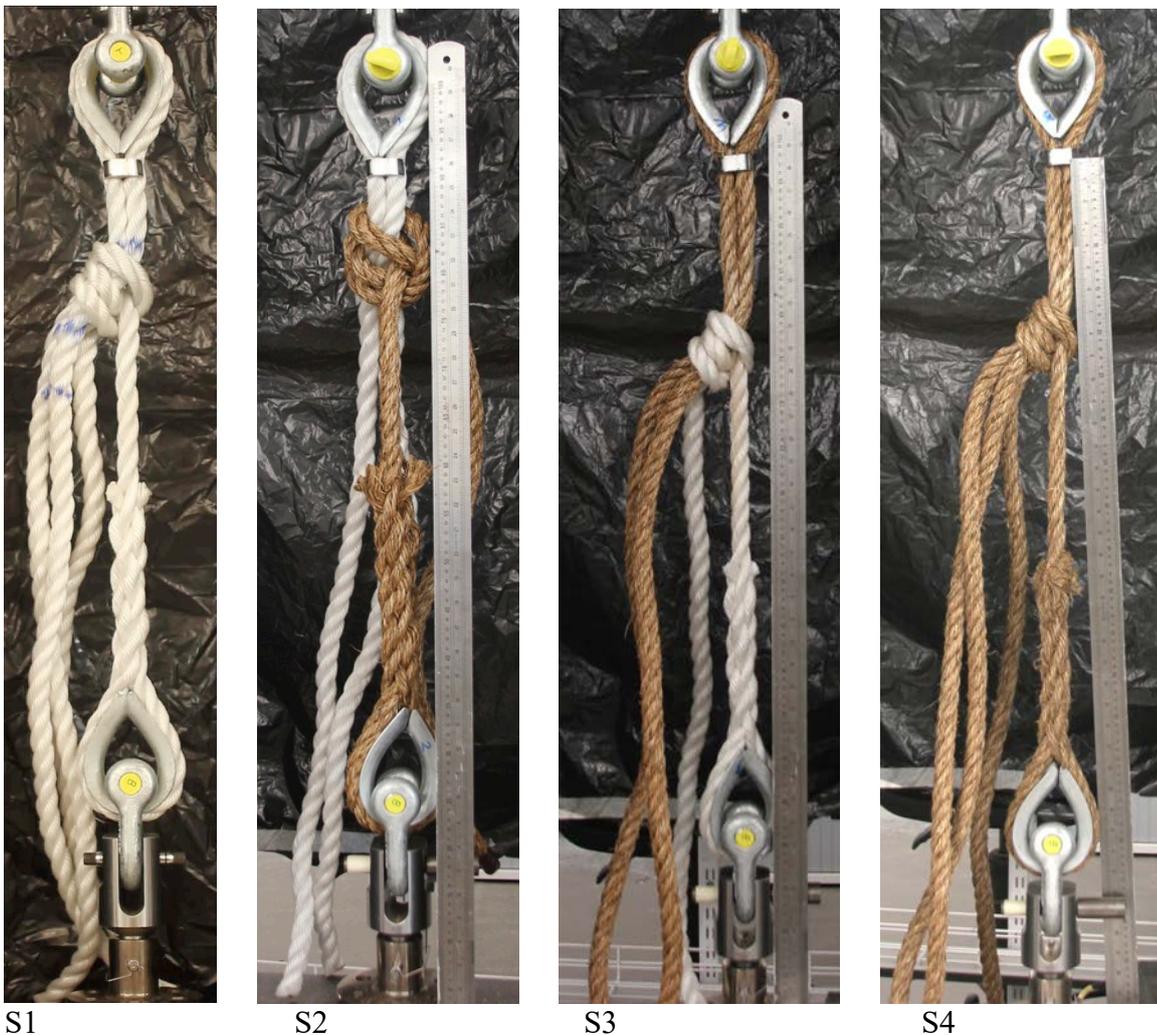
Figure 36: Initial starting positions of test runs for scenarios S1-S4.

Images recorded showing scenarios S1-S4 loaded on the tensile test rig are given in Figure 36. All four set-ups were given a tightening force prior to initiating a 100 mm lowering of the lower hard point attachment. This was repeated 50 times, each time the force-displacement was recorded. Typical force-displacement curves for S1-S4 are shown in Figure 37. The curves were generally smooth and increasing with distance, indicating that the knot was getting tighter.

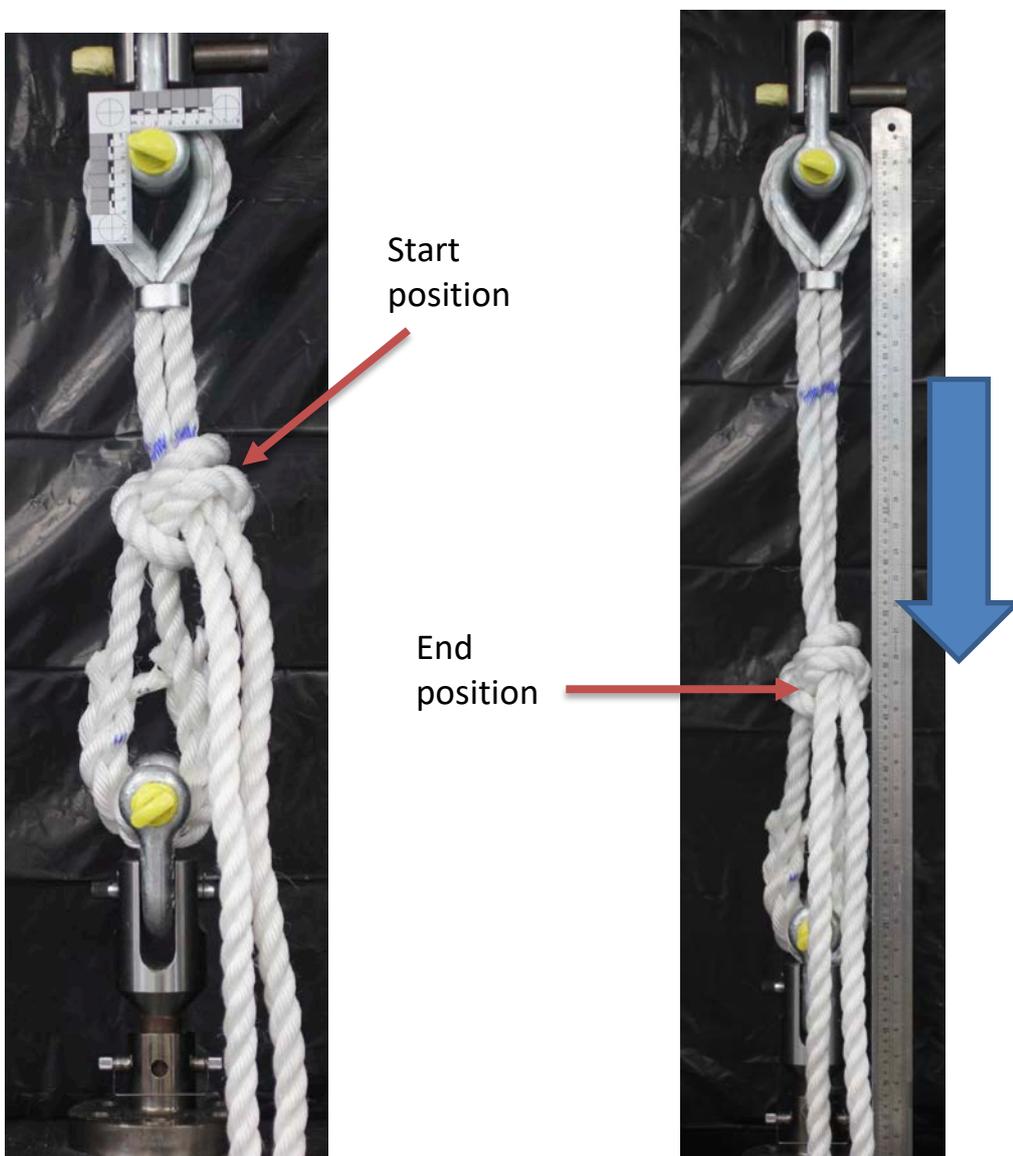
Figure 38: Images showing start and end position of cow hitch S5, that slid 250 mm.

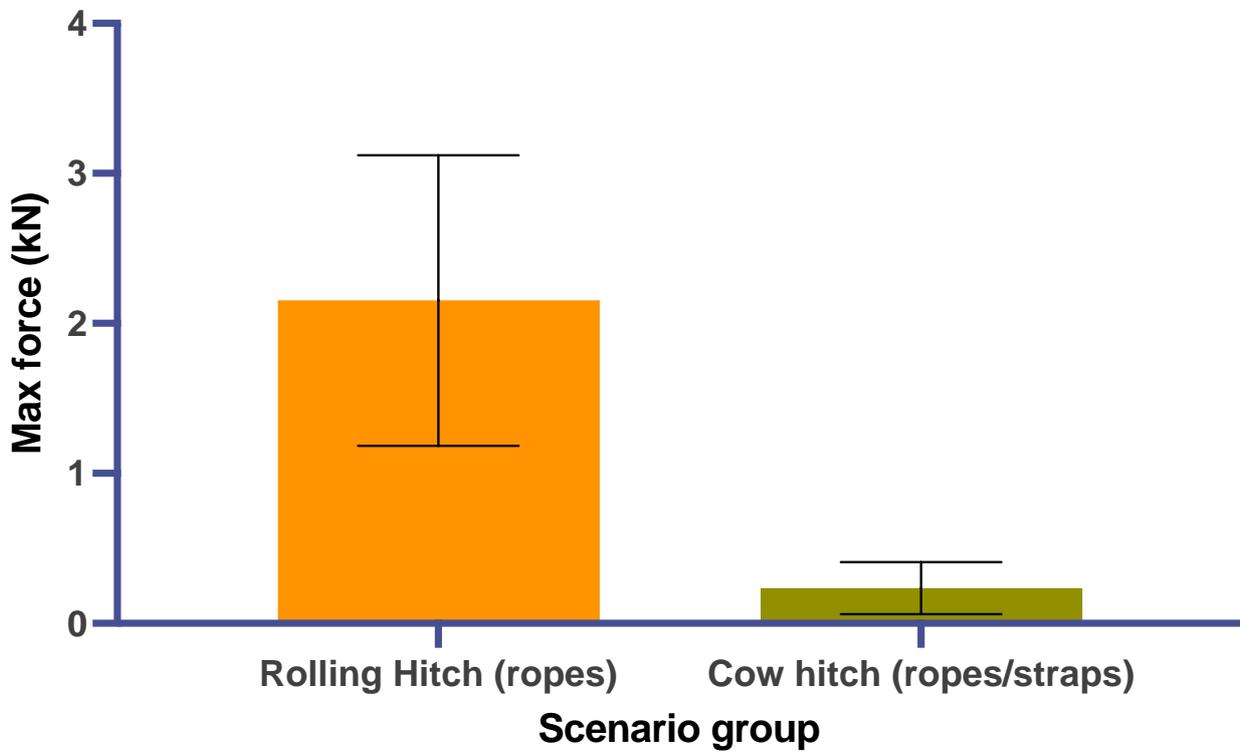
Figure 44: Average max force for rolling hitch compared with cow hitch securing methods.

The max loads reached within the WP2 testing of rolling hitch knots averaged to 2.2 kN (see Figure 44). Note that the static loads on one side of 9 metre ladder would be approx. 2.6 kN/2 = 1.3 kN (Figure 5). In the WP3 tests the max force was 2.8 kN (see Figure 6). In contrast the cow hitch knots failed to grip and instead slipped down the rope at loads less than 200 N. It can

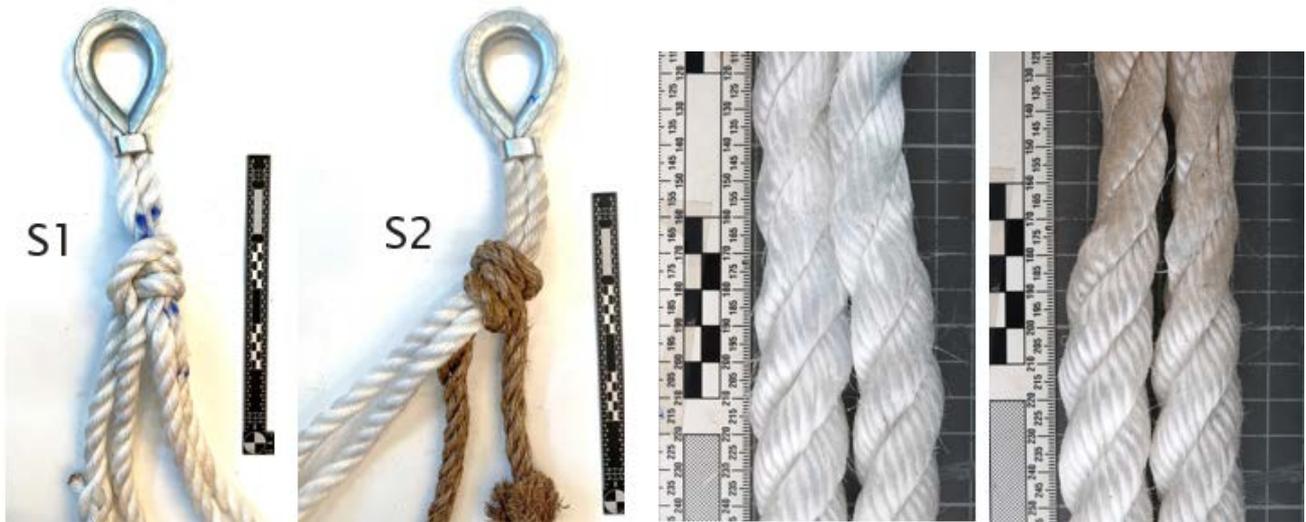
Figure 49: Scenarios 1 and 2 post-test (Left) and the examined worn section of the double rope (Right).

The ladder rope pairs were subjected to post-test inspection to identify signs of wear (Figure 49 to Figure 54). Scenarios 5 – 12 (secured via cow hitch arrangements) did not show any signs of wear after 50 runs. Some visible signs of tightening and squashing of the ladder rope pair was observed in scenarios 1 – 4 (secured via rolling hitch arrangements). The manilla on polypropylene produced a discolouration on the ladder rope pair from the manilla rope.

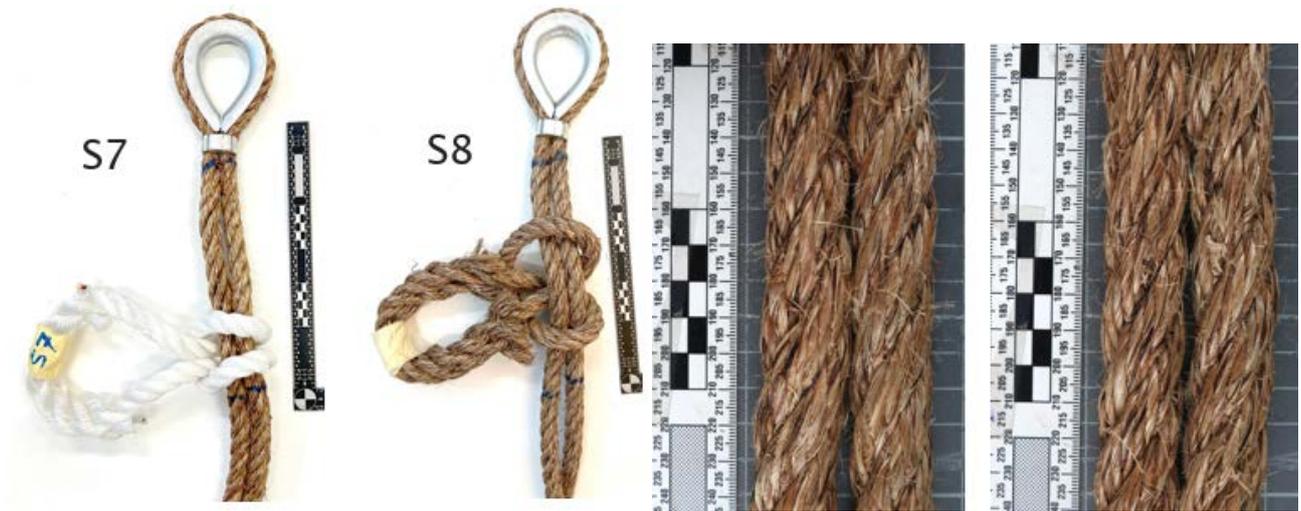
Figure 51: Scenarios 5 and 6 post-test (Left) and the examined worn section of the double rope (Right).

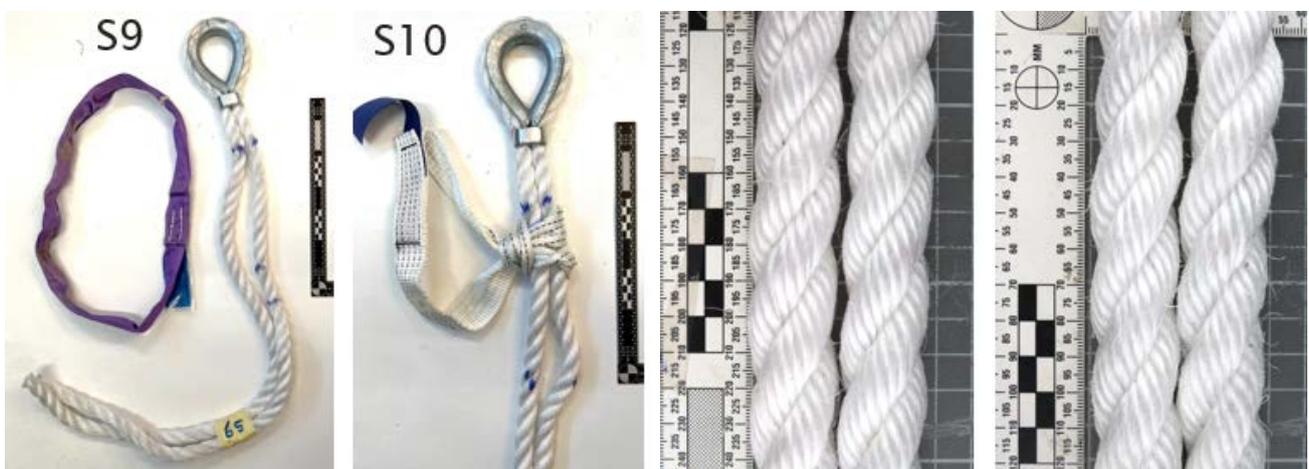
Figure 52: Scenarios 7 and 8 post-test (Left) and the examined worn section of the double rope (Right).

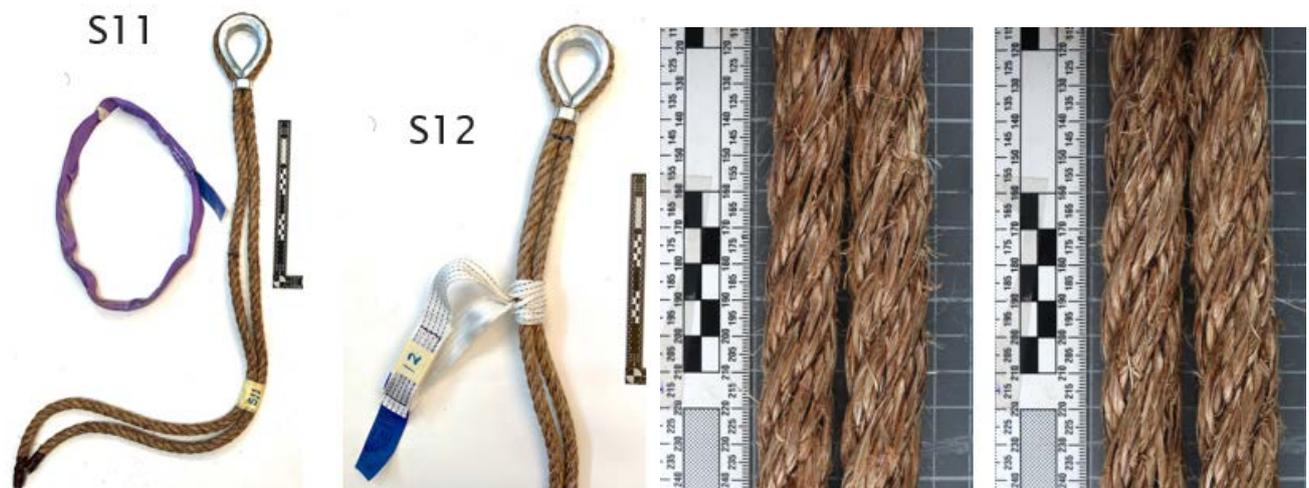
Figure 53: Scenarios 9 and 10 post-test (Left) and the examined worn section of the double rope (Right).

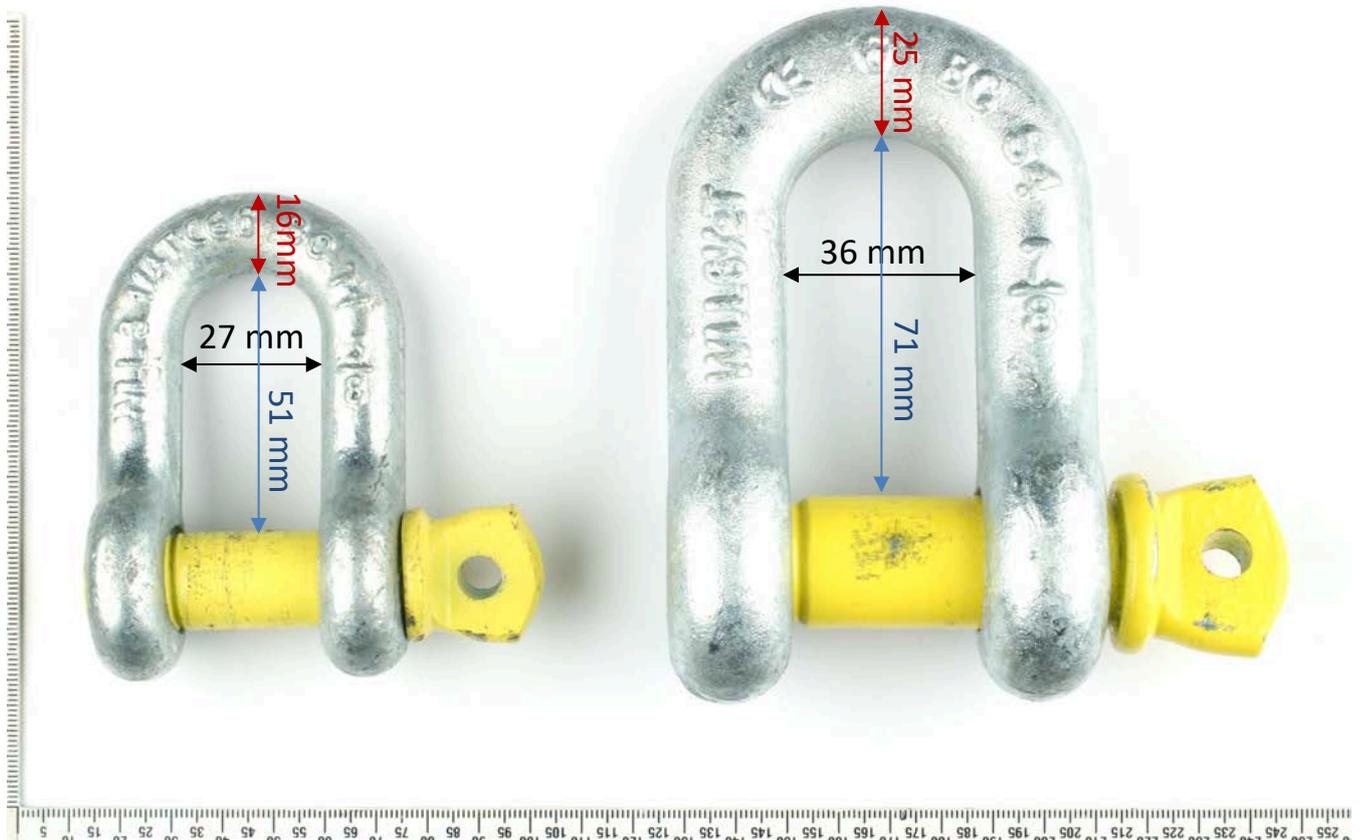
Figure 56: Two sizes of D-shackle were provided.

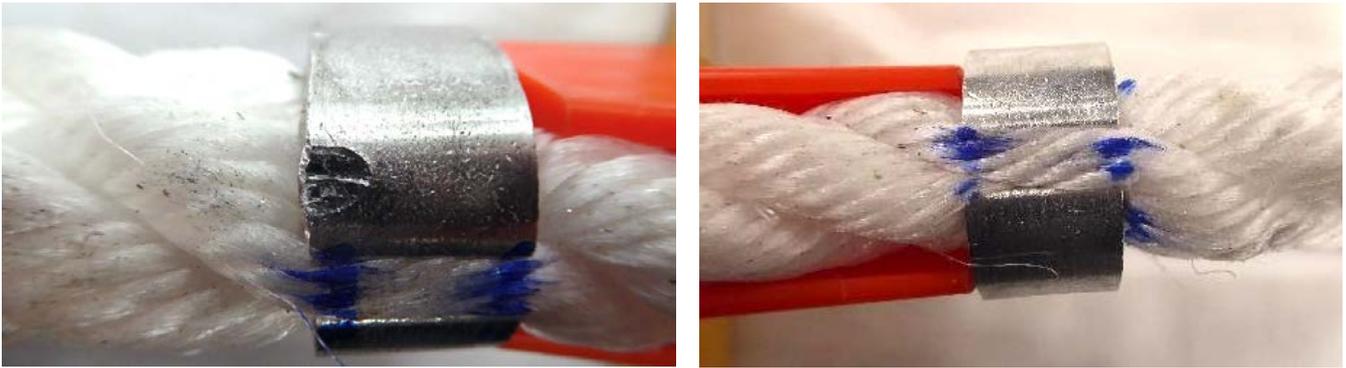
Figure 62 : Specimen O after 1500 cycles showing (Left) permanent damage to the top metal fastener from contact with the small shackle. The metal fastener did not slip during the test. (Right) No slippage was observed on the metal fastener underneath the wooden assembly.

Small shackle deforms metal fastener: The small shackle arrangement was too small to slide over the fastener and therefore the small shackle contacted the metal clip throughout the testing. After 1500 cycles, the small shackle had caused permanent deformation on the metal fastener regardless of which rope material was used (Figure 62 and Figure 63). No effect was observed on the shackle (Figure 64), hardness testing revealed that this was due to the shackle material being much harder than the metal fastener material (Table 7).

In all scenarios involving the D-shackle there was some form of damage to the rope ladder (Figure 62, Figure 65, Figure 67, Figure 69). This suggests that although an easy attachment to make there is some level of risk.

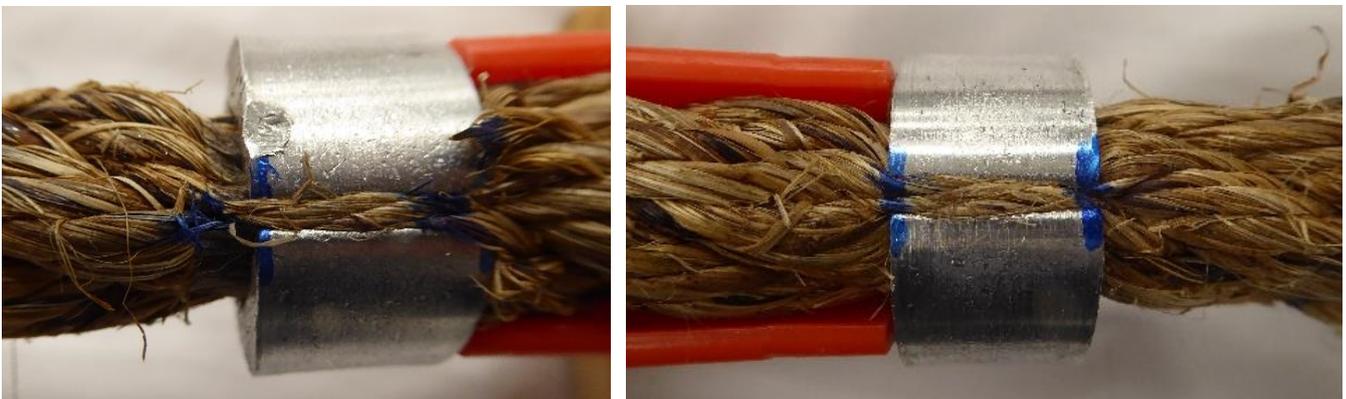
Figure 63 : Specimen H after 1500 cycles showing (Left) permanent plastic deformation to the top of the metal fastener from contact with the small shackle. The top metal fastener slipped 2 – 3 mm from its initial position during the test. (Right) No slippage was observed on the metal fastener underneath the wooden assembly.

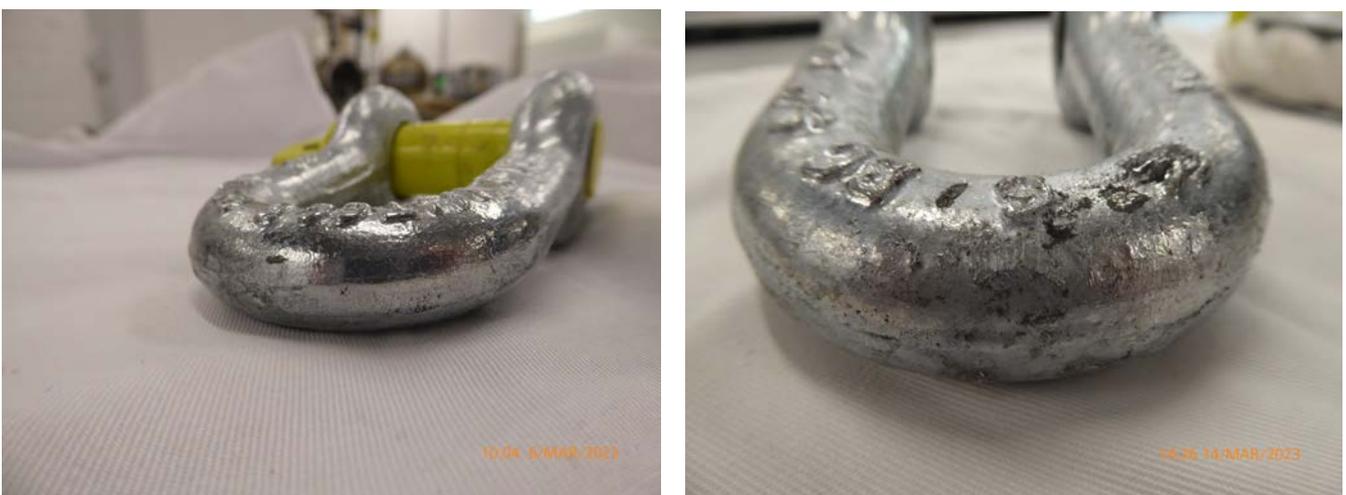
Figure 64 : No visible damage was found on the shackle after any of the tests.

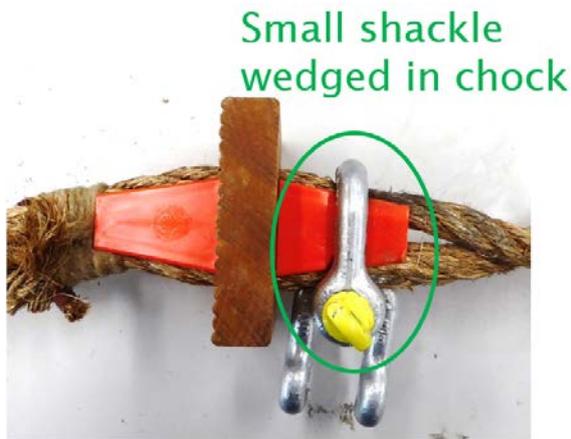
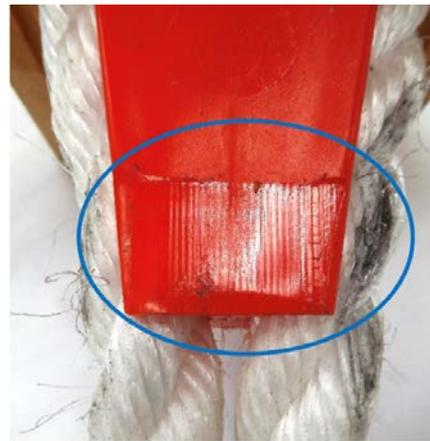
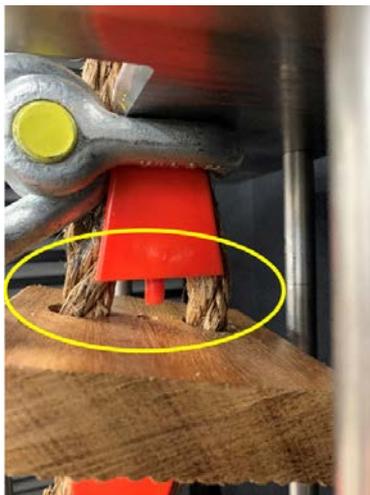
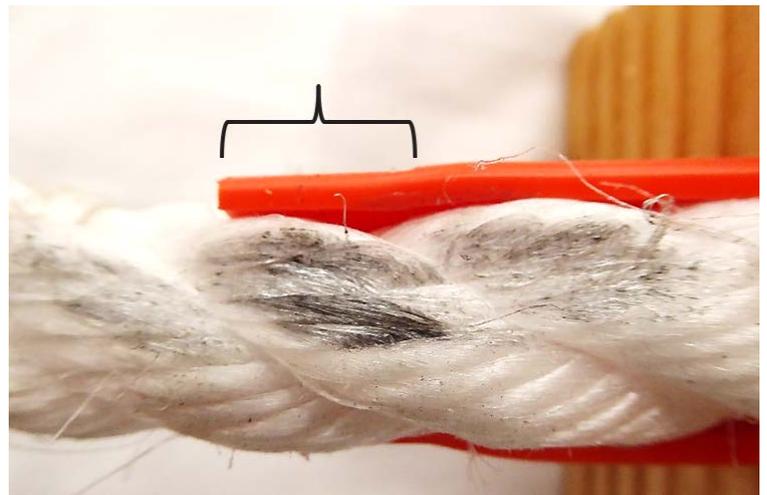
Figure 65 : The small shackle passed over the rope seizing and got wedged in the chock (Top left). When the small shackle was removed after testing, damage to the chock surface was observed (Top Right). The wedging effect resulted in the chock coming away from the wooden step during the 'ladder put away' step (Bottom left). Permanent deformation was observed to the chock (Bottom right).

Small shackle deforms plastic chock: The small shackle was able to pass over the rope seizing fastener and contact the plastic chock directly. The plastic chock tended to get wedged in the small shackle (Figure 65 top left), resulting in a lot of force and manipulation being required to remove the shackle from the plastic chock. An area of wear damage was observed on the plastic chock after removal from the small shackle (Figure 65 top right and bottom right). Due to the wedging effect, the plastic chock was forced to separate from the wooden step during the unloading step (when the ladder was put away) (Figure 65 bottom left). Potentially this

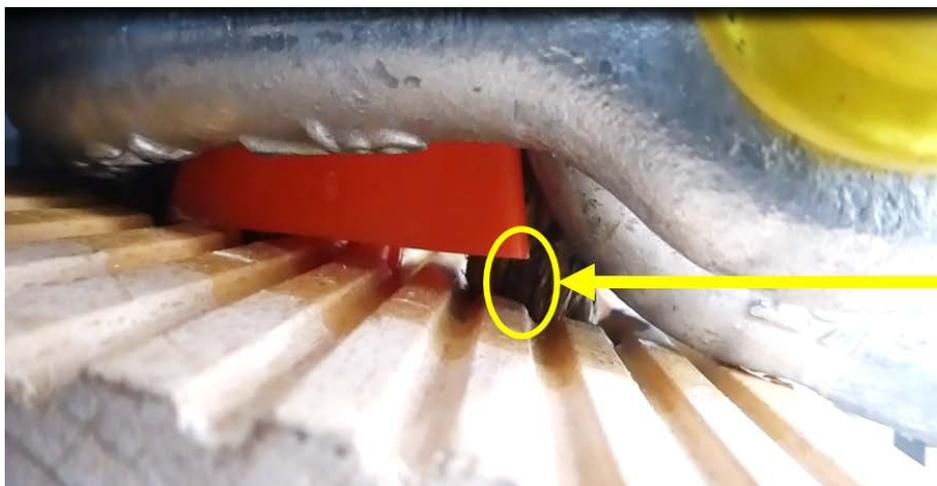
Figure 66 : The large shackle contacts the wooden step in two places at differing height levels, resulting in a tilt effect and one end of the chock becoming separated from the wooden step.

Large shackle contacts wooden step: The large shackle was large enough to pass over both the metal fastener and the rope seizing. This resulted in the large shackle contacting the wooden step. Due to the difference in the heights between the fixed and floating shackle contact points, the wooden step was forced to tilt. This caused separation at one end of the plastic chock from the wooden step (Figure 66). The floating large shackle also contacted the edge of the wooden step, resulting in a small depression about 4-8 mm diameter (Figure 67). Potentially this could be an issue as Annex A of BS ISO 799-2 requires an inspection to ensure *“Step fixtures are secure and tight”* and *“Seizings/step securing are in good condition.”*

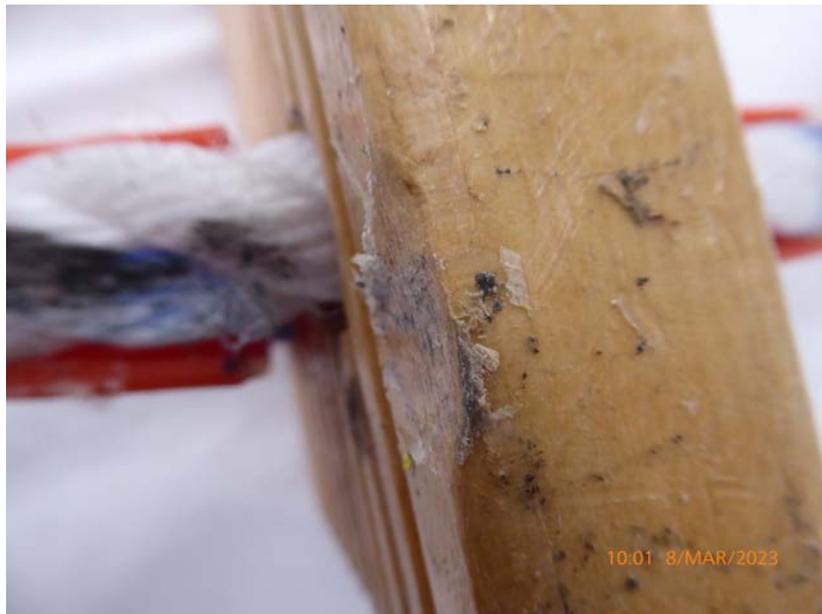
Figure 67 : Specimen N after 1500 cycles showing the damage that the large shackle did to the wooden step.

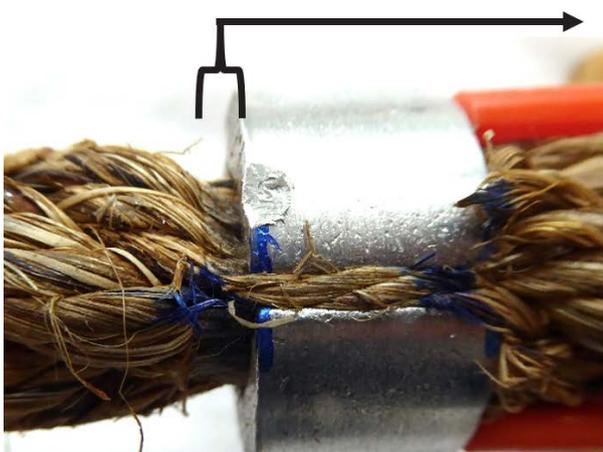
Figure 68 : When the small shackle was used, no slippage was observed for the metal fastener with polypropylene combination. The metal fastener slipped by 2 – 3 mm for the manilla rope.

Metal fastener slips by a negligible amount: No slippage was observed for any scenario tested involving polypropylene rope material (Figure 68) when the metal clip was used. A relatively minimal amount of slippage (2 - 3 mm) was observed from the top metal fastener in contact with the small shackle for manilla rope material (Figure 68). The bottom (below the step) metal fasteners did not slip when subjected to any test scenario.

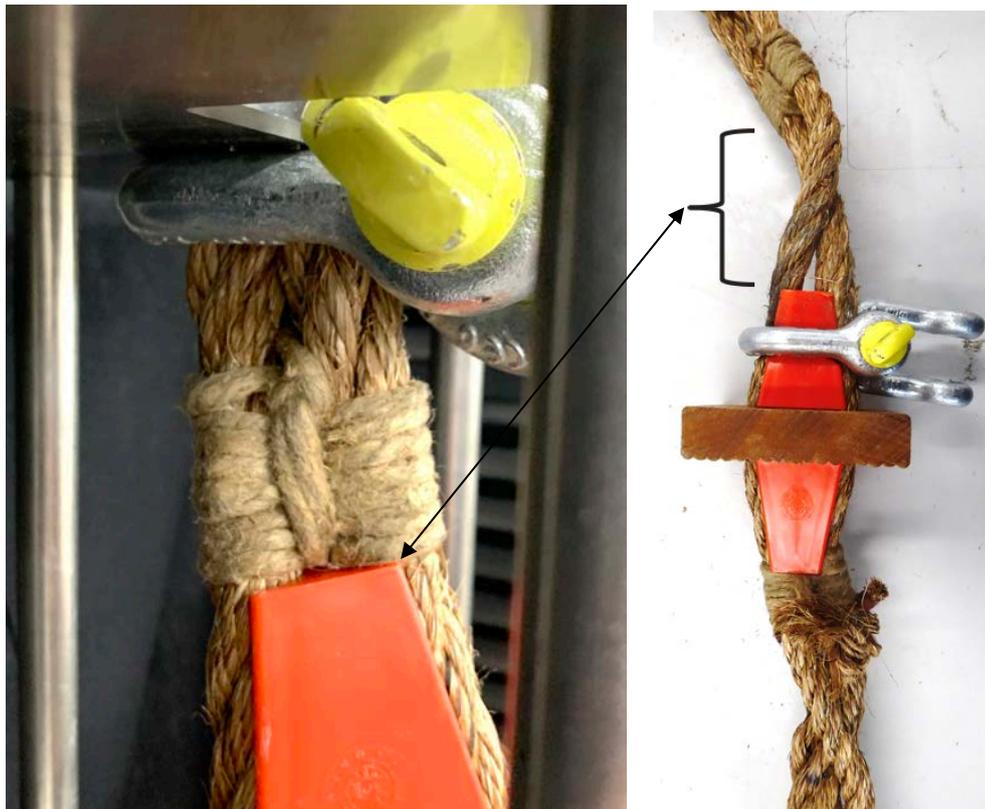
Figure 69 : Left: Specimens E at 0 cycles showing the top chock in contact with the top seizing, and Right: at 1500 cycles showing that the bottom rope seizing slipped down the rope contacting the splicing. Note the distance the chock has travelled and is now over 100 mm away from the top seizing.

A significant part of the damage witnessed was caused by the D-shackle transferring its loading to the step assembly. Each side of each step assembly is designed to carry the weight of one pilot and their kit, preventing the step sliding down the ladder pair are the fixings (rope seizing or metal clips – see Figure 10). This work has shown that the metal clip is much more effective (under the dry conditions tested) at providing a clamping force to grip the rope pair. When the D-shackle was able to transfer load to a pilot ladder with rope seizing the step assembly migrated under the test loading (see Figure 69 and Figure 71). There is therefore a risk as the same would

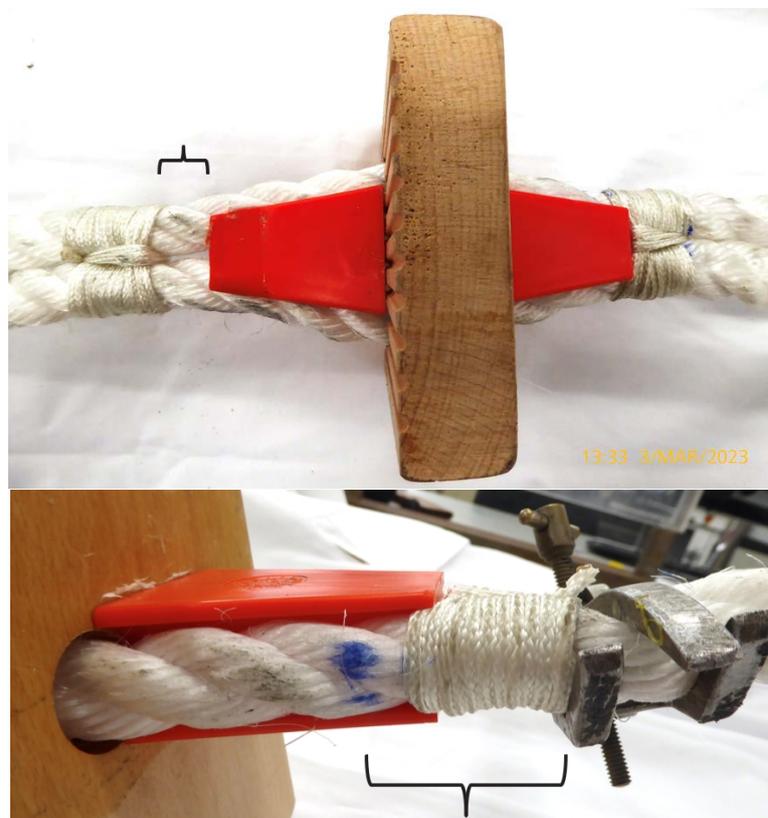
Figure 70 : Specimen M the wooden step assembly slipped downwards (top). The bottom rope seizing slipped approximately 30 mm until it was prevented from slipping due to the clamp (lower).

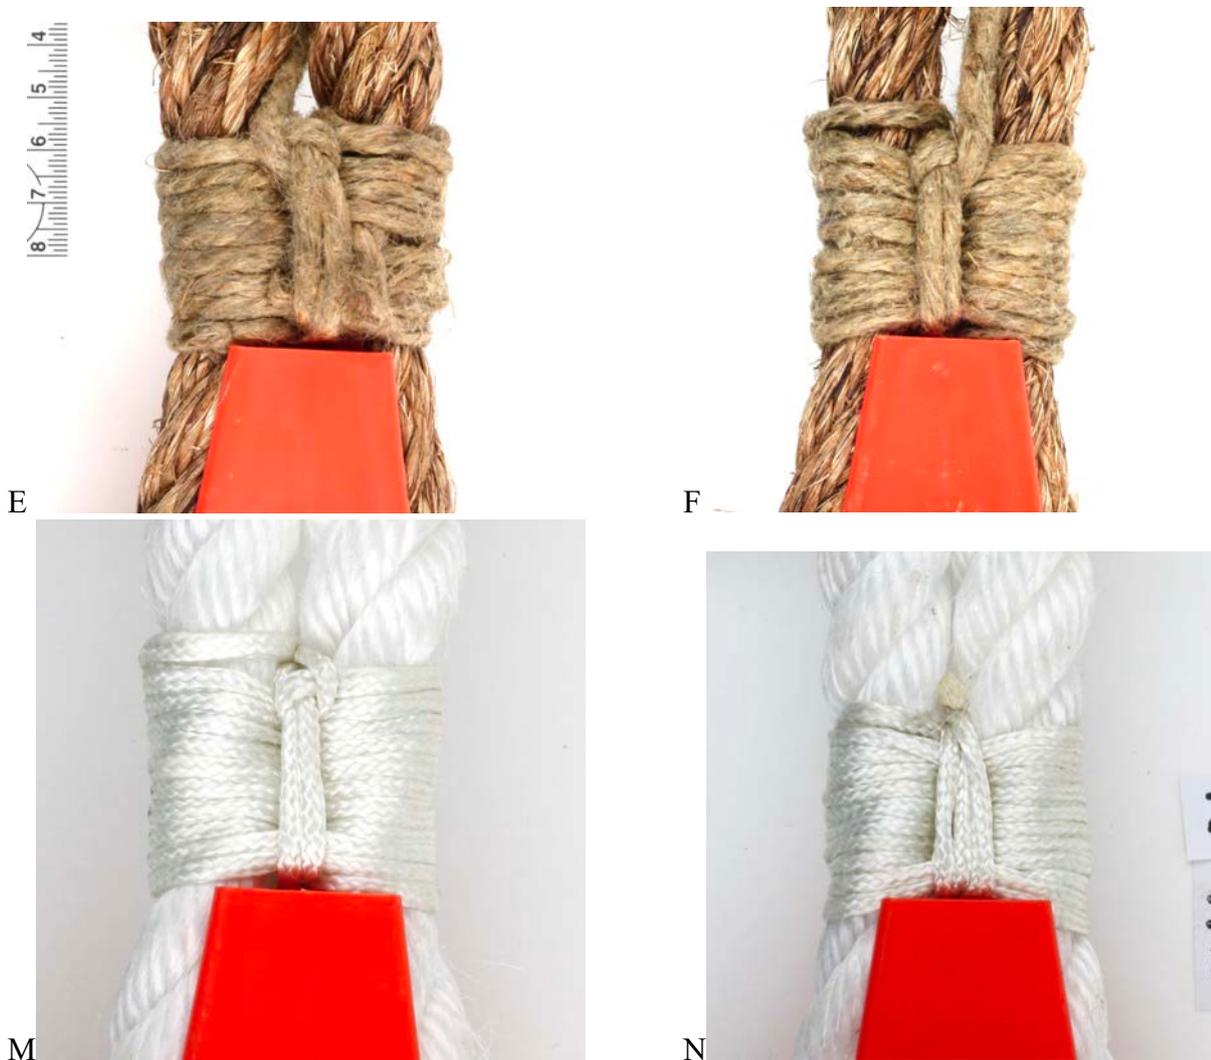
Figure 72: Images of the upper rope seizing, note each is in the required figure-of-eight racking and over the required 32 mm length (BS ISO 799).

There may be several reasons why this may not occur to this extent in-service. The ropes tested were dry ropes (see Figure 72), however, in-service it is likely the ropes will be saturated with sea water. The sea water may cause rope swelling which may increase the effectiveness of the rope seizing. Additionally, the fixed angle of the shackle results in a constant perpendicular angle with the axis of the rope. This is a worst-case scenario, in-service the shackle will likely be able to twist at an angle reducing the load in the slippage direction.

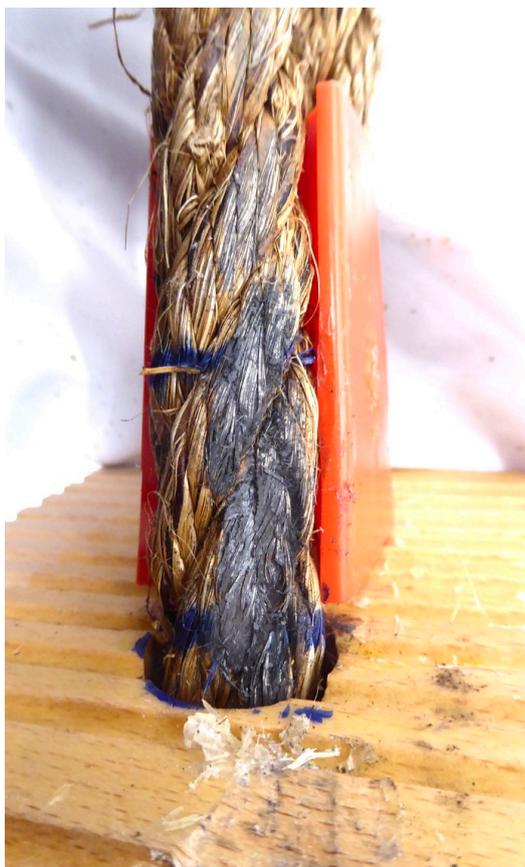
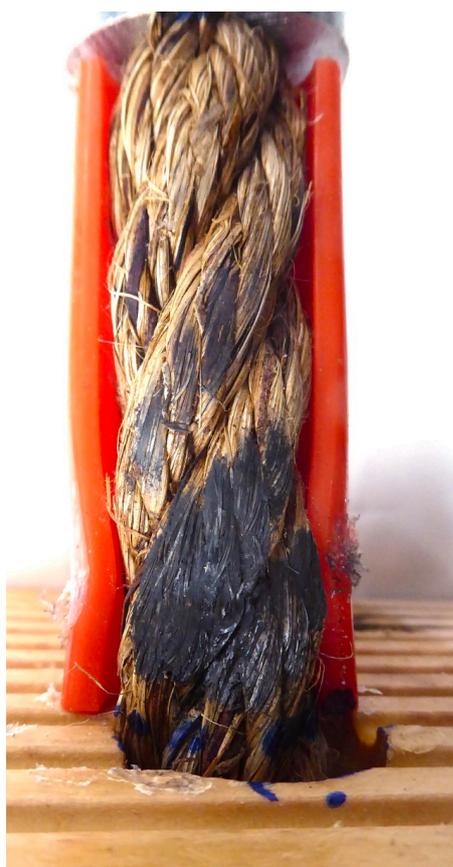
F: Maninla rope (manila seizing) large shackle. G: Maninla rope (metal clip) large shackle

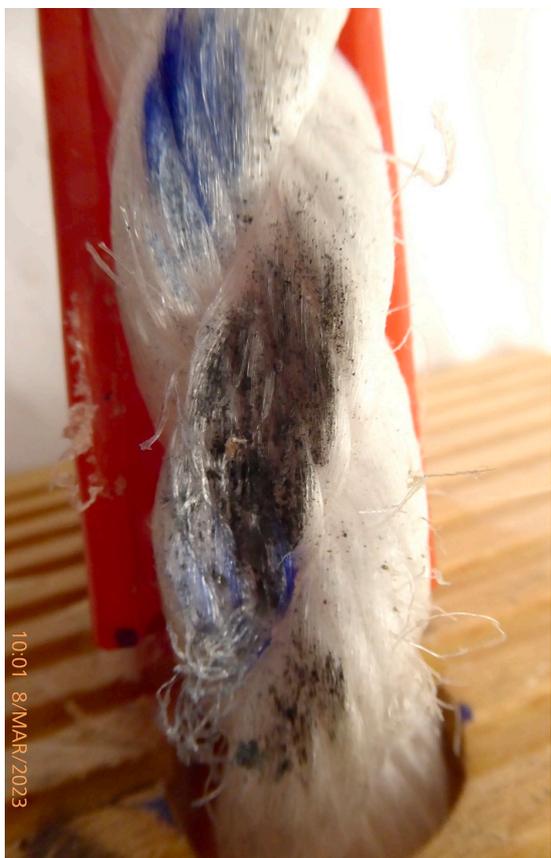
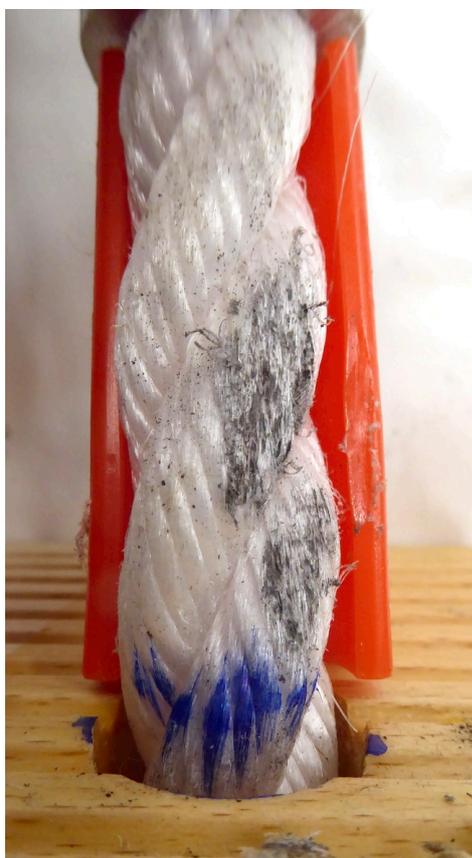
N: Polyprop rope (polyprop seizing) large shackle. O: Polyprop rope (metal clip) large shackle

Figure 73 : Specimen F, G, N, and O showing damage to the rope from the large shackle.

*The shackle caused rope wear:* Both the small and large floating shackles wedged in between the inside faces of the chock and the rope during testing. With the addition of a release step (applied release force to simulate removing the shackles), some level of rope wear occurred to both rope materials. A black deposit can clearly be seen on the surface of the ropes (Figure 73). This black deposit is most likely due to the shackle coating rubbing on the rope surface (fretting). A more prominent black deposit can be seen on the manilla rope due to the rougher surface of the manilla rope material (Figure 73 and Figure 74). The individual strands from the polypropylene and manilla rope were observed under a macroscope after testing had been carried out. The strand with the most amount of wear for both the manilla and polypropylene rope material are shown in Figure 75. The strands remained predominantly intact with less than 10 % of the fibres, in the strand examined, becoming broken. Clearly broken fibres and obvious wear would not pass any regular inspection of the pilot ladders in-service.

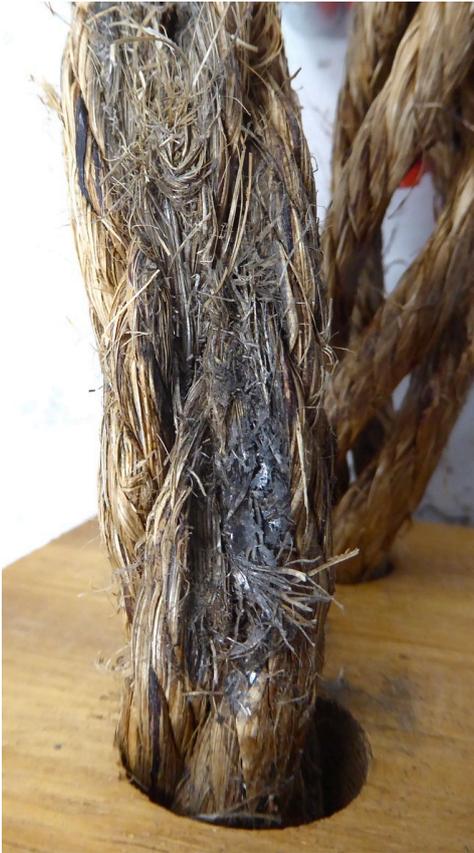
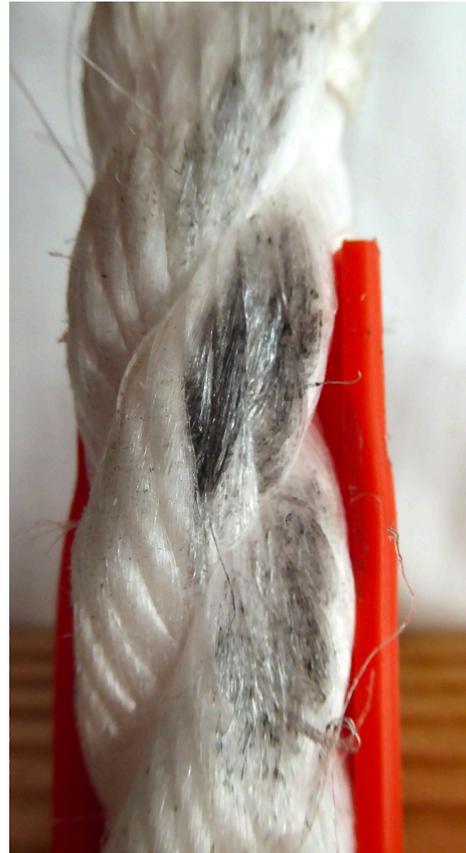
E: Manila rope (manila seizing) small shackle. M: Polyprop rope (polyprop seizing) small shackle.

Figure 74 : Specimen E and M showing the damage to the rope from small shackle rubbing – note that H and P are not shown as the small shackle stopped at the metal clip.

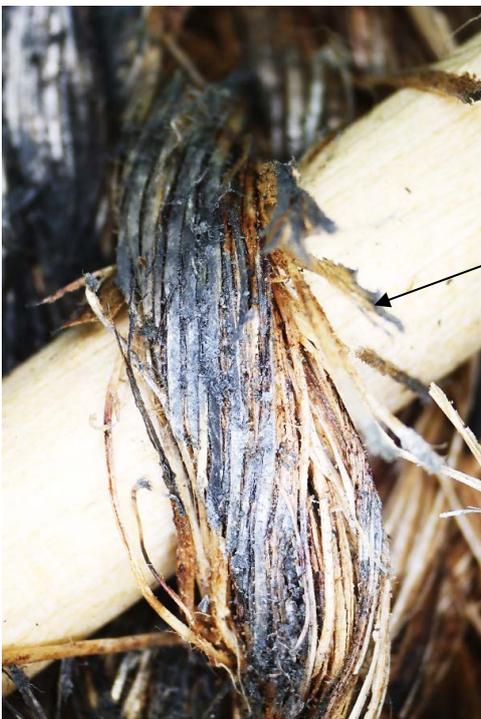
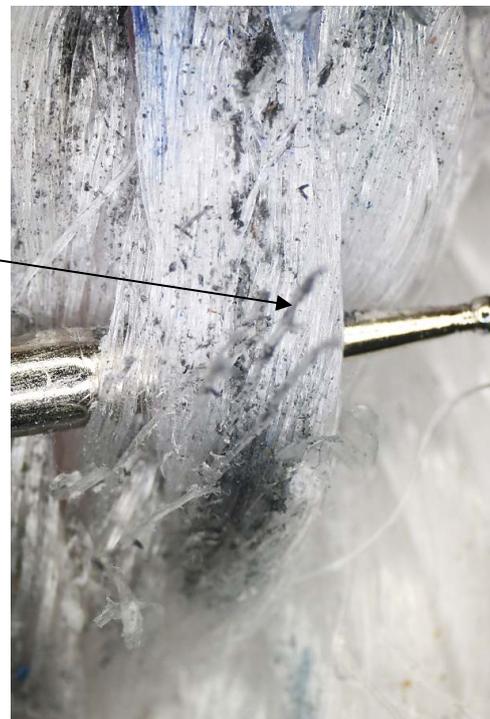
Broken fibres

Figure 75 : Macroscopic images of the worst worn strands from Manilla and the Polypropylene rope material.
