Title of Work: *Securing of pilot ladders at intermediate lengths – testing*

Reference No: *NCC453*

Work for: *International Maritime Pilots Association*

Report Issue No. *3*  
Date: *17 July 2023*

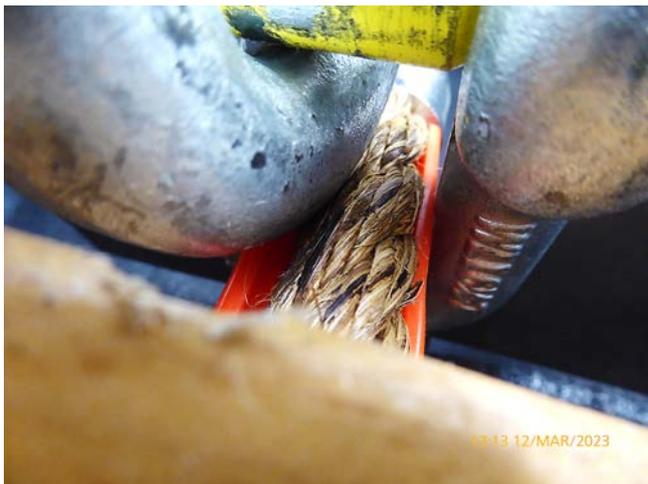
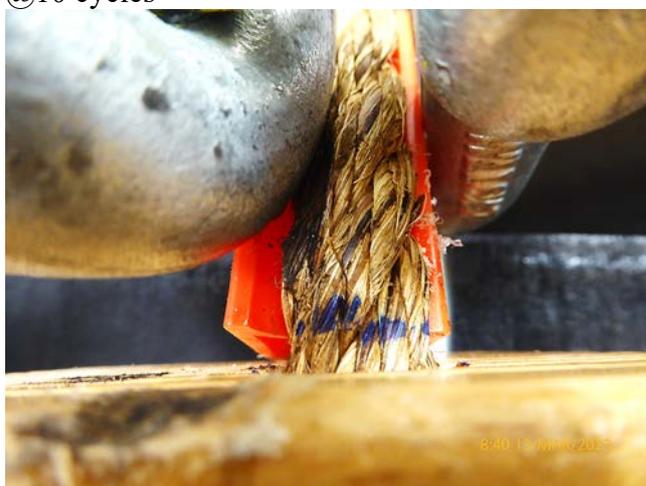
Figure 76 : Specimen G showing the progression of the rope wear during testing for 5 cycles (Top left), 10 cycles (Top right), 100 cycles (Bottom left), and 1300 cycles (Bottom right).

*The rope wear was observed within the first 100 cycles:* Within 5 cycles, black deposit from the shackle material coating was observed on the rope. The black deposit built up and became more prominent over a 100-cycle period. Comparing the 100<sup>th</sup> cycle to the 1300<sup>th</sup> cycle showed that the majority of the black deposit and the rope wear tended to occur in a short period of time, typically by 100 cycles (Figure 76).
