PTR HOLLAND® GROUP

**PILOT LADDER MAINTENANCE,
USE, REPLACEMENT
& INSPECTION RECORD BOOK**

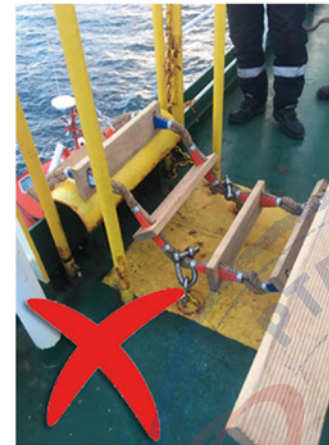
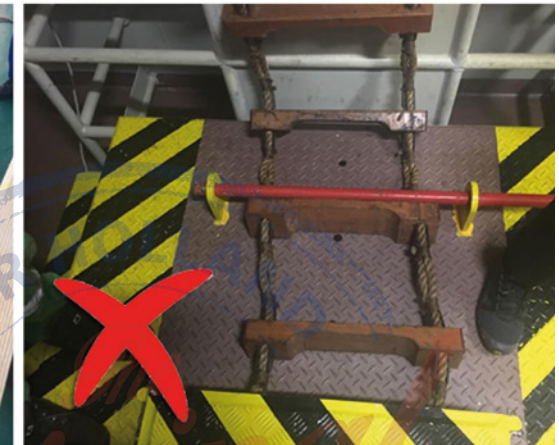
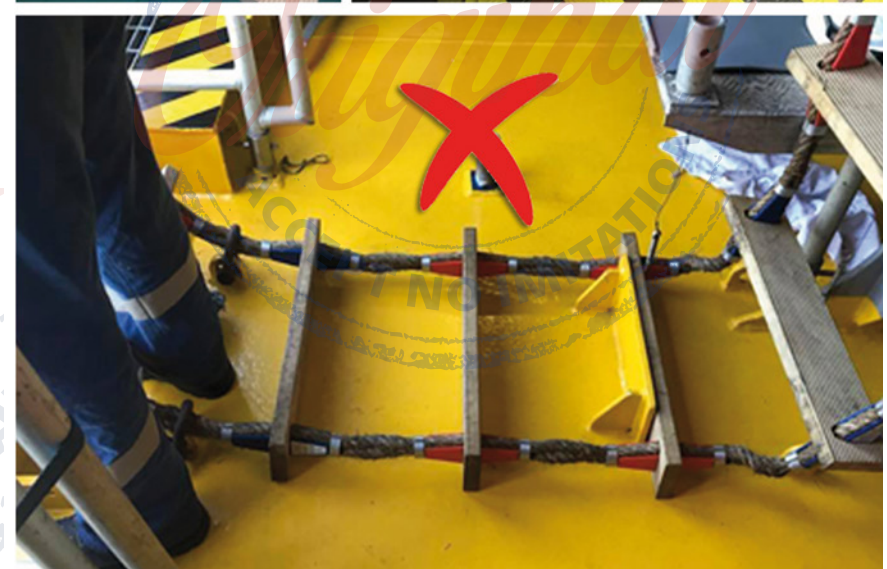
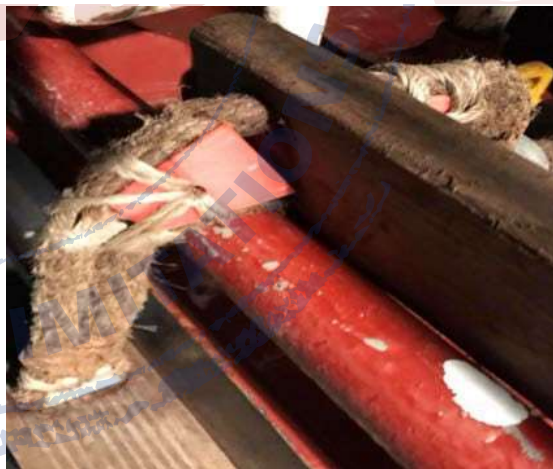
Examples of unacceptable Rigging for a Pilot Ladder

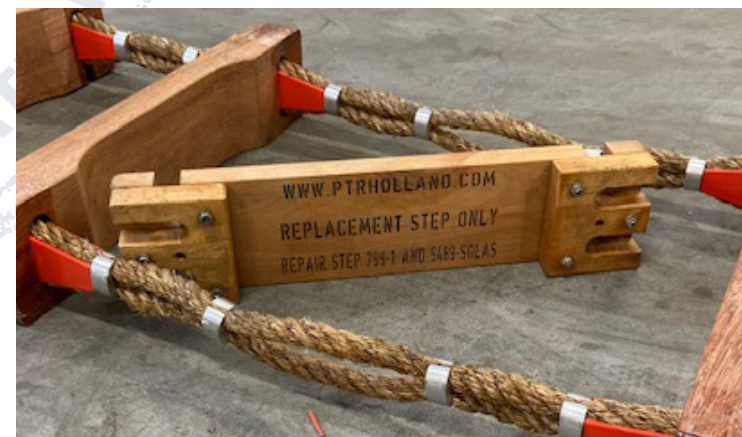
Replacement Procedure For Whippings

1. The damaged step or spreader should be carefully removed along with the whippings above and below the step. Every care should be taken not to damage the side ropes during this operation.

2. The replacement step/spreader should have the chokes placed on either side of the step where the cut outs are. Half of the choke one side of step and half the other side of step.

4. A figure 8 seizing of 3 ply tarred marlin should then be applied both above and below the winnet on both sides of the ladder to hold them tightly in place. The whipping should consist of a minimum 38mm length around both ropes and should be locked off with by means of a double frapping and finished off by passing between the side ropes.
