PTR HOLLAND® GROUP

**PILOT LADDER MAINTENANCE,
USE, REPLACEMENT
& INSPECTION RECORD BOOK**

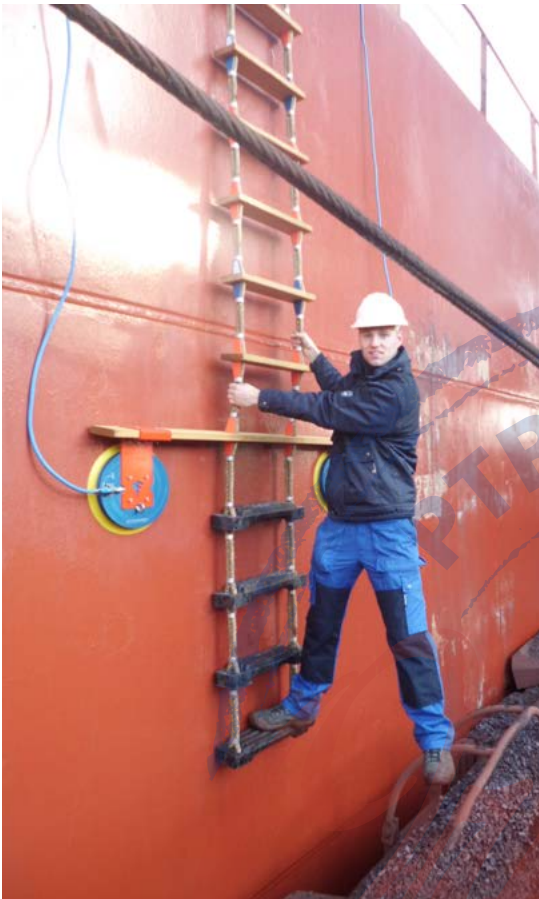
Examples acceptable Rigging for a Pilot Ladder

Inspection Intervals for securing equipment (bowing), due regard should be given to the inspection intervals of this instruction booklet, and ISO799-1

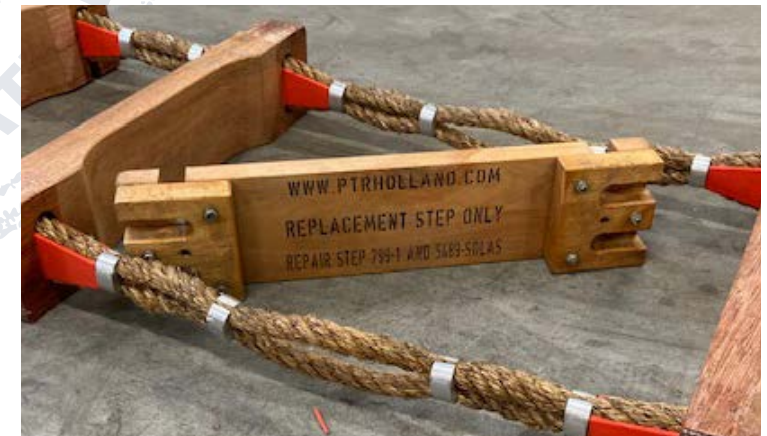
Replacement Procedure For Whippings

1. The damaged step or spreader should be carefully removed along with the whippings above and below the step. Every care should be taken not to damage the side ropes during this operation.

2. The replacement step/spreader should have the chokes placed on either side of the step where the cut outs are. Half of the choke one side of step and half the other side of step.

4. A figure 8 seizing of 3 ply tarred marlin should then be applied both above and below the winnet on both sides of the ladder to hold them tightly in place. The whipping should consist of a minimum 38mm length around both ropes and should be locked off with by means of a double frapping and finished off by passing between the side ropes.
