BW guide to Pilot Ladder compliance

Marking, Certification

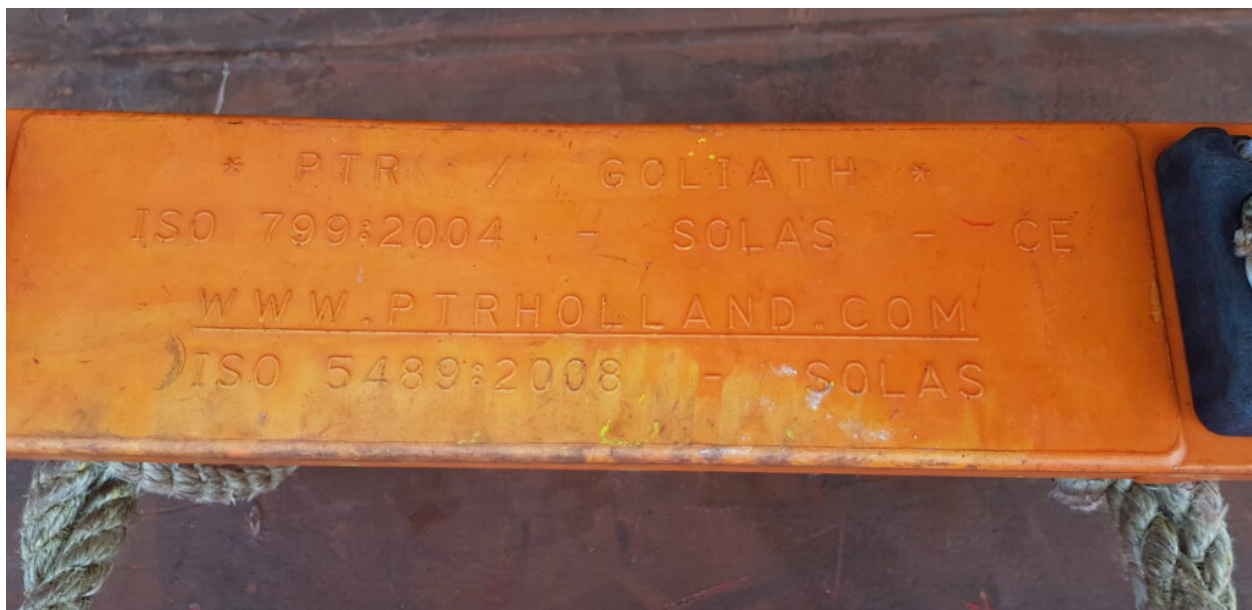
Marking under the step of the mentioned ladder

This is for instance a PTR Goliath ladder marked with all of the above items, except for the fact that ISO 799:2004 is still mentioned. This standard has now been replaced by ISO-799-1:2019.

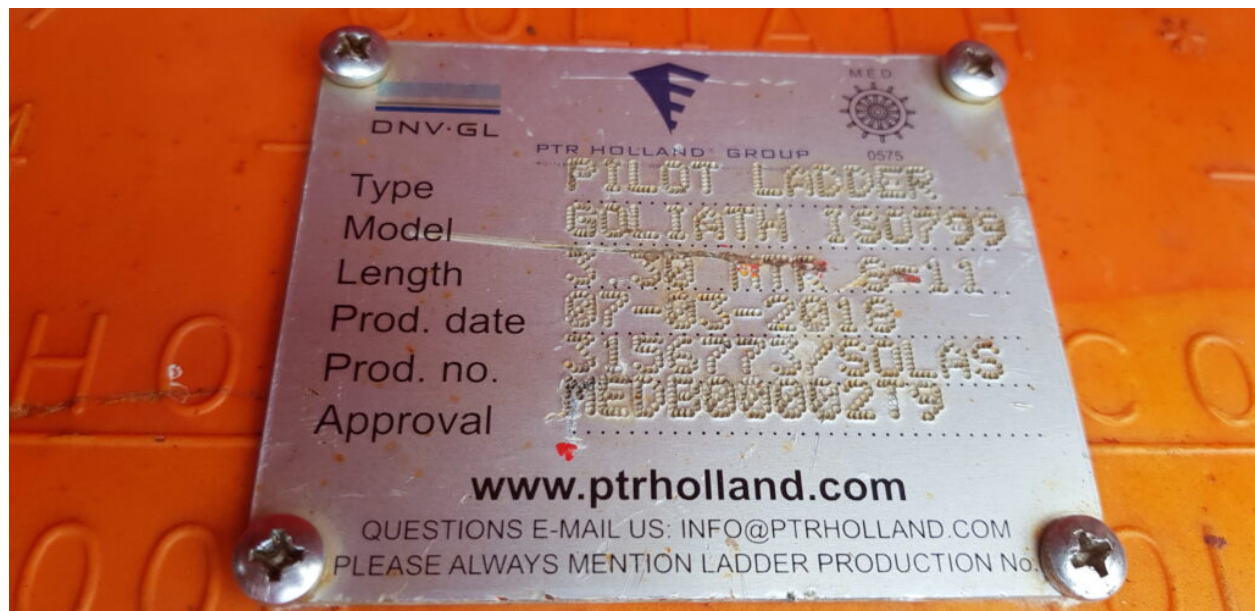
Name tag plate of the mentioned pilot ladder

The name tag plate on this ladder displays a few important items that can be cross referenced with the certificate: Type, Model, Length, Production date, as well as the serial number (Prod.No) and the approval standard.

There are **3 logo's** on the top of this plate, which are important in this respect:

- **The DNV-GL logo**, the classification society that type approves this ladder, as well as the Manufacturing Company.
- **The PTR Holland logo**, which is the logo of the Manufacturing Company
- **The Steering wheel**, marked with MED, as well as the number 0575. The symbol and "MED" stand for Marine Equipment Directive 4.49, the EU standard for pilot ladders for all EU flagged vessels. The number indicates the EU designated number of the "Notified Body" which is DNV GL in this case.

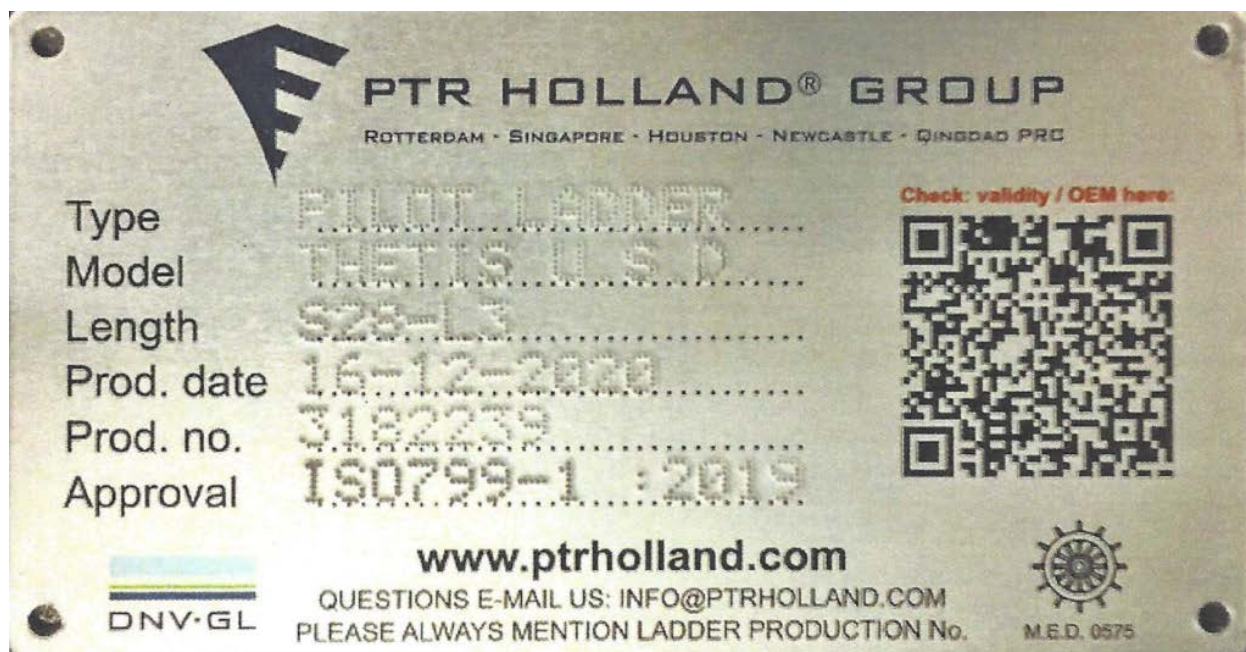
- **Registration QR code:** The manufacturer of these ladders uses blockchain technology to keep track of the ladders produced. On the latest ladders, the steel plate on the ladder also shows the same QR code. This allows inspectors to easily scan the pilot ladder and check online if all specifications are correct. (see below)

Pilot ladder name tag with QR Code

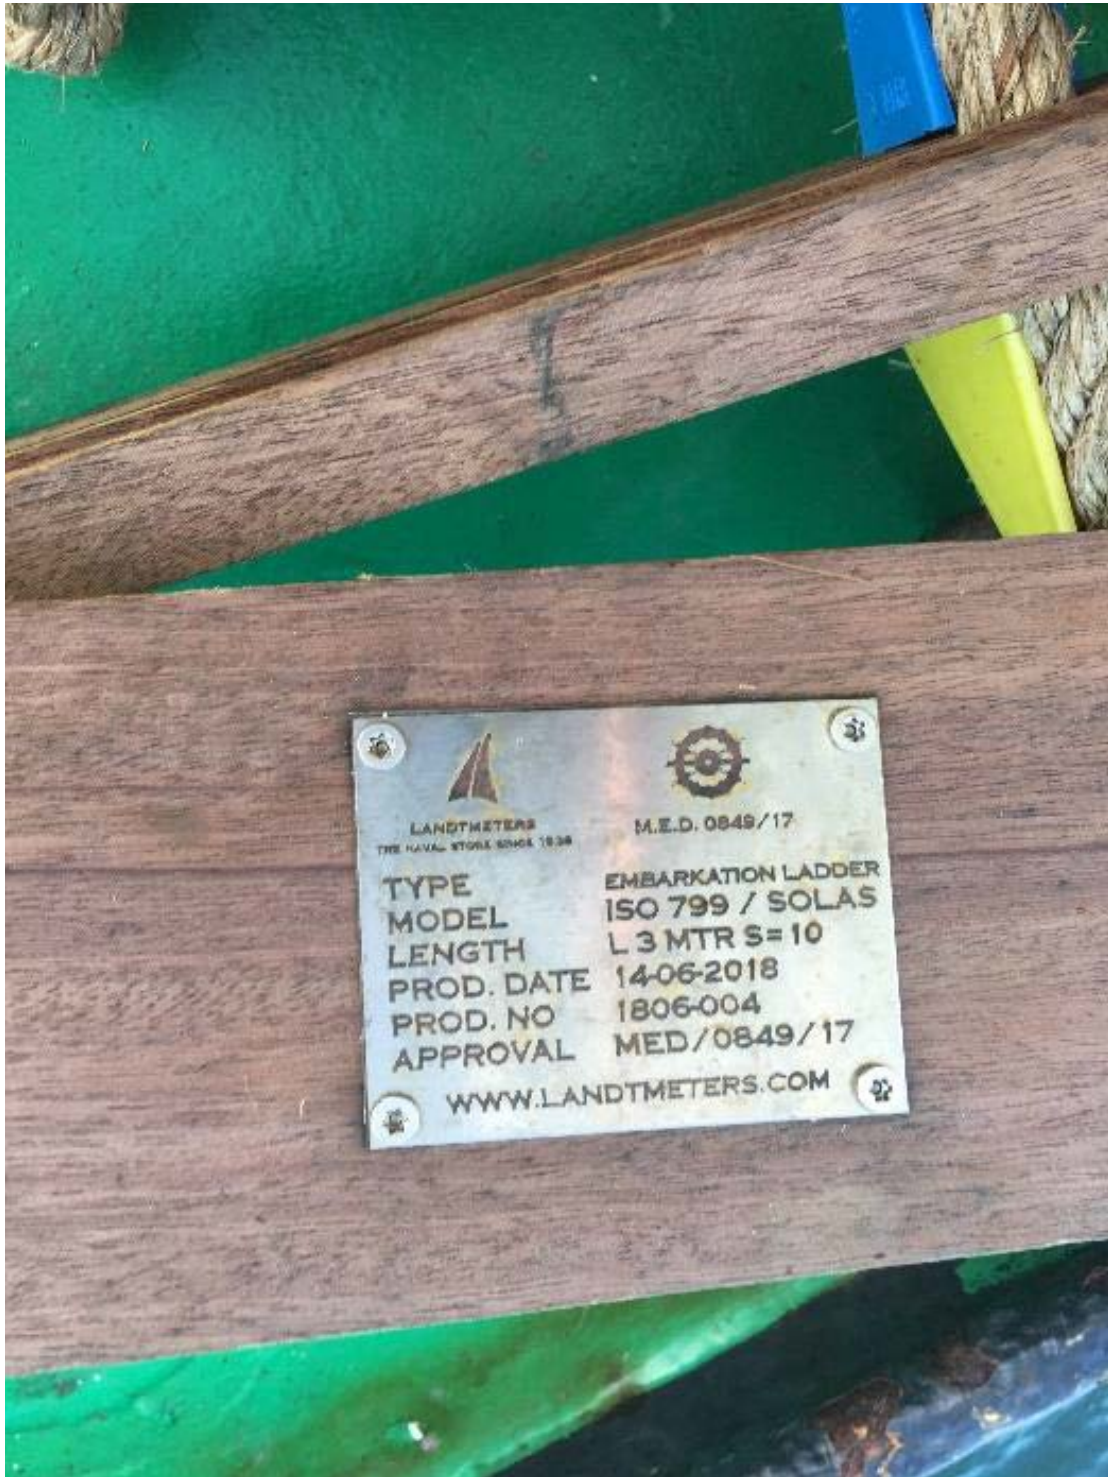
On this particular tag we see ISO 799 reference, which is the correct ISO standard for a pilot ladder, but when we look closer, we see 'embarkation ladder' on the tag. This basically means the tag is wrong, ladder cannot have been tested and approved to specs as required for a pilot ladder. Embarkation ladders have a different ISO number, different specifications than a pilot ladder and will be used for a different purpose.

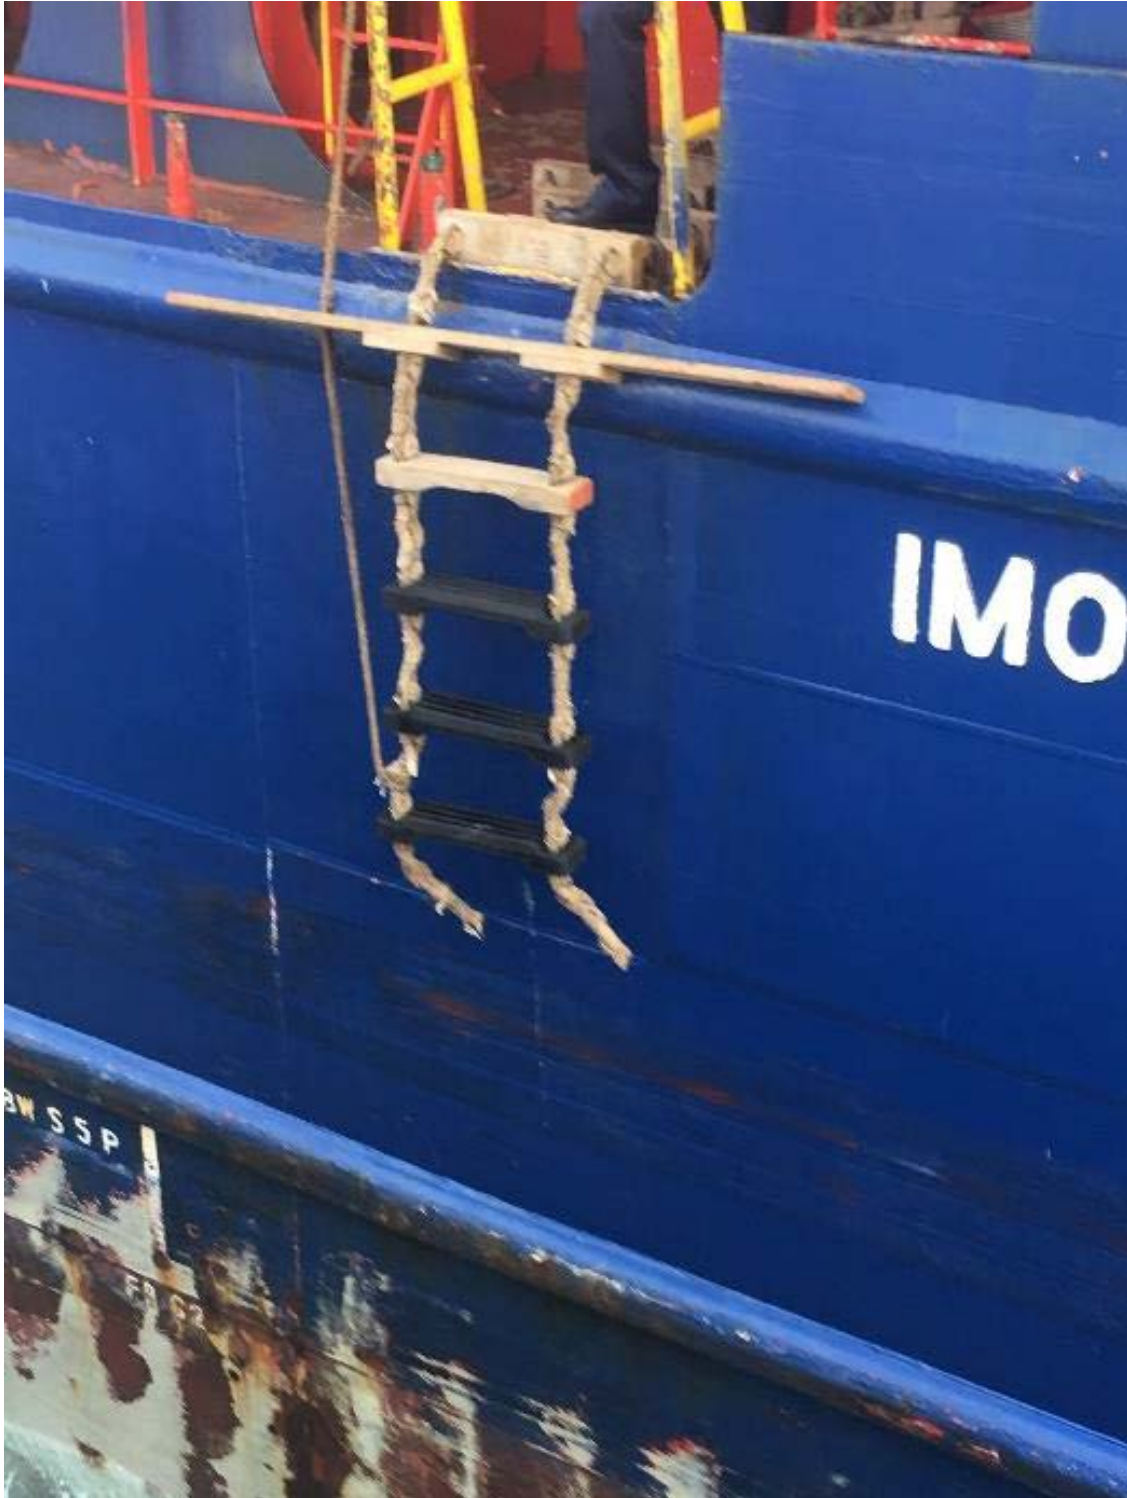
In the photo we see a ladder with 3 rubber steps instead of 4 as required. Therefore, this can never be a certified pilot ladder. We also see a spreader in this ladder. There are rules concerning spreaders as well-off course: (IMO A.1045, 2.1.4) *Pilot ladders with more than 5 steps should have a spreader not less than 1.8 m long....The lowest spreader should be the fifth step from the bottom of the ladder and the interval between any spreader step and the next should not exceed nine steps.*

IMO a.1045 2.1.2.1: if made of hardwood, they should be made in one piece, free of knots.

Every step on the ladder has to be made out of one-piece, self-made ideas on steps or spreaders are not allowed and make the ladder non-compliant and it cannot be used anymore.

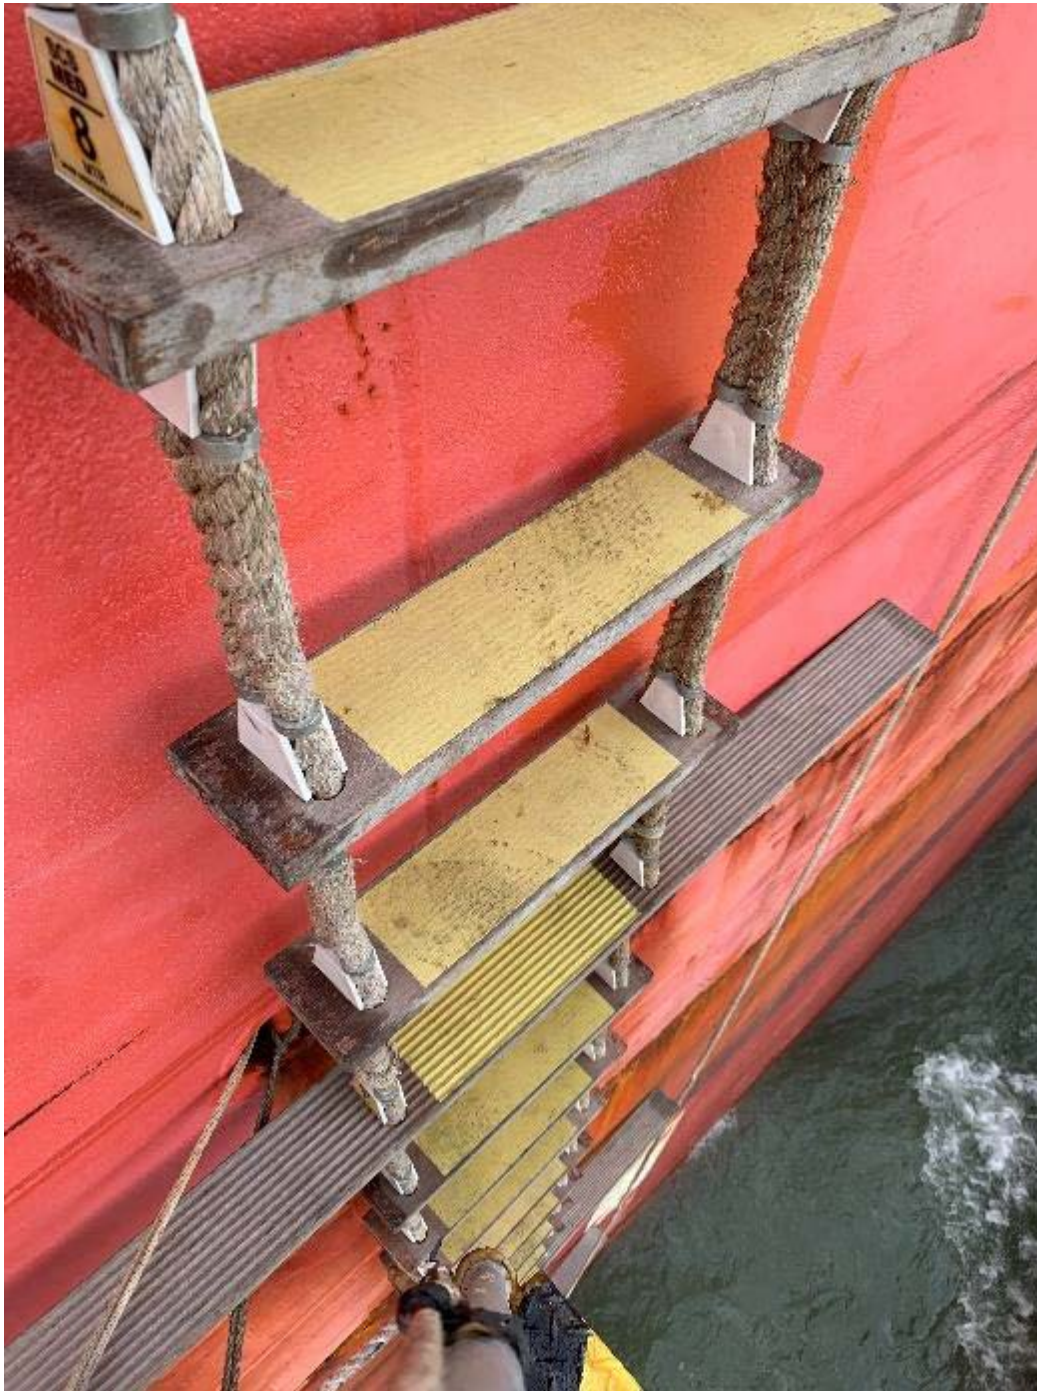
This brand of ladders you can come across quite often, ladders shall not be painted or varnished, which means this is absolutely a non-compliant ladder.

IMO a. 1045 states in 2.1.2.4: they should have an efficient nonslip surface...varnish and non-slip don't go together really well.

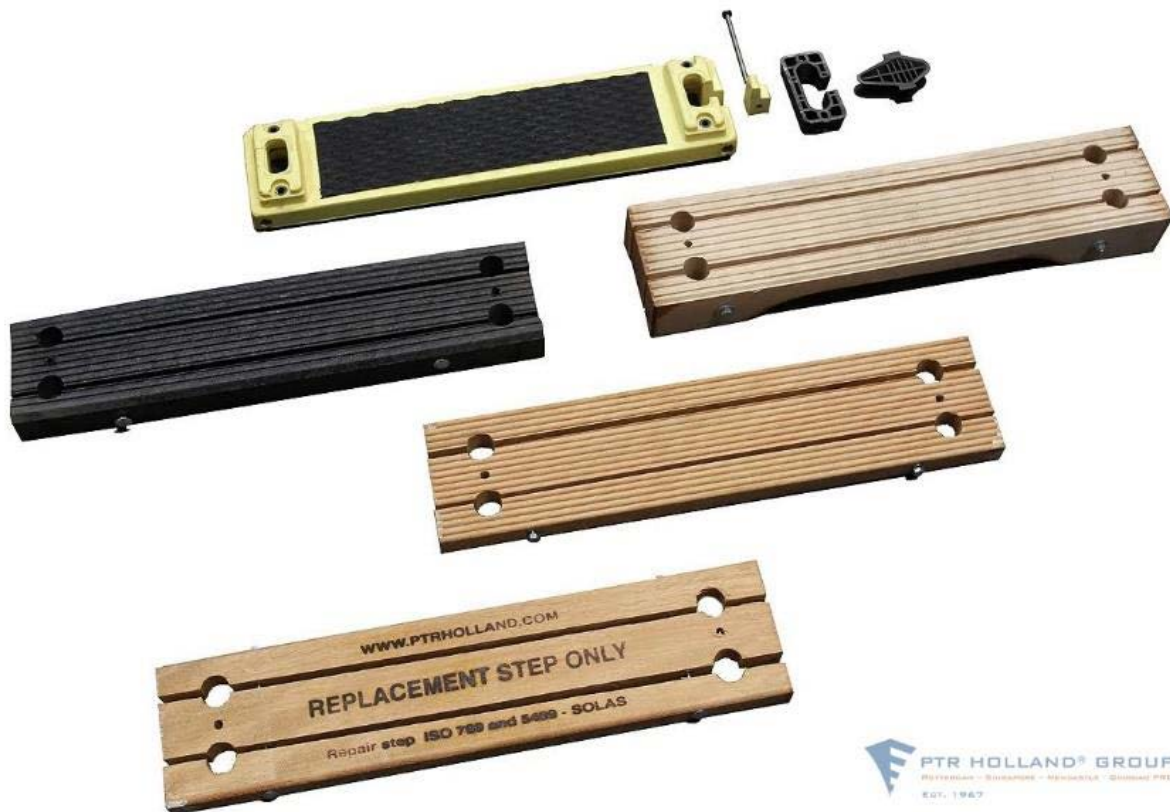
Every manufacturer has to deliver repair steps and spreaders together with every sold pilot ladder. On this picture we see different repair steps, as they will be delivered with the ladder.

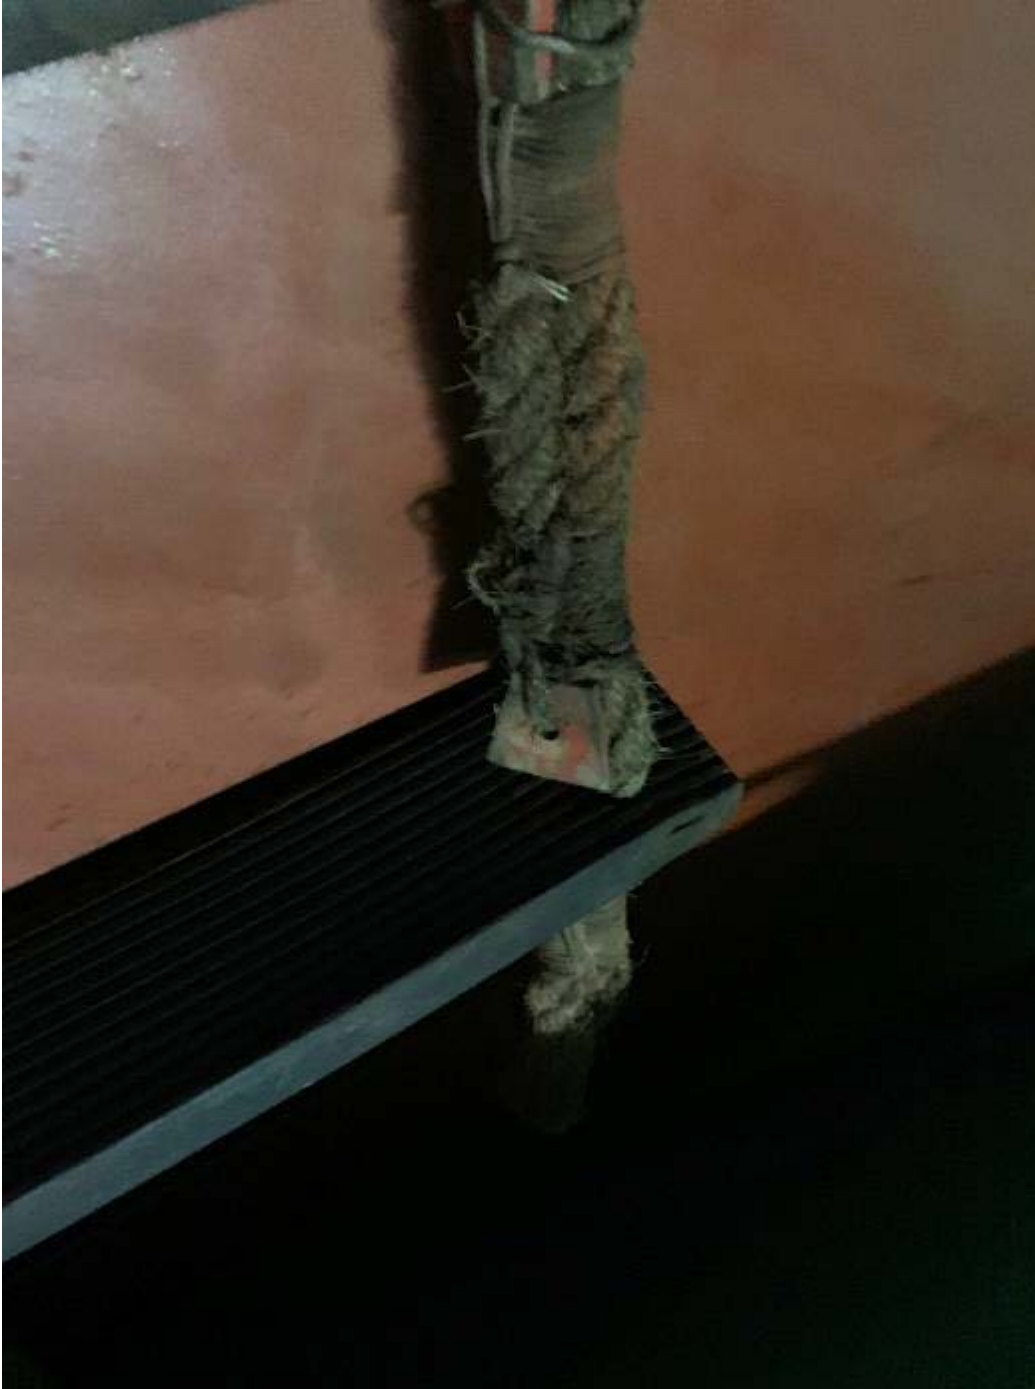
In the photo above, we find the whipping method and right away we see the danger of this method, when no proper maintenance has been given. The whipping ropes are, as the side ropes, natural fiber and have to be inspected and maintained on a regular base. Whippings can come loose as you can see and then the steps are not hold in place anymore. This will lead to loosen and not horizontal steps.

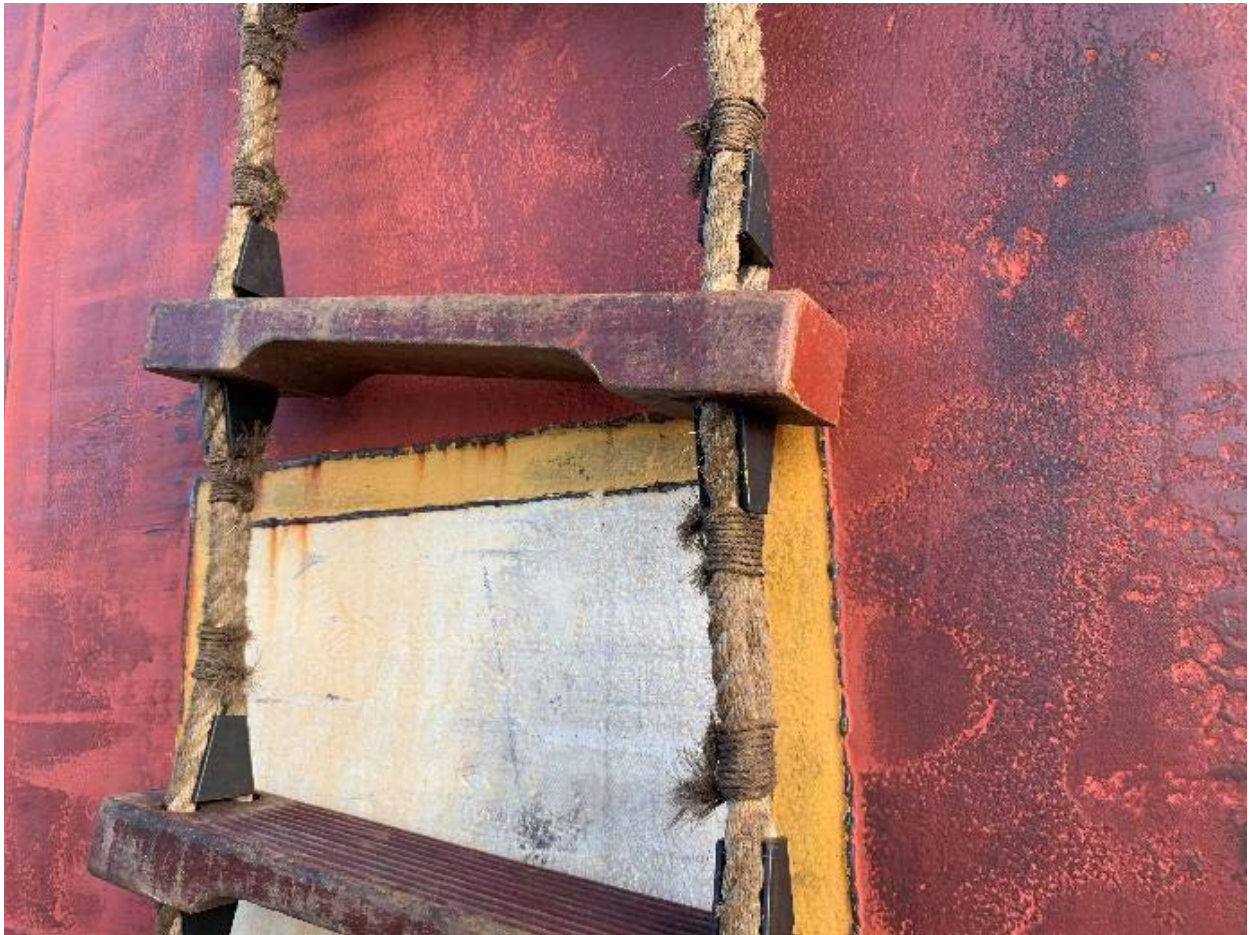
Loose steps due to worn out whippings.

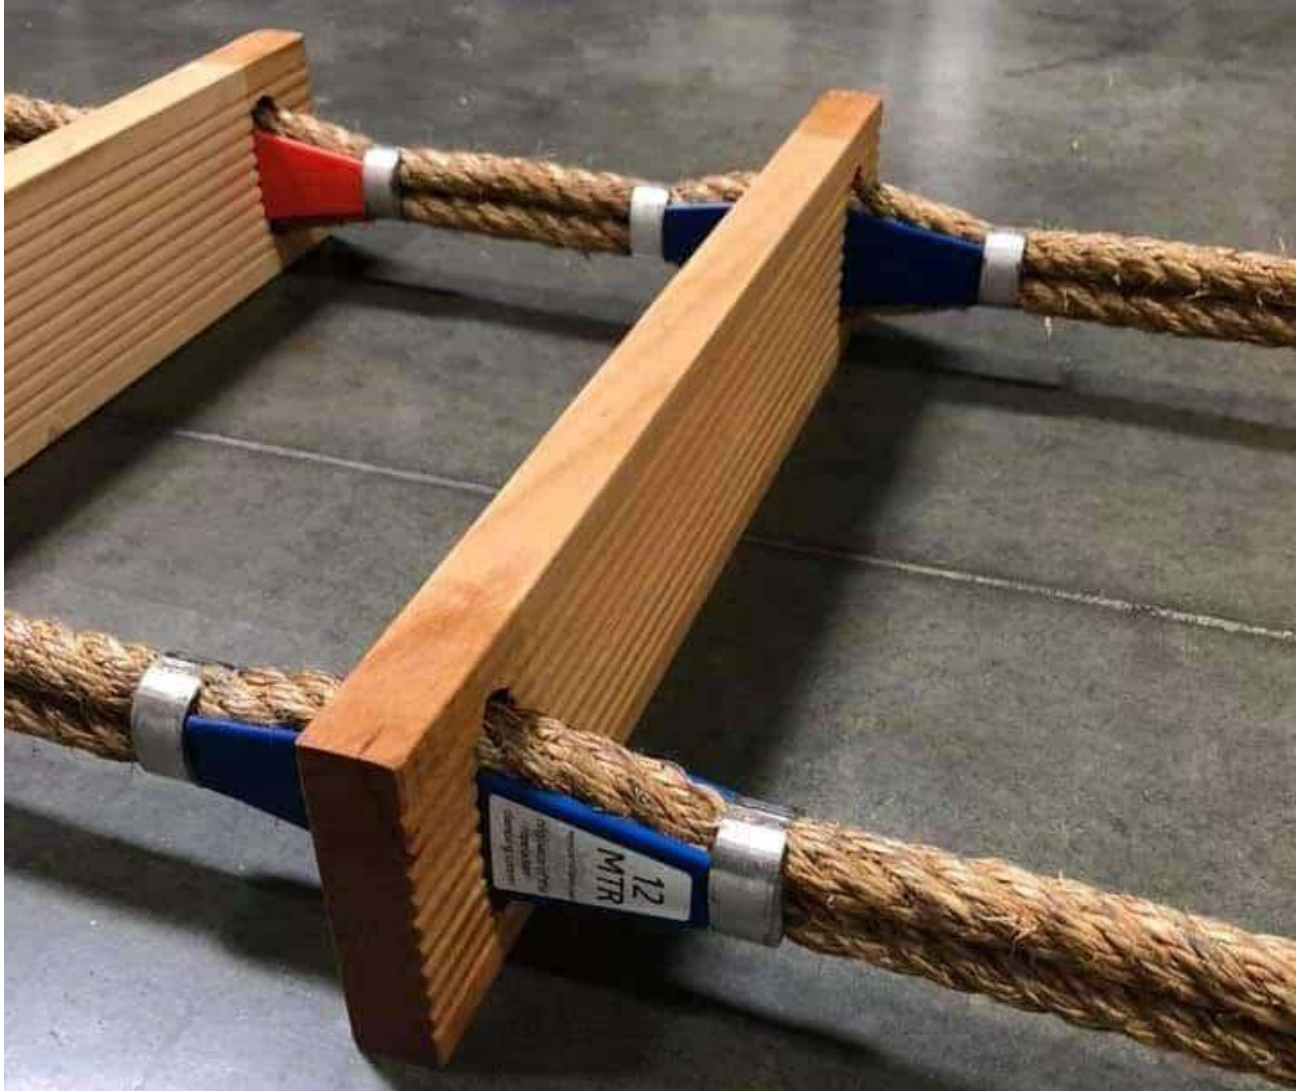
This is a proper clamping method: clamp is around the rope, but does not touch itself, which obviously means the rope will not be choked.

A method that has been invented by one of the bigger ladder manufacturers back in 1986. They have also patented the system. The danger in this system is that, when the clamps have not been installed correctly, they will 'choke' the side ropes, and that can result into breaking of the side ropes, because the internal structure of these ropes will be damaged.

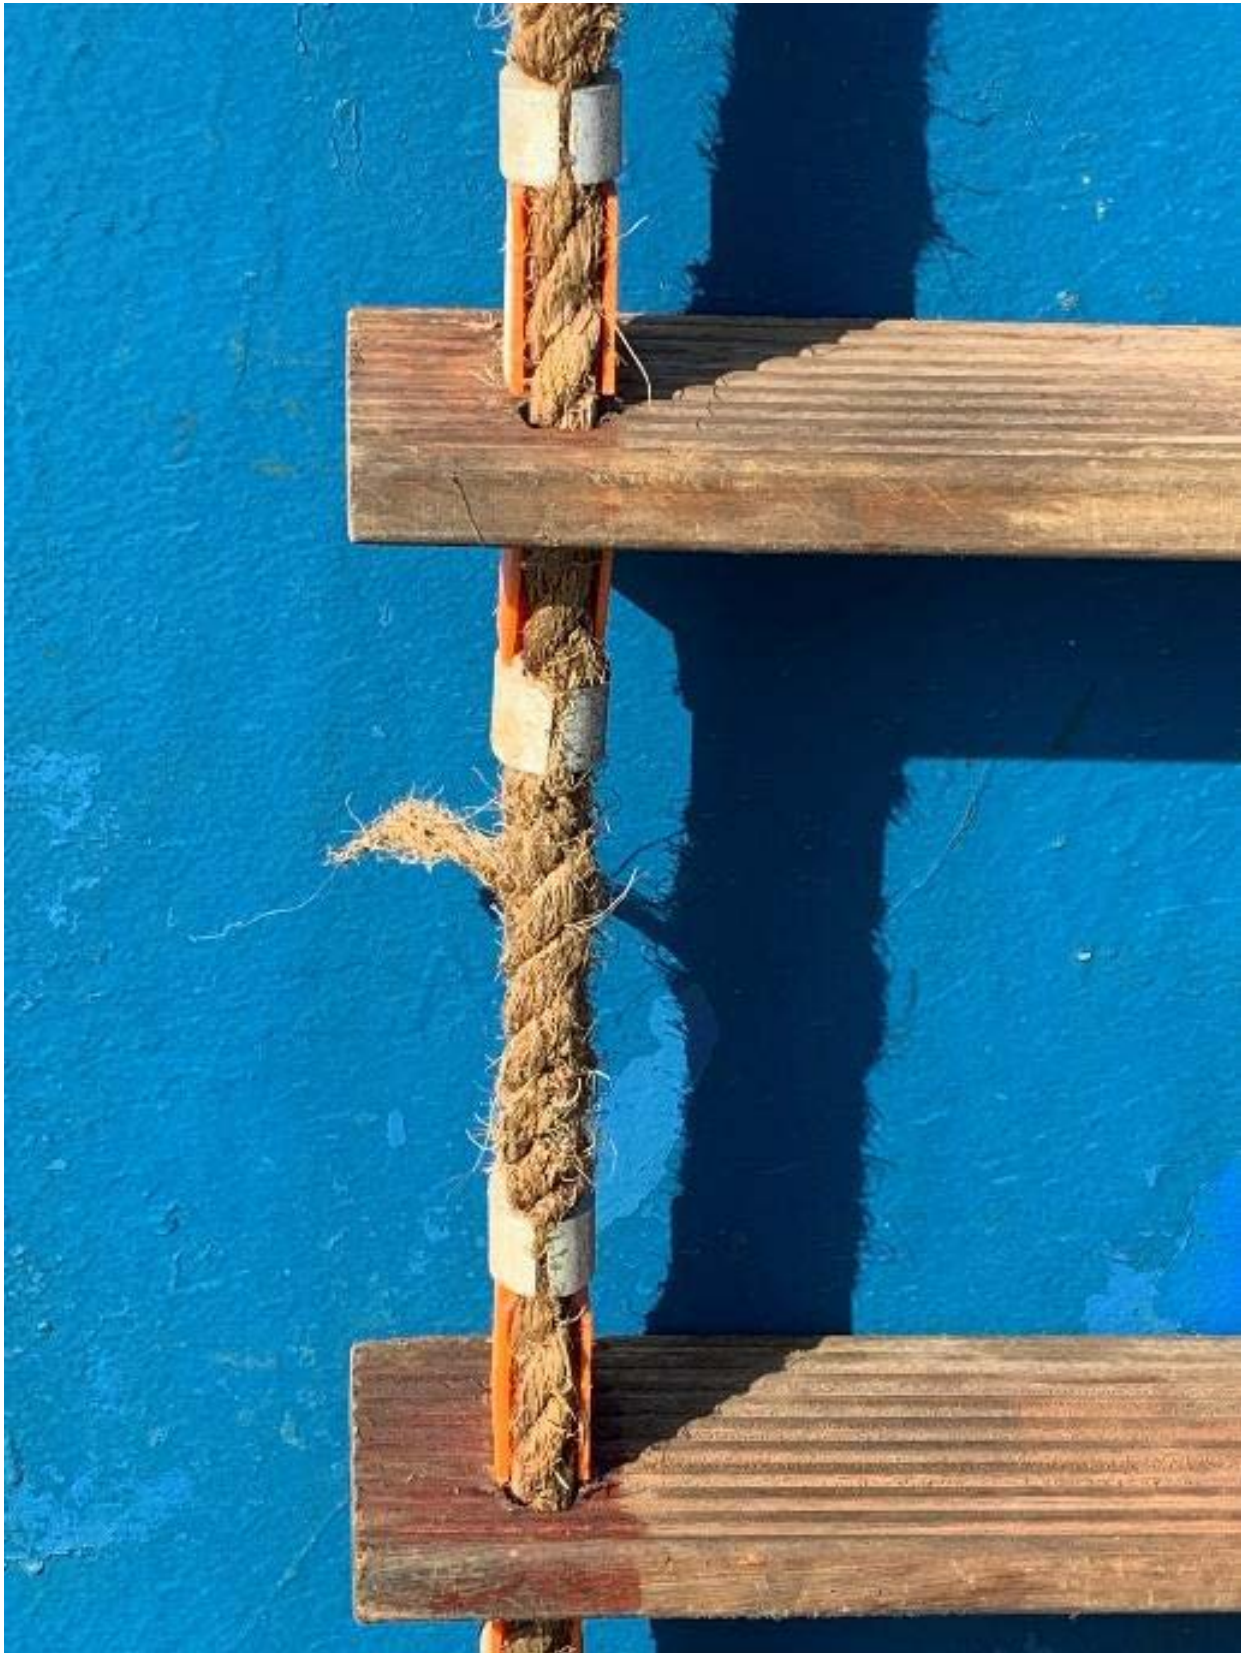
Here we see the clamps are too tight and the result is visible: rope gets stuck in between the two ends of the clamps...rope comes apart and the ladder could break when you use it.

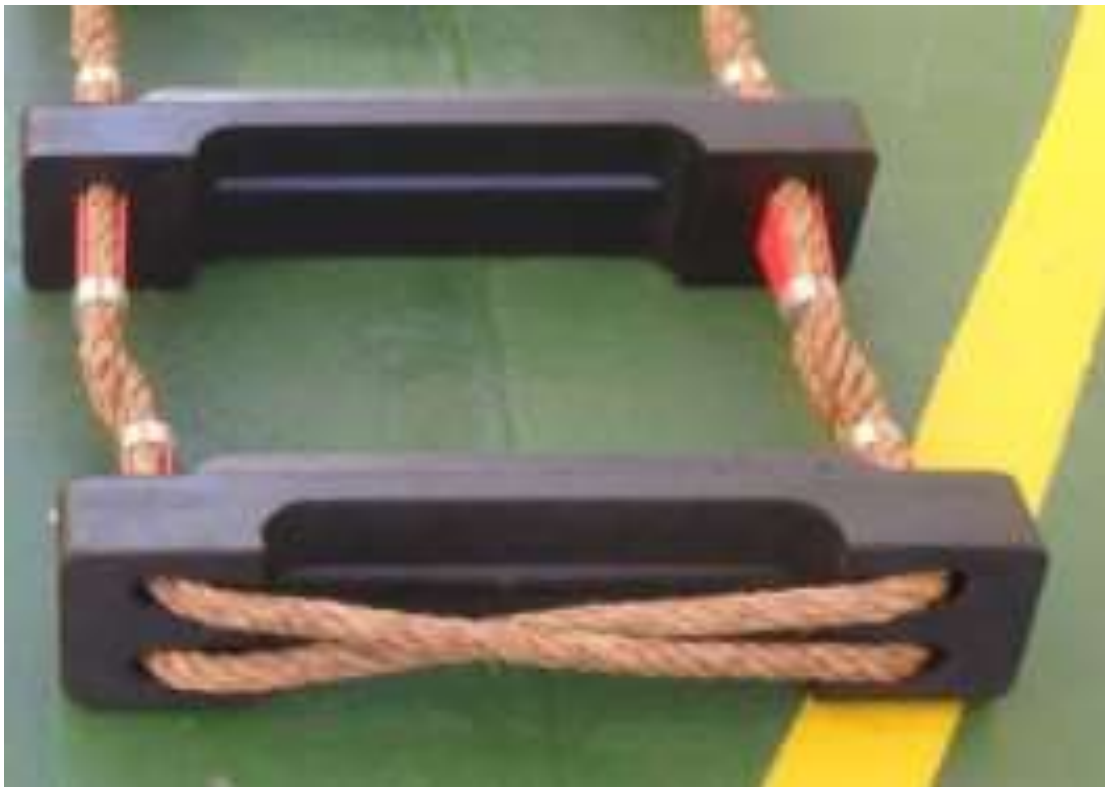
Example 1 – rope crossing

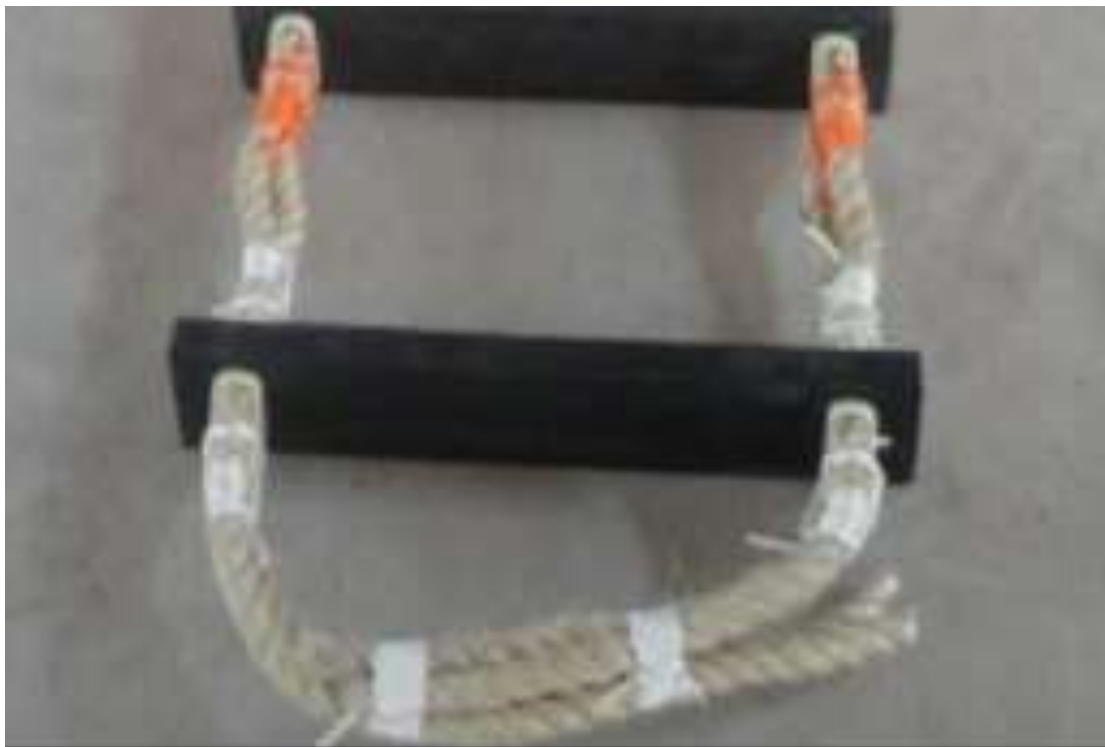
Example 2 – loop below lowest step
